DYNAMIC BEHAVIOUR OF ADOBE MASONRY HOUSES IN CENTRAL MEXICO

Julio Rojas ¹, Hugo Ferrer ², and Julio Cuenca S. ³

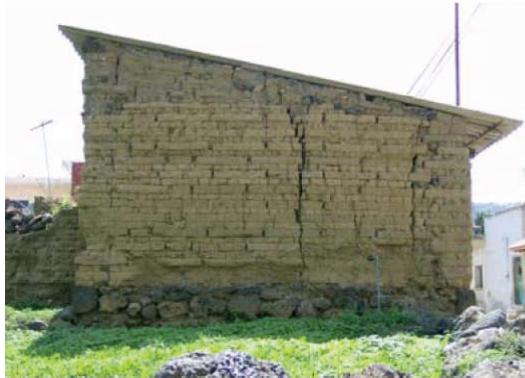
In Tlayacapan, we found a house with two vertical cracks (Fig. 3) and without columns, beams or frames in windows and doors and reflecting self-building. A house with a wall of stone on its base of 0.5m to 1m thick, the adobe blocks with a large between 45 and 50 cm, which gives a good stability to adobe walls, roofs with tiles or sheets (prior coverage insulating material) and wooden beams (figure 4).

Figure 3: Adobe house in Tlayacapan, presents vertical cracking, there are no beams or columns. A short wall of stones on the base is not sufficient, on support the house on foot. Its roof is laminate.

Another typical failure in adobe houses is the cracking of the walls due to the absence of columns or beams or adequate frames at door or windows, which gives to the structure the stability and flexibility necessary. This type of failure can be appreciated in figure 3 where is showed a vertical crack. Moreover, due to most of adobe houses have very large walls without reinforcement this provokes flexion at middle of the wall (figure 9) that generate failures in some elements.

Finally, due to the instability of walls in a seismic, and to the fact that roofs are usually heavy, the fall of the roof could occur as it can be appreciated in figure 3 where the original roof has fallen and has been replaced by a laminate roof that is less heavy.

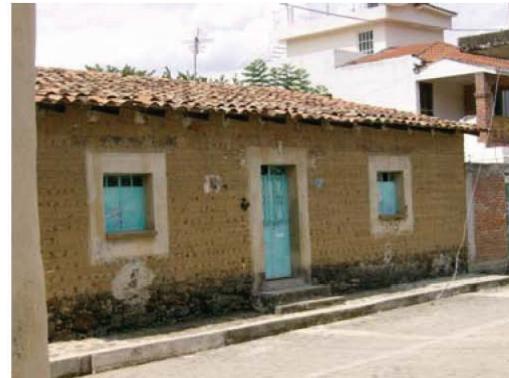
Figure 4: Another adobe house with reinforcements. See the frames on doors and windows and on its base with stones about 50 cm high. The roof is with tiles.

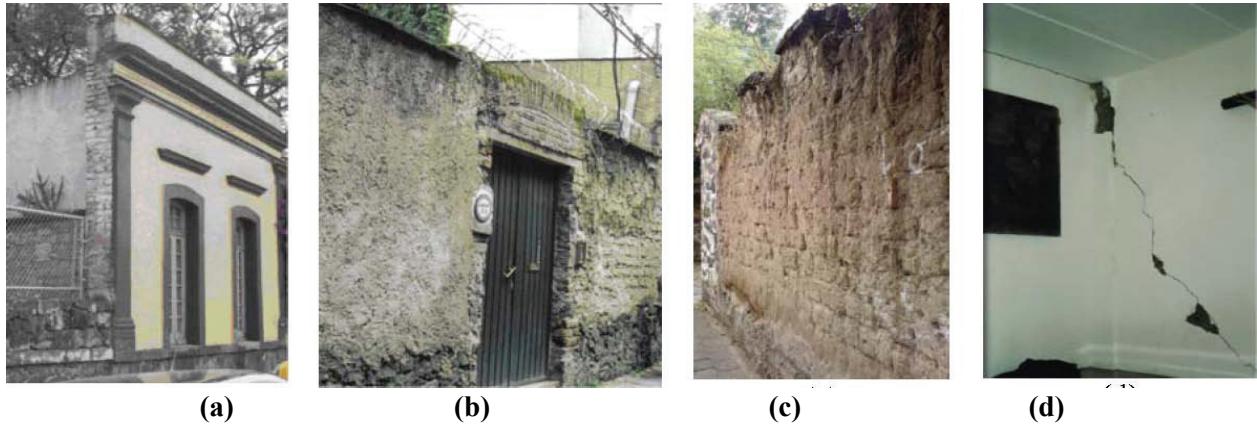
The adobe house showed in Figure 5(a) have a good state of preservation, as well as the presence of wall on its base and frames on doors and windows made of stone, also shows coverage and flattened in good condition in the facade.

The house in the Figure 5(b) is in a state of neglect, but it does not manifest a state of conservation severely damaged from its facade. Like the previous houses presenting stone at the base of their walls. It is appreciated that the construction of adobe walls is reinforced by a column of brick to be located between two orthogonal adobe walls. Despite the damage to the flattened, the structure of the exterior walls of the house shows no significant damage as mud cracks.

In the Figure 5(c) a wall of stone at its base, however it shows a lack of columns at one end of the wall, just where the property ends on the street. It has in certain places on the top of the wall a cover for the rain. Some parts of the wall are leaning. At the base of the walls there is a minor than 50cm high of stones. The case of fences made of adobe, not showed the existence of a column that shared the wall of stone and adobe.

In the Figure 5(d) presents a room damaged by a diagonal crack of tension in the adobe wall viewed in its interior as in its exterior (Church “La Conchita”), because of the slight sinking of its sacristy.

Figure 5: Adobe houses in Coyoacan D.F. (a) The first photo shows a good coverage of cement in its facade. (b) The facade neglected, without frames in its door. These houses have a wall in its base with stones near 1 m. (c) It is a fence made of adobe without columns, only a short wall of stones in its base. (d) Shows a diagonal crack in its interior as in its exterior. in the room with adobe walls (church “La Conchita”).

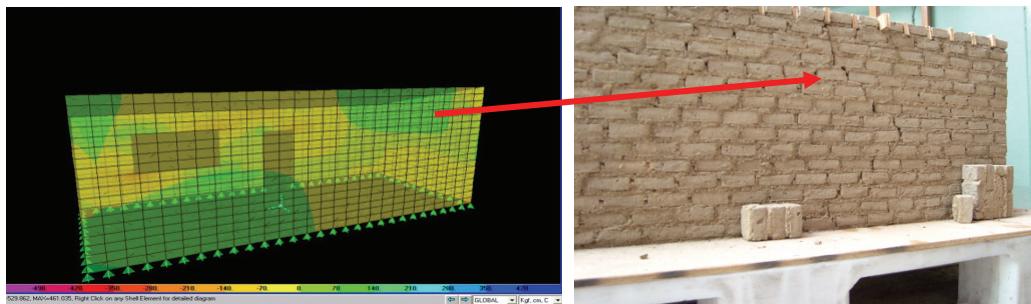
Figure 16: Visible failures showed in the computer and the scale model

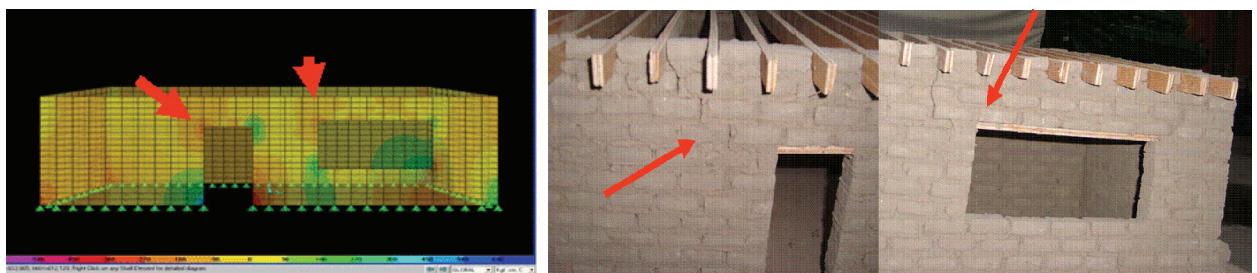
Figure 17: Visible failures showed in both models on the door and window
