Jasper, Alberta
May 31 - June 3, 1998

Freeze-thaw Testing of Vertical Mortar Joints used in Horizontal Projections (Capstones, Plinth Stones and Window Sills)

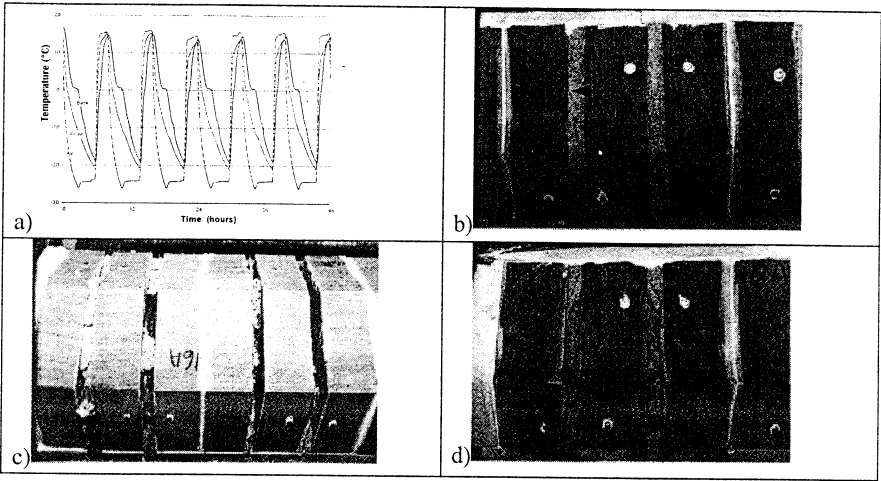
Figure 3

The masonry cement-Type N hydrated lime mortar mix show the better freeze-thaw performance, completing all 120 cycles although some damage was present. The capstone full mortar specimen showed the best performance with the percent expansion less than a value of 0.04% which is considered as a failure criteria for mortar in severe environments (2). The plinth stone specimens showed earlier, but not severe failure with the cause of joint expansion due to mortar deterioration. (Fig. 3b). The foam backer rod/sealant specimens failed due to what appeared to be water at the back of the specimen. The damage at the back often exceeded that at the front. The manifestation of failure was the protrusion of the sealant from the specimen (Fig. 3c).

The cement- lime putty and cement-type S hydrated lime mixes did not perform as well. All the capstone joints reached 120 cycles, but with significant damage. The full mortar joints failed through progressive delamination of the mortar from the front to the back, as well as

showing bond failure (Fig. 3d). The foam backer rod/sealant specimens failed relatively early, with significant damage to the back of specimen as well as the front.

It appears that the foam backer rod/sealant system did not provide any significant protection to the mortar below the sealant. This is probably due to the penetration of water down the back of the specimen and along the edges. This appears to point out a potential weakness of the configuration. If water passes the barrier it can pond and not be able to drain out.

- a) Temperature profiles within the unidirectional freeze-thaw cabinet. Profiles determined by placement of thermocouples in the air, at the front and back of specimens.
- b) Mix 6A-45° showing good mortar performance. Bond failure of a joint resulted in large joint expansion.
- c) Mix 16A/C-20° to left showing protrusion of sealant and Mix 16B-45° to the right showing complete deterioration of mortar.
- d) Mix 22A-45° showing surface delamination of the mortar joint.

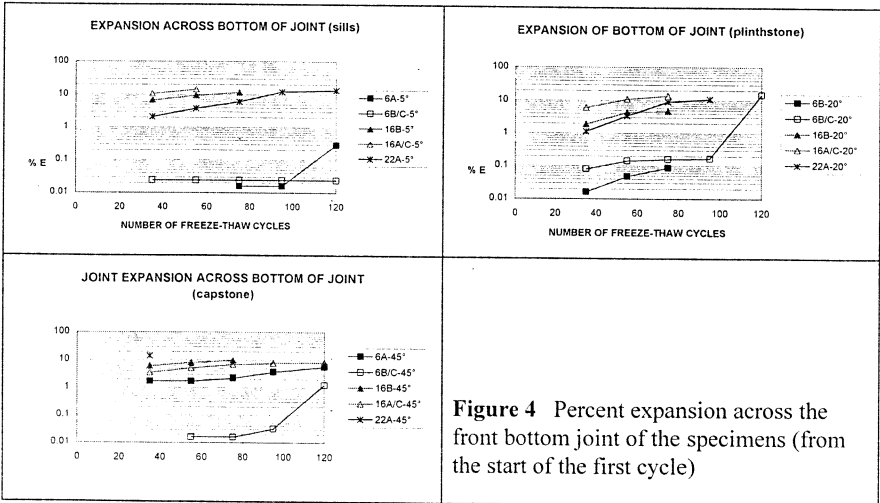
Figure 4 Percent expansion across the front bottom joint of the specimens (from the start of the first cycle)
