IN-PLANE STIFFNESS AND STRENGTH OF ADJUSTABLE WALL TIES

KEYWORDS: adjustable wall ties, brick veneer, cavity walls, tie stiffness, tie strength

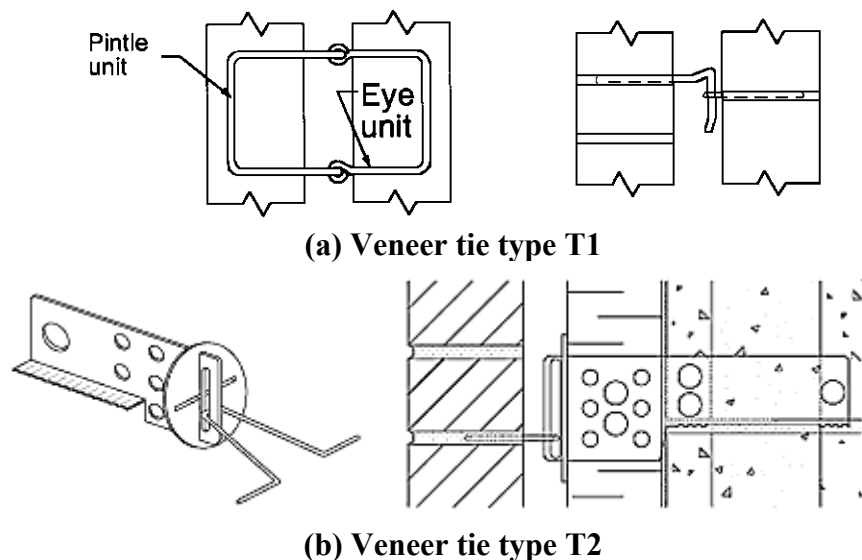
Figure 1 – Ties Used In This Research Program

- Tie T1: Tie which allows vertical movement between the veneer and the back-up wall (Figure 1.a). An example is the eye & pintle tie [4].
- Tie T2: Tie which allows for both vertical and horizontal in-plane movement of the veneer and the (Figure 1.b). For examples, see references 5 and 6.
- Tie T3: Tie which allows for only horizontal in-plane movement of the veneer (Figure 1.c). For an example, see reference 7.

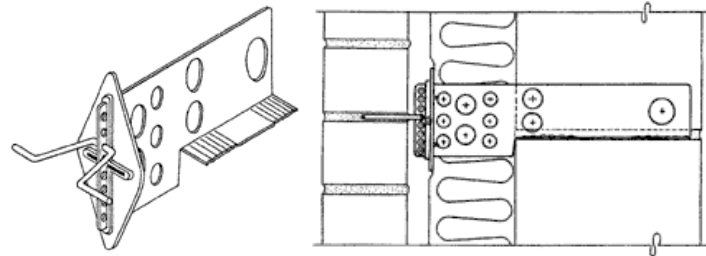
Figure 1 (continued) – Ties Used In This Research Program

(c) Veneer tie type T3

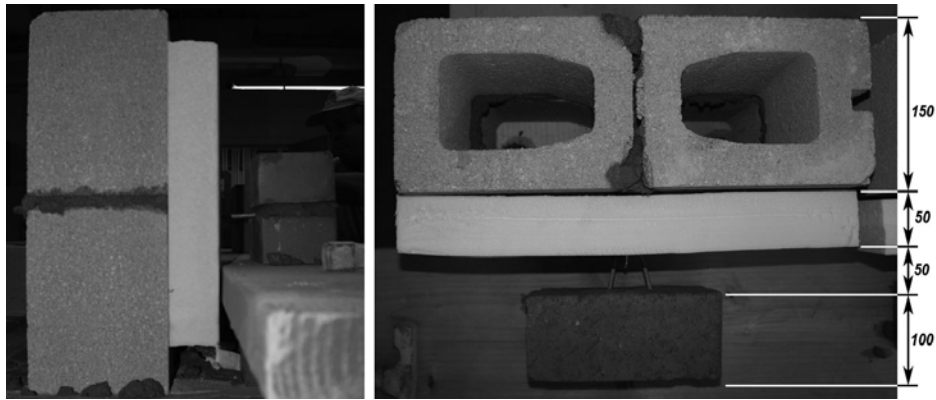
(b) Side view and top view of test specimen
Figure 2 (continued) – Test specimen

Since these specimens include multiple concrete blocks and clay bricks, size and weight became a consideration for ease of handling. The minimum amount of masonry necessary for an accurate representation of the in-situ condition is two concrete blocks (one full and two half blocks) and two clay bricks. To minimize both weight and the overall thickness of the specimen, 150 mm (6 in) block was used for our mock back-up. Figure 2.a shows a design sketch of the test specimen and Figure 2.b for photographs of a constructed specimen.

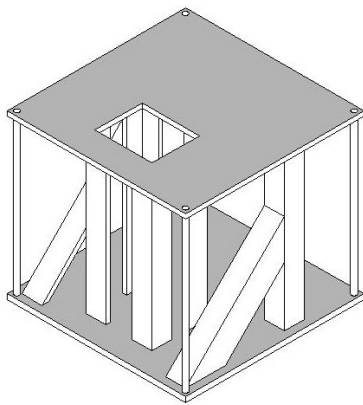
(a) – Design sketch of testing apparatus

Once the specimen design was complete, a custom apparatus for restraining the specimen during testing was designed and constructed. A major consideration in designing the testing frame was the choice of a method in which the specimens were to be tested, measured and observed. The availability of a new, computer-controlled, screw-drive Tinius-Olsen compression/tension testing machine provided the ability to easily and accurately apply a load, while simultaneously recording displacement. Since the movement to be measured is the differential displacement (and corresponding load) between the back-up and the veneer, one wythe of masonry must be acted upon by a measurable force, while the other wythe is restrained from moving. Due to the size and weight of the back-up portion of the specimen, it was determined that restraining the back-up and loading the much smaller and lighter veneer portion of the specimen would be most appropriate. A custom testing frame was then designed that restrained all movement of the 150 mm (6 in) CMU (mock back-up), while allowing movement of the mock veneer.

A problem arose in that the two-brick mock veneer swings in all directions on the wire through the steel plate of ties T2 and T3. To limit motion of the bricks to a linear, unidirectional, in-plane motion, a vertical chute was formed with four lengths of steel angle. These angles were fixed to a steel base plate. That base plate, along with a top plate, was used to confine the specimen and restrict any movement of the mock back-up. Finally, to allow for load application to the end face of the bricks, a hole was cut in the top plate that allowed access to the inside of the chute.

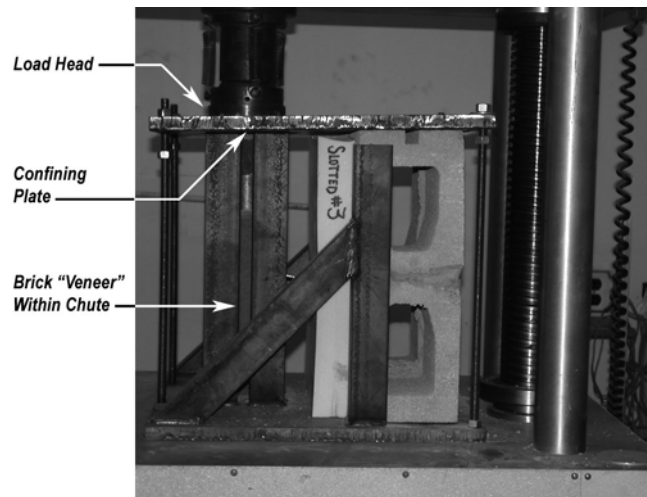
Figure 3 – Test setup

(b) – Test specimen under load

After all of the planning, design and construction, everything was in place for testing to commence. Each specimen was turned on its side so that the lateral, in-plane desired motion of the mock veneer was moving in a vertical path. The rotated specimen was then lowered on to the base plate of the frame, with the bricks inside of the chute. The top plate was placed and lowered until it rested on the concrete block mock back-up. Tie rods allowed clamping of the top plate that securely held the back up in place during testing. The entire frame apparatus was placed on the table of Tinius-Olsen testing machine and aligned so that the load head on the Tinius-Olsen machine was centered over the opening in the top plate. A short steel column was placed in the chute, resting on the end of the two-brick mock veneer. This rigid member was used to transfer the load from the load head on the machine, to the specimen within the chute. The load head was lowered until making contact with the column and all displacements and loading readings were zeroed in the recording software. Load was applied at a rate of 5mm/min (0.2 in/min) while time, load and displacement were recorded at a rate of 200 times per minute.

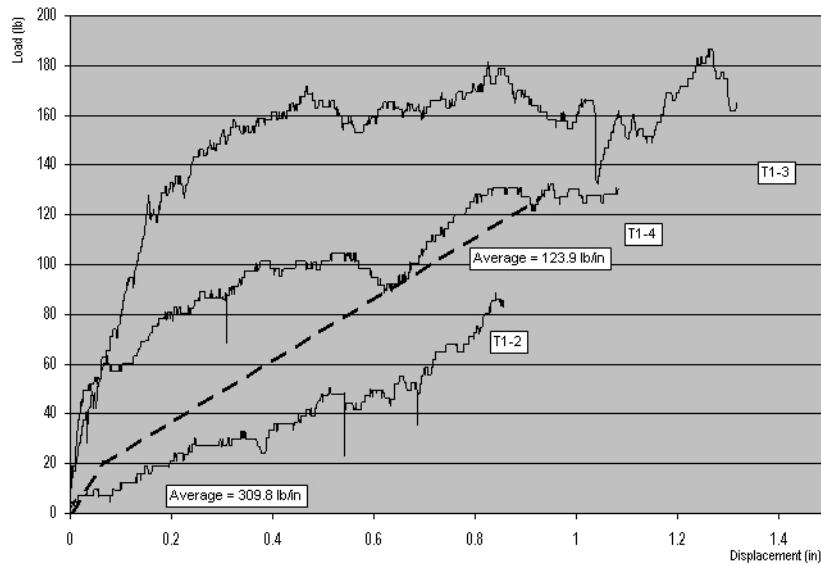
Figure 4 - Load-Displacement curve for T1 ties

While not all ties performed the same under the identical loading conditions, all the values recorded will still be used. Figure 4 shows the load-displacement curves for the T1 specimens. The biggest variable seemed to be the bond strength of the eye portion of the tie in the mortar bed joint of the back-up wall. While quality assurance/quality control can help to minimize these types of problems in the real world, they cannot be eliminated, and thus, the results of the tests in which the bond failed will be included in the calculations to determine the average stiffness of the T1 ties. That average, composed of Specimens #2, #3 and #4, was found to be 0.05 kN/mm (309.8 lb/in).

The second T1 specimen was only slightly more useful. Again, the mortar bond to the wire eye was insufficient and the wire shifted upon initial loading. The wire did not break free, and the loading caused the wire to bend gradually as load was applied. The graph (Figure 4) shows that although there was no initial stiffness, the load did increase to 0.38 kN (86 lb) at a displacement of 21.8 mm (0.9 in) before the wire completely dislodged from the mortar.

The third T1 specimen was the first that performed as anticipated and gave an accurate value of the stiffness of the two-piece wire system. Upon application of the load, the tie exhibited an initial stiffness of 0.144 kN/mm (819.8 lb/in) up to 0.57 kN (127.4 lb). Upon reaching this point, the wire began to bend and the load temporarily dropped. Once load carrying capacity was restored, the load climbed to the range of 0.71 kN (160 lb) where it fluctuated in the ± 0.09 kN (20 lb) range until 0.72 kN (162.8 lb) at 26.4 mm (1.0 in) of deflection when the wire broke free of the mortar and slipped.

The fourth and final T1 specimen, like the three previous, exhibited a completely unique performance under the loading. While the wire eye remained embedded in the mortar upon initial application of the load, there was much less resistance to the load than exhibited in Specimen #3. Specimen #4 performed with an initial stiffness of 0.229 kN/mm (1320 lb/in) up to 0.22 kN (49.9 lb). As you can see in Figure 4, this is a higher value of stiffness than was exhibited by Specimen #3, but the wire legs of the tie began to bend and the stiffness broke at only 40% of the load of Specimen #3. The wire continued to bend under loading up to 0.45 kN (100.9 lb) at which point the wire became dislodged from the mortar and slipped. From then on, the load increased gradually to approximately 0.58 kN (130 lb) where the load caused constant displacement with no additional load capacity.

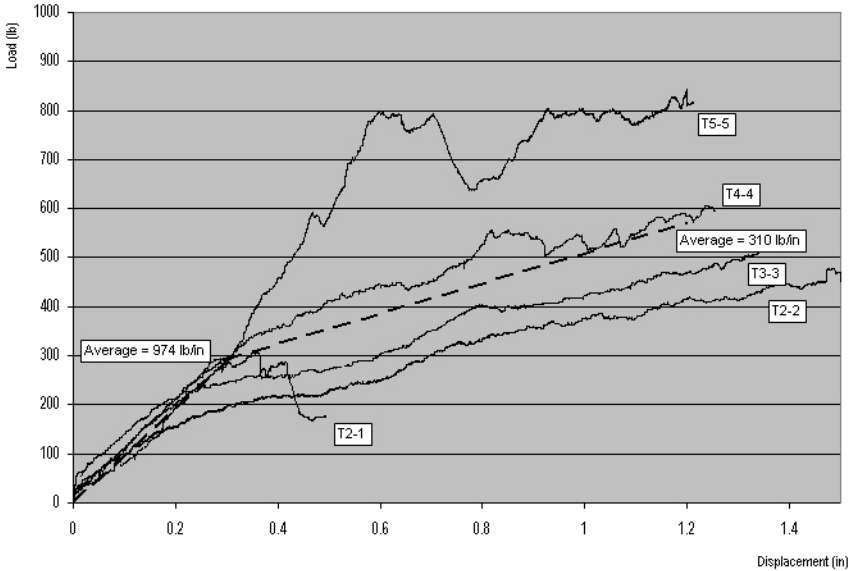
Figure 5 - Load-Displacement curve for T2 ties

Upon initial loading, the specimen performed just as expected. The initial stiffness was linear up to a load of 1.25 kN (280 lb) with a displacement of 7.9 mm (0.31 in). When the initial break in linearity was reached, the loading continued to approximately 1.38 kN (310 lb) when the first

sign of distress appeared. The mortar in the bed joint between the two bricks began to show signs of bond breakage. The “V”-shaped wire portion of the tie was rotating about its flat base in the slot in the block shear connector. That rotation was too much for the mortar bed joint between the brick, and the mortar was sheared off from between the two bricks. Immediately, concern was raised as to the remainder of the specimens. One aspect of the test design that is not similar to the in-situ application of these ties is the inherent compressive stress at the bed joint of the brick veneer due to the self-weight of the brick.

Slotted Specimen #2 performed considerably different right from the initial application of the load. Rather than displaying a high initial stiffness and then a drastic drop in stiffness due to deformation of the connector plate, this specimen began to deform quite early on. The deformation came in the form of the slot in the plate being pulled apart (Figure 6a). The outermost portion of the plate (outside of the slot) is only connected to the rest of the plate at the top and bottom, leaving the length of the slot, where the wire applied load to the plate, unsupported. The V-shaped wire twisted the outer portion of the plate and once the two were in full contact, the moving bricks continued to deform the connector plate. The slot widened slightly and the bricks moved so far that the wire was actually pulling the tie away from its place in the head joint of the concrete blocks (out-of-plane loading). While not testing the plate in pure bending, this was the second consecutive test that proved correct the decision to test the ties in a small mock wall specimen due to the complex interactions of all of the individual components.

Specimen #3 performed very similarly to Specimen #2. Although displaying a relatively high initial stiffness of 0.17 kN/mm (997 lb/in) up to a load of 0.88 kN (197 lb), the same deformation of the connector plate occurred and the load resistance dropped drastically. It is interesting to note that Specimens #2 and #3 were acting in the same manner under load and their load-displacement curves are nearly identical at each change in stiffness. The only real difference in performance between the two is the initial stiffness mentioned previously.

Specimen #4 performed in a manner similar to Specimen #1 in that it did not fail early in the test like the previous two specimens. Actually, the load-displacement curve for Specimen #4 matches up perfectly with that of Specimen #1 up to the point where its mortar failed. Specimen #4 did not fail and continued to provide load resistance to a load of over 2.67 kN (600 lb). The specimen, however, did display a significant ductile behavior in its displacement from 20.8 mm (0.8 in) to 31.9 mm (1.26 in) with an increase in load capacity of only 0.2 kN (45 lb) over that displacement.

Specimen #5 performed very similar to Specimens #1 and #4 in the initial stages of the testing procedure. Those three specimens' plots grouped extremely well to give an apparent accurate stiffness of the ties. When the 1.33 kN (300 lb) value was reached, however, Specimen #5 the stiffness did not break like #1 and #4, but rather continued up to a load of 3.52 kN (791 lb) before a drop in stiffness was observed. This value is significantly higher than any of the other specimens. The apparent cause for this unique behavior can possibly be attributed to a manufacturing characteristic of the system. The wire V-tie portion of the tie appears to be formed by use of a large press utilizing a shaped die. That die, on some wires, deformed the circular cross-section of the wire, leaving a flat spot in the inner portion of the radius at each end of the flat at the bottom of the “V”. In this test, that flat spot hooked itself on to the slot in the

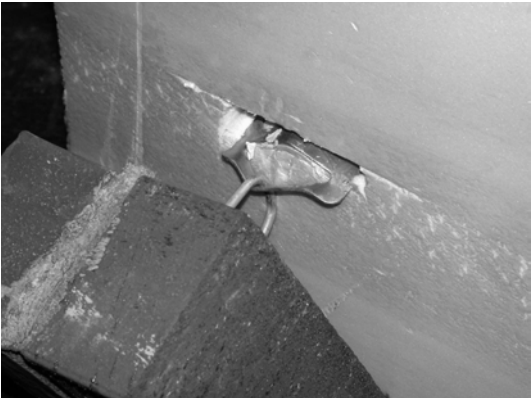
(a) T2 tie after testing

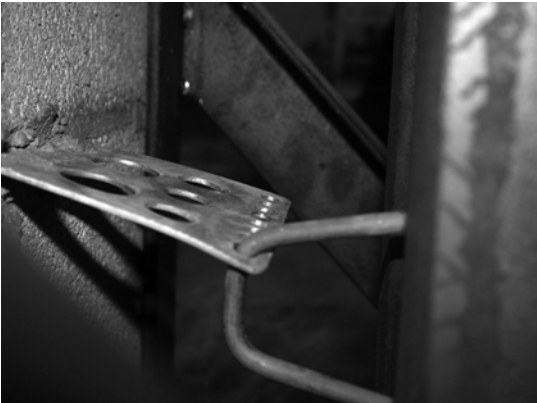
Figure 6 – Tie failure modes

(b) T3 tie after testing (rigid insulation removed for clarity)

mm (0.5 in), however, the stiffness quickly increased and the load reached a maximum value of 2.74 kN (615 lb). Upon reaching this load capacity, the plate began to deflect quite quickly, and the load dropped accordingly (Figure 6b). The test was terminated as the tie was exhibiting a zero stiffness, continuously deflecting with no change in load capacity.

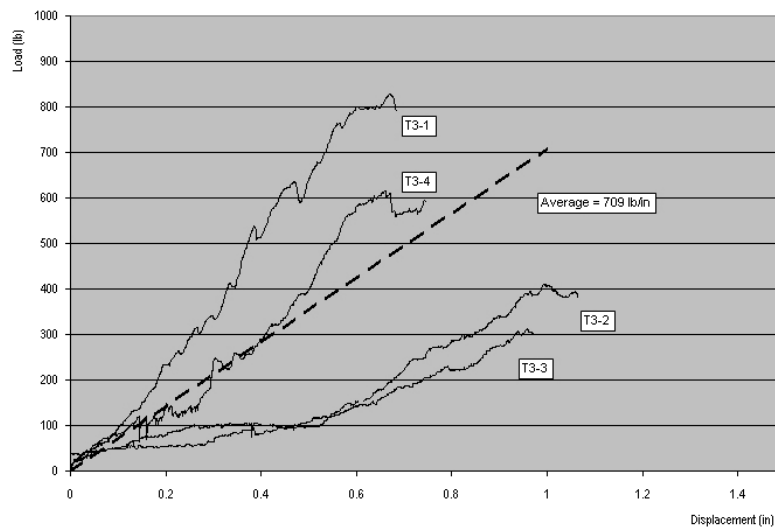
Figure 7 - Load-Displacement curve for T3 ties

Specimen #1 behaved in a manner exhibiting high stiffness of the connector plate, as compared to that of the slotted tie. Upon initial application of the load, the stiff tie immediately began resisting the increasing load. For the most part, the load increased to 2.38 kN (535 lb) with a stiffness of 0.25 kN/mm (1421 lb/in) before the first drop, which was due to minor slippage. The high stiffness can be attributed to the fact that a portion of the load was being applied torsionally to the steel plate due to the fact that the “V” could not rotate. This torque on the outside portion of the steel plate was not great enough to bend the plate, so the plate’s ability to resist the applied load was large. Additional slippage of the wire tie within the connector plate took place at various points in the testing, but all were only limited. Finally, at a load of 3.41 kN (766 lb), the plate began to yield under the applied moment. The plate bent about its support point at the face of the concrete block, and the loaded end slowly began deflecting. The load continued to increase throughout this deflection up to a value of 3.69 kN (829 lb), when the load finally dropped and the plate began to bend significantly.

The second and third T3 specimens performed very similarly to each other. In both tests, the wire “V” did not bind within the hole in the plate. Since the wire rotated within the hole the load that the wire transferred from the brick to the plate was applied as a vertical point load on the edge of the plate, as opposed to an applied moment as observed in Specimen #1. The plate began to deflect almost immediately upon application of the load. The load-displacement curves for these two tests both show the low stiffness characteristic of a soft, ductile material. A similar characteristic of both curves is an increase in stiffness beyond the range of 12.7 mm (0.5 in). Specimen #3 reached a maximum load capacity of 1.36 kN (306 lb), while Specimen #2 reached a maximum of 1.82 kN (410 lb), and while the load capacity was 33% higher in #3 than it was in #2, the displacement corresponding to that load value was only 0.9 mm (0.04 in) different.

The final T4 specimen was tested without the two inches of rigid foam insulation in place around the extended plate of the tie. Observing the graph, one can see that while the load values were not as smooth under the constant displacement, the stiffness was almost exactly the average of all four of the specimens. Up until a displacement of 12.7 mm (0.5 in), the normalized stiffness of Specimen #4 and the trend line for the average of all specimens is almost collinear. Beyond 13.0

The most useful results can be found by comparing the stiffness of the three ties tested in the serviceability limit state within the initial, linear-elastic response. Tie T1 exhibited an initial stiffness of 0.05 kN/mm (309.8 lb/in), 0.17 kN/mm (974 lb/in) for tie T2 and 0.12 kN/mm (709 lb/in) for tie T3. Test results presented herein clearly demonstrate that T1 ties have a very low stiffness, and therefore, transfer a very minimal amount of load between the wythes of masonry, even at high tie displacements. Conversely, the high stiffness exhibited by ties T2 and T3 show a higher load transfer upon engagement of the adjustable “V” tie.
