EFFECTS OF CONFINEMENT REINFORCEMENT ON BAR SPLICE PERFORMANCE

Jeffrey H. Greenwald, P.E.¹, Jason J. Thompson² and David I. McLean, Ph.D., P.E.³

ABSTRACT

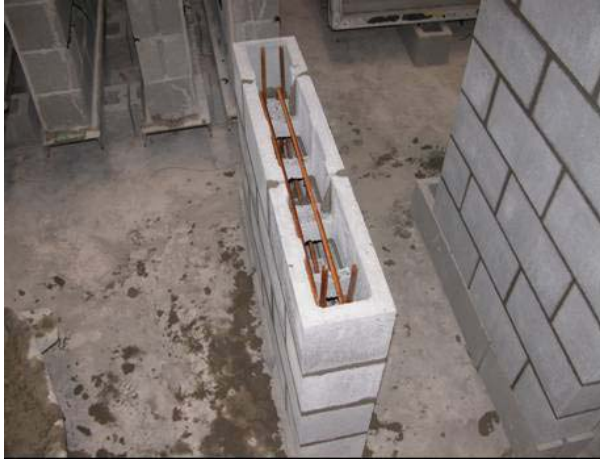
Figure 2 – Placement of Confinement Reinforcement

The panels were laid in a running bond configuration using face shell bedding except at the ends of the panels where the end webs were mortared. Each panel contained six courses, resulting in a height of 1200 mm (48 in.) to fully encompass the splice length. The 25M (No. 8) spliced bars were lapped using contact splices and tied together using small-gage wire. The 10M (No. 4) confining reinforcement was placed in the appropriate courses and tied in place using small-gage wire. Figure 2 shows placement of the confinement reinforcement within the walls.

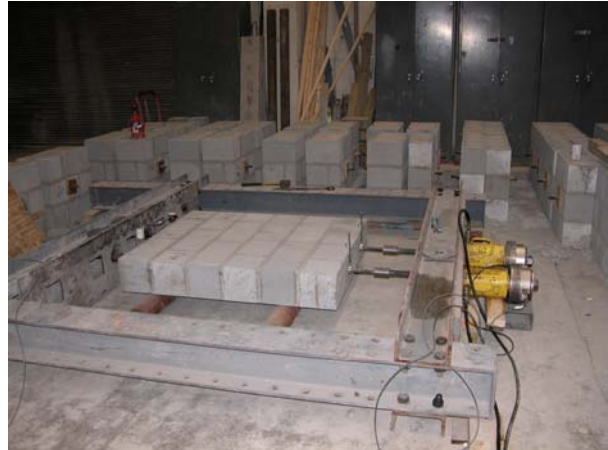
Figure 3 – Test Setup

The testing frame was constructed of four structural steel members bolted together to form a rectangular perimeter around the test panel (see Figures 1 and 3). To alleviate the need for bracing or shoring of the testing equipment or test specimens, the structural frame was placed horizontally on the laboratory floor.

Once a panel was positioned in the frame, high-strength steel couplers were attached to each of the four reinforcing bars protruding from the panel. On the other end of the coupler, another reinforcing bar, threaded on both ends and having a diameter greater than the spliced bars, was attached. These connector bars extended through the holes in the steel frame and were anchored with steel washers and threaded nuts. At one end, the connector bars passed through two center-hole hydraulic rams before being anchored. A hydraulic pump was used to supply pressure to the rams. The hydraulic hoses to the rams were connected in parallel using a “T” connector, resulting in equal pressure to each of the rams.

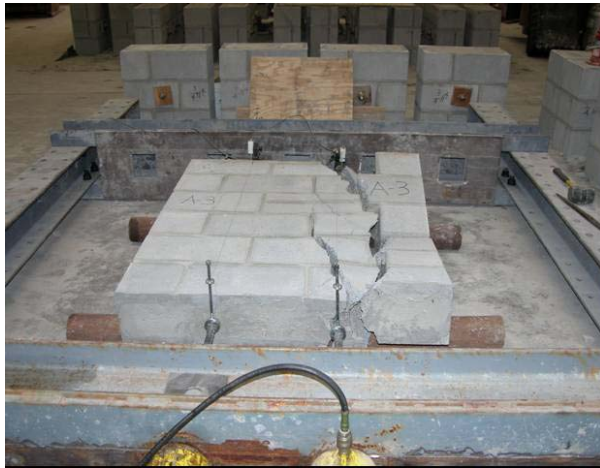
Figure 4 – Typical Cracking in Specimen Set A

Specimen Set A: The panels of Specimen Set A contained no transverse reinforcement as confinement to the spliced bars. Very little cracking was observed in the panels prior to the development of a sudden splitting failure in the masonry directly over one of the spliced bars and running the full length of the panel, as shown in Figure 4. While major splitting did not occur over the adjacent spliced bars, Figure 5 shows tension cracking in the end of the panel indicating the onset of longitudinal splitting (taken after removal from the testing frame). The average splice capacity for Specimen Set A was 246 kN (55400 lbs).

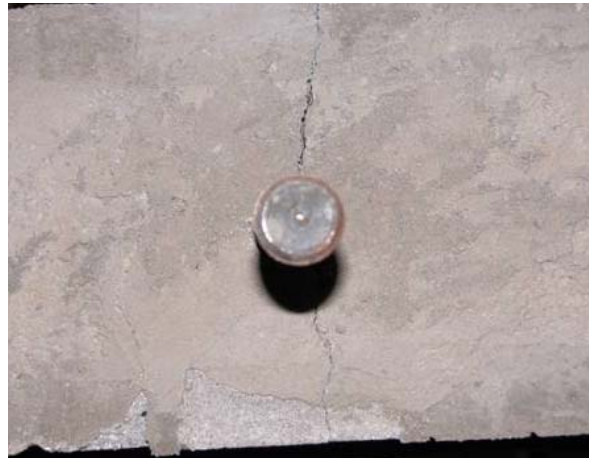
Figure 5 – Onset of Splitting Cracks in Specimen Set A

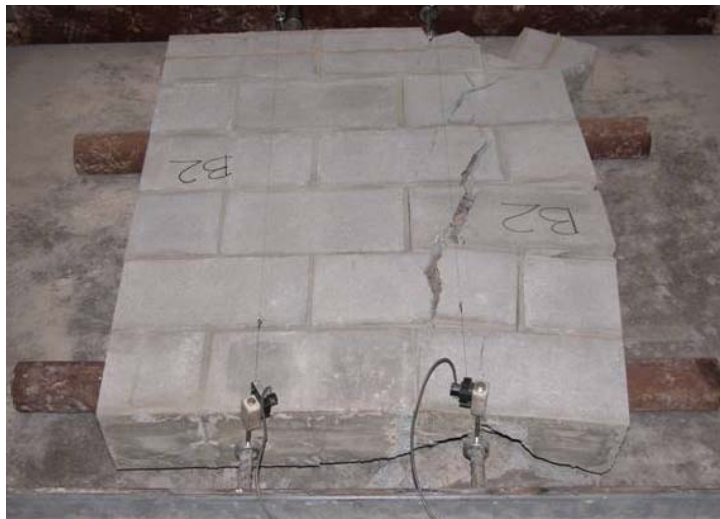
Figure 6 – Typical Cracking in Specimen Set B

Specimen Set B: The panels of Specimen Set B contained one 10M (No. 4) bar in the top and bottom courses of the panel (one bar at each end of the splice). Small cracks were observed in the masonry units, parallel to and directly above the splice, as well as in the mortar joints perpendicular to the splice, prior to the peak load being reached. Failure occurred suddenly when large splitting cracks occurred in the masonry over one of the spliced bars. As shown in Figure 6, these cracks were predominately concentrated in the middle of the panel. The average splice capacity for Specimen Set B was 314 kN (70500 lbs).

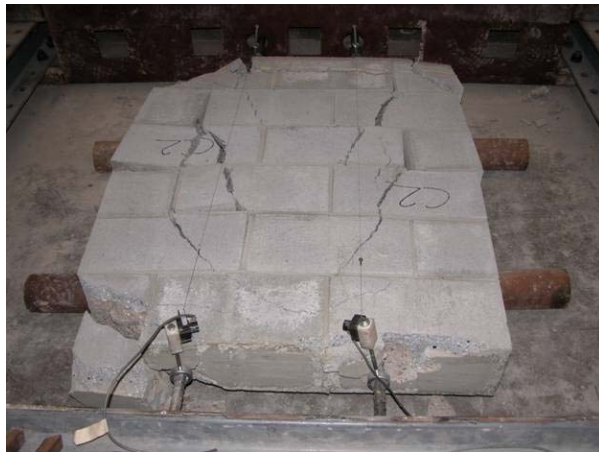
Figure 7 – Typical Cracking in Specimen Set C

perpendicular to the splice, prior to the peak load being reached. Failure occurred suddenly when large splitting cracks occurred in the masonry over both of the spliced bars, as shown in Figure 7. As with the panels of Specimen Set B, the splitting was primarily in the center of the panels, away from the panel ends where the 10M (No. 4) bars were located. At the ends of the panel, adjacent to the location of the 10M (No. 4) transverse reinforcing bars, cracking occurred in the masonry units perpendicular to the splice. The average splice capacity for Specimen Set C was 336 kN (75500 lbs).

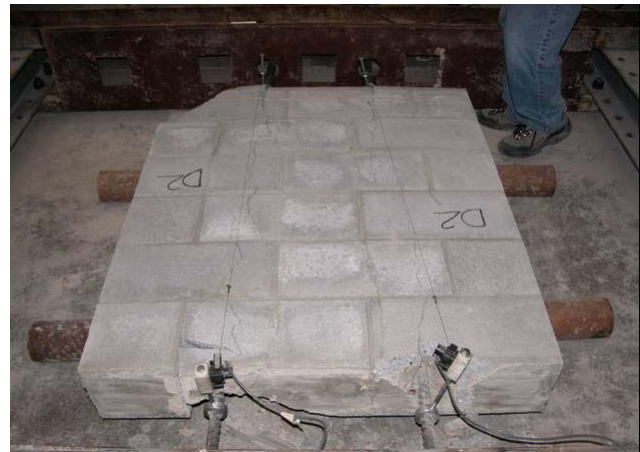
Figure 8 – Typical Cracking in Specimen Set D

Specimen Set D: The panels of Specimen Set D contained one 10M (No. 4) bar in each course of the panel. Small cracks were observed in the masonry units, parallel to and directly above the splice, as well as in the mortar joints perpendicular to the splice, prior to the peak load being reached. Significant yielding of the spliced bars occurred in all three panels, resulting in the hydraulic rams reaching their maximum stroke for one of the specimens. When maximum ram extension occurred, pressure was released, spacers installed in the loading frame, and the spliced bars reloaded until panel failure occurred. Failure occurred suddenly when splitting cracks occurred in the masonry over both of the spliced bars, as shown in Figure 8. The splitting cracks occurred over the full length of the splice. The extent of cracking and the width of the cracks were substantially less than the cracks observed in Specimen Sets A through C. The average splice capacity for Specimen Set D was 331 kN (74500 lbs).

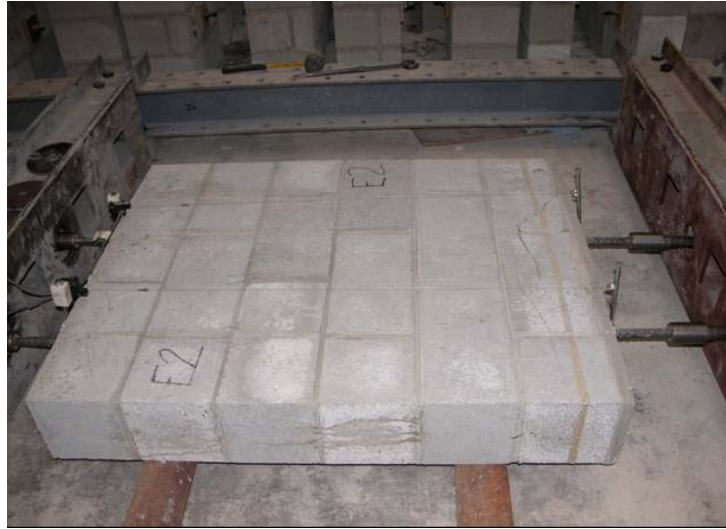
Figure 9 – Typical Cracking in Specimen Set E

Specimen Set E: The panels of Specimen Set E contained two 10M (No. 4) bars in each course of the panel. This arrangement of transverse reinforcement was considered to represent an upper bound on what might be practical for providing confinement reinforcement in a masonry wall using straight bars. Small cracks were observed in the masonry units, primarily parallel to the splice and near the ends of the panel, as well as in the mortar joints perpendicular to the splice, prior to the peak load being reached. Extensive yielding of the spliced bars occurred in all three panels, resulting in the hydraulic rams reaching their maximum stroke for two of the specimens. When maximum ram extension occurred, pressure was released, spacers installed in the loading frame, and the spliced bars reloaded until panel failure occurred. Typical cracking present in the panels of Specimen Set E is shown in Figure 9. For two of the panels, the splitting cracks in the

masonry increased in size and the spliced bars slipped. In one panel, fracture of the spliced bars occurred. The average splice capacity for Specimen Set E was 369 kN (82900 lbs).
