## **EXPERIMENTAL EVALUATION OF THE SHEAR CAPACITY OF REINFORCED MASONRY SHEAR WALLS**

**S.C. Miller<sup>1</sup>, W. El-Dakhakhni<sup>2</sup>, and R.G. Drysdale<sup>3</sup>**

### **ABSTRACT**

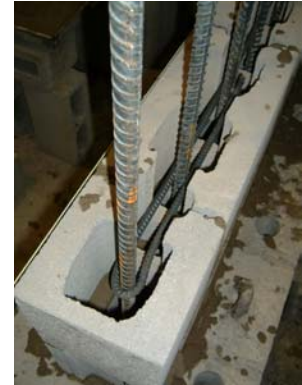
d) Knock-out web blocks with vertical and horizontal reinforcement

10M bars were used as horizontal reinforcement and were placed in either every second or every fourth course. As shown in Figure 1(c), the webs of the concrete block stretcher units were saw cut to half the block height to create knock-out web blocks. These blocks were used for the masonry courses containing horizontal reinforcement and had the advantages of having the same properties as the block in other courses. As can be seen in Figure 1(d), to provide the adequate anchorage, the horizontal reinforcement was hooked 180° around the outside vertical bar and extended back 400mm. As mentioned by others [7], lack of adequate anchorage of shear reinforcement in practice and in wall tests may be one of the reasons that effectiveness of shear reinforcement has been discounted. Also, through the use of Equation 2, limits have been imposed on maximum amounts of shear steel that can be used effectively in shear capacity calculations.

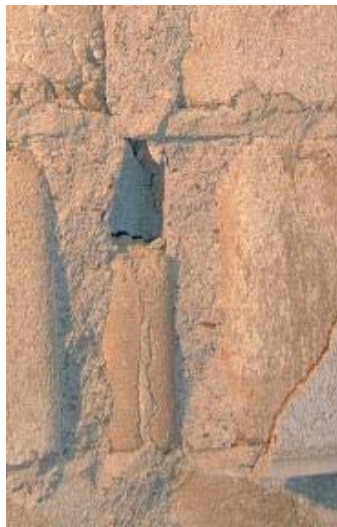
a) Partial grouting of head joint cell

**Figure 2 – Incomplete grouting of cells at frogged ends of blocks**

After completing the tests, dismantling of the test walls showed that all of the block cells were completely filled with grout to form continuous well compacted grout columns. However, for the discontinuous cells in the head joint at the frogged ends of the blocks, about  $\frac{1}{3}$  were incompletely filled with grout (Figure 2(a)), which was sometimes also poorly compacted (Figure 2(b)). This experience causes some concern for use of coarse grout to achieve solid masonry where standard units create isolated cells between the ends of blocks. It should be noted that delays and warm weather caused significant loss of fluidity during construction.

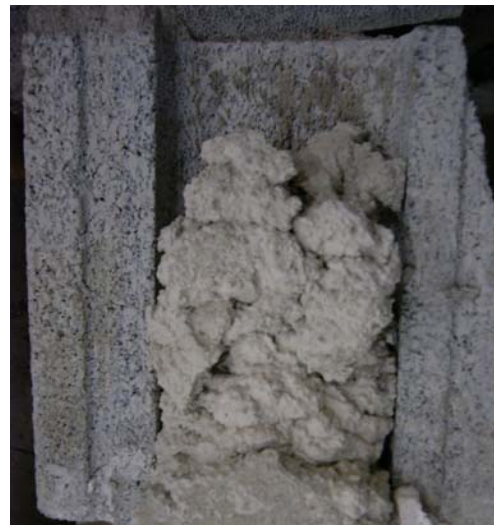
b) Poorly compacted grout

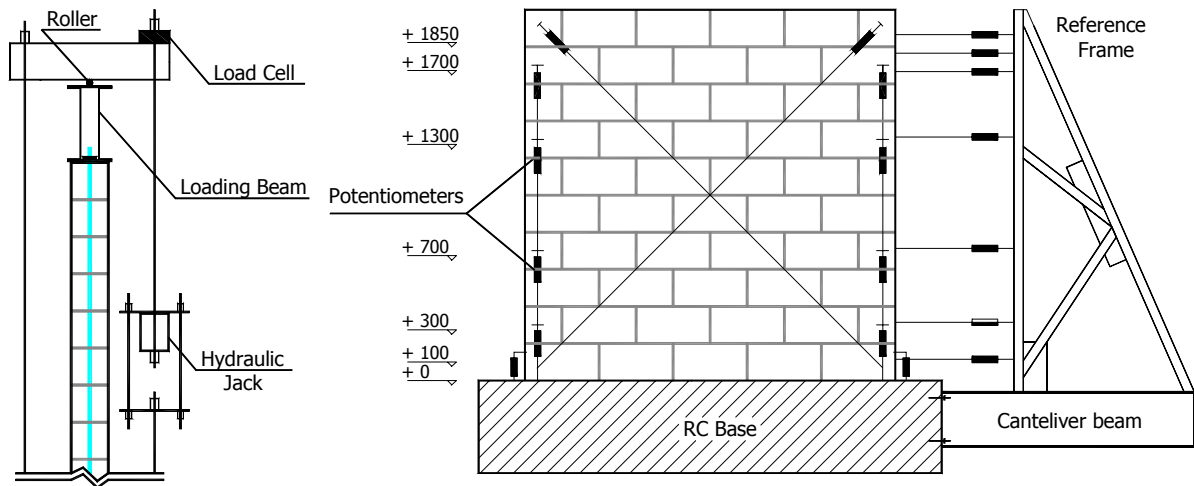
a) Application of Axial Load

b) Instrumentation (for 2m high walls)

**Figure 4 – Axial Loading Setup and Instrumentation Arrangement**

An axial load that produces a compressive stress of 1 MPa was applied through the use of two hollow cylinder hydraulic jacks as shown in Figure 4(a). The roller at the top of the loading beam ensures an equal force in each of the rods. The two point loads were monitored with load cells and independently adjusted throughout the tests as bending of the wall caused changes in their forces. As can be seen in Figure 4(a), inverting the hydraulic jack allowed compressive force on the jack to apply tension to the rods that transfer compression onto the top of the loading beam. These rods were high strength prestressing steel, anchored into the floor beam. A small adjustment to the magnitude of the applied horizontal in-plane shear force was required to account for a horizontal component of the axial load as the wall deflected during lateral loading.

Another element used in the test setup was a reference frame, rigidly connected to the wall base as shown in Figure 4(b). Having such a frame attached to the base of the wall, eliminated potential problems associated with sliding or rotation of the base, with respect to the laboratory floor. Horizontal linear potentiometric displacement transducers were attached to the reference frame and to the wall at various heights. In addition, to be able to calculate flexural and shear displacements, vertical and diagonal potentiometers were placed directly on the wall between two common anchors. These strain rosettes were necessary to distinguish between shear and flexural deformations.

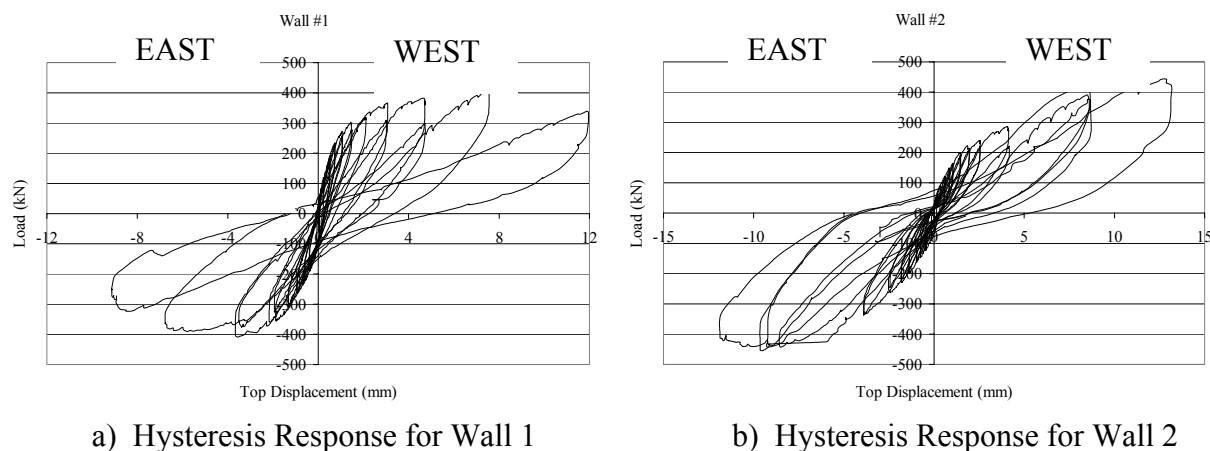
**Figure 5 - Load vs. Top Displacements for 2m x 2m Walls**

The walls were initially loaded to 20 % of the expected capacity based on Shing et al test results [9]. Then cyclic testing was continued using displacement control with two cycles at each displacement. Displacement increments were gradually increased as illustrated in Figures 5 and 6. As can be seen in these figures, the hysteresis loops are quite symmetric up to failure. Failure was deemed to have occurred when the load decreased for an increase in displacement. At failure, the response in the first loaded direction (West) appears to be slightly more ductile than when loaded back in the other direction. Possibly this is an indication of the effect of damage during the failure load cycle. As can be seen, despite extensive visible damage, significant post-peak deformability remained with relatively little degradation of capacity for large increments of deflection. The shear failures were neither sudden nor brittle.

Wall 1. In common with Wall 3, maintaining the axial load using two independent jacks required continuous adjustment as tensile and compressive deformations occurred due to bending of the wall. For this wall, substantial diagonal “X” type cracking was visible at 300 kN lateral load. This followed initial flexural cracking along bed joints and smaller diagonal cracks following a path through a combination of head and bed joints. As can be seen in Figure 5(a), stiffness decreased significantly at lateral loads above 300 kN and larger cracks, passing through blocks were observed as shown in Figure 7(a). As the load approached its maximum value for loading in the East direction, the “toe” on the East side of the wall began to crush as shown in Figure 7(a). From this point on, not many new cracks formed but the main diagonal “X” cracks became much wider. With displacement controlled loading, there was no sudden change in behaviour.

Wall 2. The behaviour of Wall 2 was very similar to Wall 1 with the net effect of no superimposed axial compression and doubled shear reinforcement producing about 10 % increase in shear capacity. Unfortunately, after the wall had reached its maximum load for loading in the West direction, no further loading was carried out in that direction to document the degradation of capacity with damage due to cyclic repetitions of deflection. The reason was that the wall was beginning to be pushed out-of-plane causing large forces on the out-of-plane bracing. Reloading in the more stable East direction resulted in the load cycle beyond maximum load.

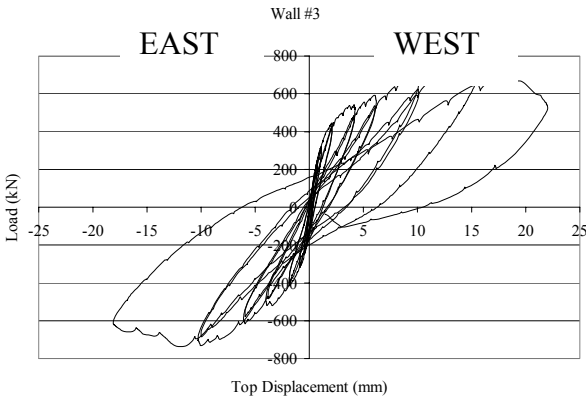
a) Hysteresis Response for Wall 3

**Figure 6 - Load vs. Top Displacements for 3m x 3m Walls**

Wall 3. This wall displayed very small mortar joint cracks for displacements up to 2.5 mm corresponding to lateral load of nearly 500 kN. At approximately 550 kN, cracks began to cross through blocks rather than follow mortar joints. Near maximum load, vertical end cracks began to propagate through the webs on both sides of the block cell from the base up seven courses. Increased displacement loading produced delamination of the face shells from the grouted cores of the wall. As shown in Figure 6(a), the hysteresis loops for the final loading cycles were not symmetric. Loss of a displacement potentiometer attachment point caused a 2.5 mm additional

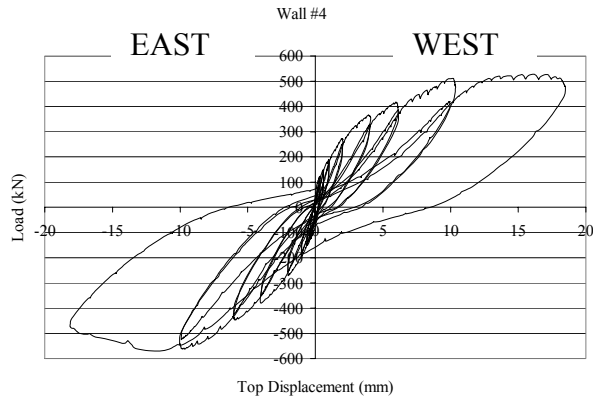
b) Hysteresis Response for Wall 4

Wall 4. The behaviour of Wall 4 was very similar to Wall 3. As shown in Figure 6(b), symmetry was observed over the length of the test. Face shell delamination over most of the lower corners of the wall was observed near maximum/post-maximum loading. Nonetheless, large post-peak deformations were observed corresponding to relatively small post-peak degradation of capacity. Figure 7(b) shows well developed diagonal cracking at maximum capacity for loading in the West direction.

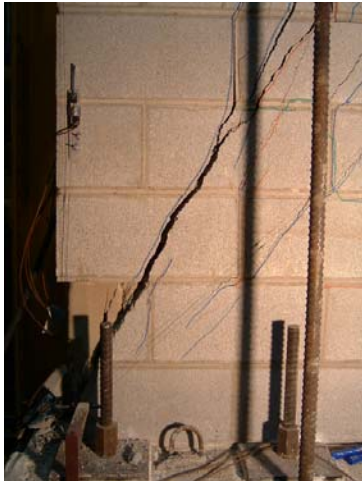
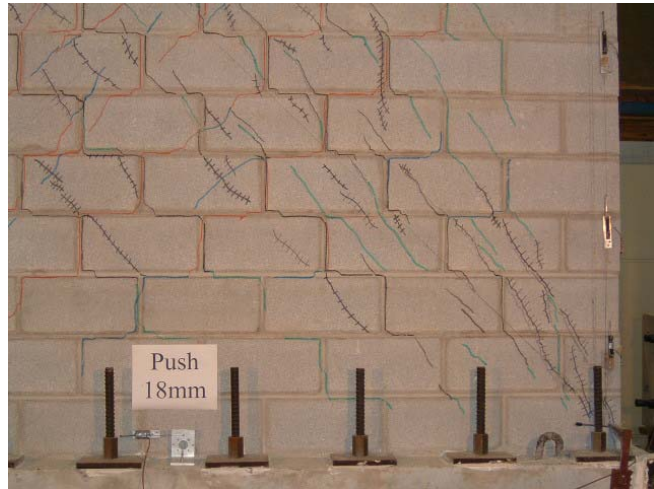
a) Wall 1, East Toe

b) Wall 8, West Toe

**Figure 7 - Diagonal Crack Photographs**
