# SHEAR TESTS ON WIDE-SPACED PARTIALLY REINFORCED SQUAT MASONRY WALLS

N. G. Shrive<sup>1</sup>, A.W. Page<sup>2</sup>, G. Simundic<sup>3</sup>, M. Dhanasekar<sup>4</sup>

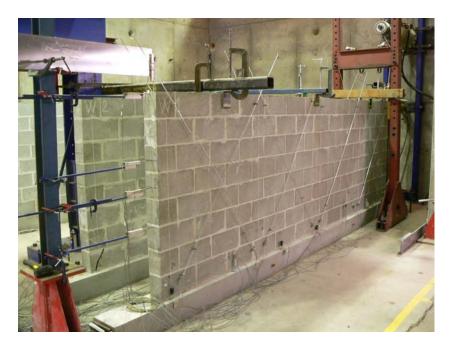
Figure 4: Instrumentation on Wall 1 with four panels of hollow masonry, 1.2m centre to centre. The three bracing points to prevent out-of-plane displacement can be seen at the top of the wall.

The walls were instrumented with displacement transducers on each side, mounted diagonally across each hollow panel to monitor for diagonal cracking of each panel. Thus three pairs of transducers were mounted on each side of the wall with the 1.6 m hollow panels, six pairs on the wall with 0.8 m panels and four pairs on the wall with 1.2 m panels, as shown in Figure 4. In addition, transducers were mounted against the vertical faces at the ends of the walls to measure the in-plane deformed shape of the wall. The movement of the concrete base was also monitored with transducers.

Each wall was restrained from out-of-plane movement at three locations along the bond beam on the top of the wall to prevent out-of-plane buckling of the wall, as may be seen in Figure 4. Load was applied to one end of the bond beam through a hand pumped hydraulic actuator (Figure 5). This actuator was braced against the vertical wall of the load floor/frame, with load being transferred through a load cell, a section of HSS and then through a spherical seat to a plate bonded to the masonry (Figure 5). Load was applied until the wall had displaced beyond peak load capacity, and cracked substantially. No vertical load was applied, so the walls were tested under self-weight only.

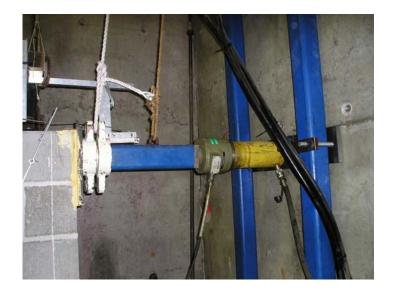
Figure 5: The actuator for applying lateral in-plane load at the top of one end of the wall.

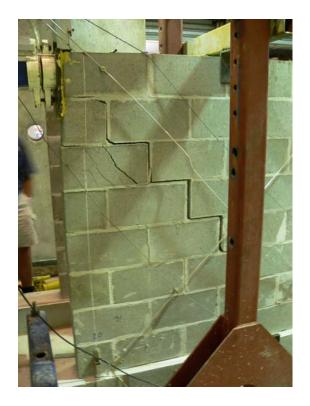
Figure 10: Actual cracking from the loading point (top left of the wall in this view) in wall 2 (1.6 m spaced reinforcement).
