## EFFECTS OF SUPPORT CONDITIONS ON LINTEL-MASONRY INTERACTION

### ABSTRACT

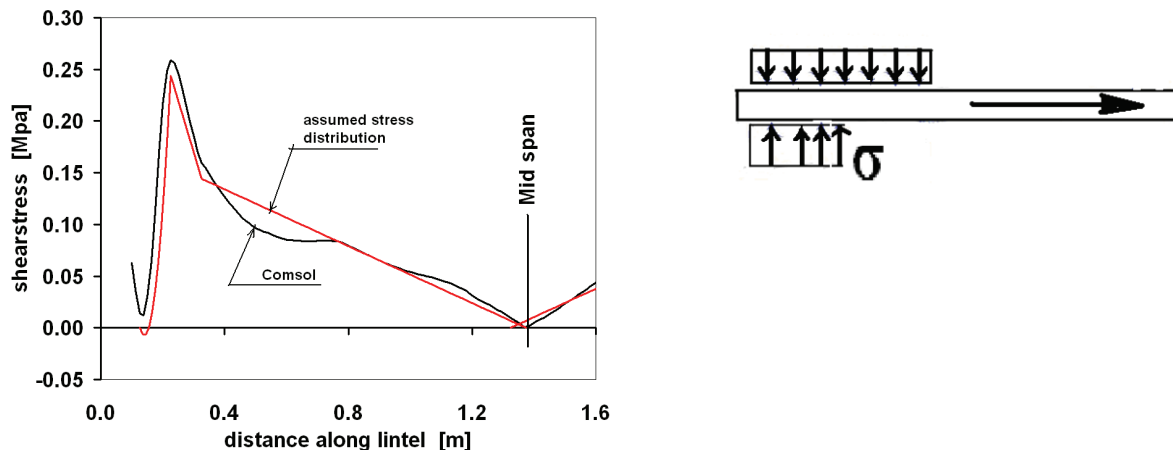
Figure 2: Shear stress distribution along the lintel-masonry interface; calculated on the basis of the stress distribution shown in Figure 1 and as the result of simulations [4].

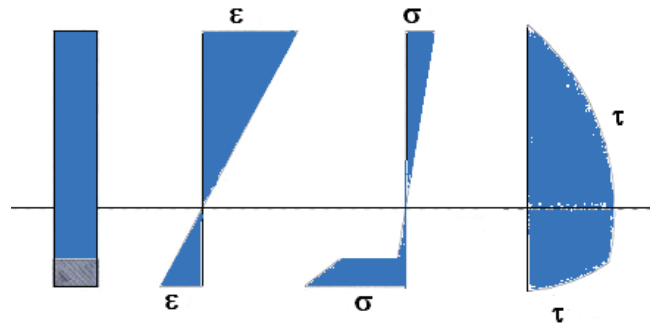
Shear capacity must be controlled in a vertical section near the support [7]. When differences in Young's moduli of concrete and masonry are taken into account, and assuming uncracked linear behaviour a shear stress distribution as shown in Figure 4 is obtained, with a maximum value at the neutral axis. However, the shear capacity in the (horizontal) joint between lintel and masonry seems most critical, location 1 in Figure 1. In that area, stress distribution is not uniform as found in [4]. Further, after cracking, arching becomes prominent. Other possible failure modes are shear in the arch at other locations and failure of the arch due to splitting, location 2 in Figure 1. At location 3, bending stresses must be controlled.

**Figure 4: Strain and bending and shear stress distribution with stiffer lintel.**

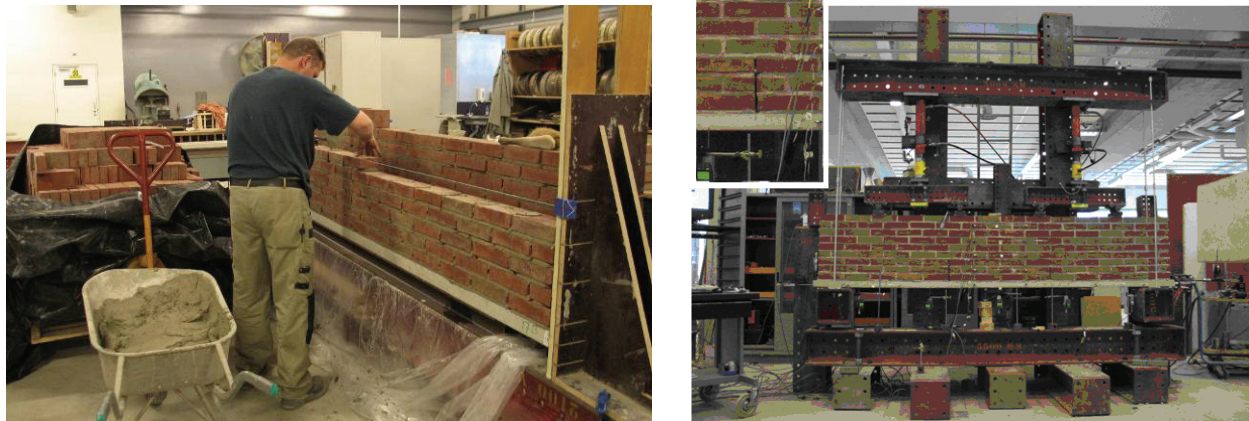
Half of the four point loaded walls (indicated V1 through V9) were “pre cracked” by vertical header joints at one third span, Figure 5b. An additional series (3 walls) were supported on rollers but the lintel was stiffened by four external bars.

**Figure 5: a) Building the test walls, in the TU/E laboratory. b) Test set up roller support with, in detail, open header joints above the lintel**

However, the masonry will have some tensile capacity and, to obtain an arch which is completely ‘free’, the masonry has to crack. The load-bearing capacity of the uncracked masonry may be higher than the load-bearing capacity of the arch developed after cracking. Therefore, half of the walls that were S4P-loaded were pre-cracked by vertical joints, as shown in Figure 5.

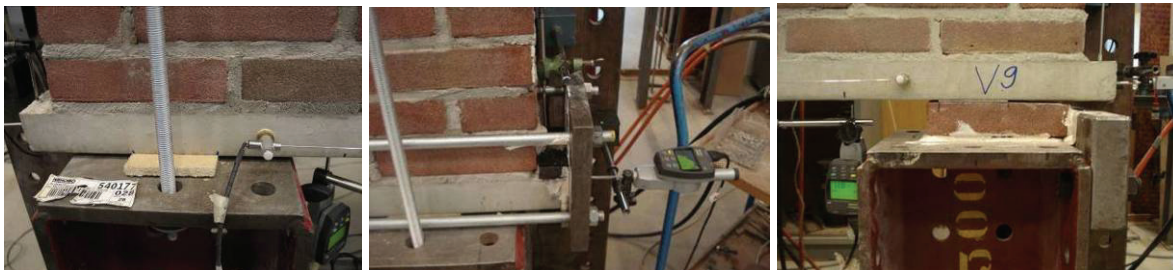
A roller support was simulated by suspending a steel block from the roof beam of the test frame using two threaded rods, 1500 mm in length. In this way, the steel support block rotated easily and moved freely in the horizontal direction. Another support condition, often used in practice, was simulated by a layer of felt on a brick. This brick was positioned in a two mm thick layer of gypsum on the same steel block as used for the roller support. However, this block was bolted to the bottom beam of the test frame. Each wall had either two roller or two supports on felt. The external stiffening bars used in the additional tests (A1, A2 and A3) are shown in Figure 6b. Figure 6a en Figure 6c show the other two types of support used in detail.

**Figure 6: Supports in detail: a) roller, b) stiffened lintel and c) brick with felt.**

The felt-support condition simulated a practical situation. An attempt was made to simulate pinned support conditions using four external tensile bars to couple the supports horizontally, Figure 6b. However, these bars introduced unintended eccentricities in the lintel. Elongations in the length of the lintel were measured. Only the ones at mid span were used, together with other measurements, to establish the size of the compressed area. Displacements of the lintel-head in the direction of the length of the lintel were affected by movements perpendicular to the measuring direction (the lintel rotated at the support, its end moved upwards) and therefore not used. The observed crack patterns confirm the confining effects in the felt support condition. Two of the roller supported walls failed in bending with broken lintel reinforcement. All other walls failed in shear.

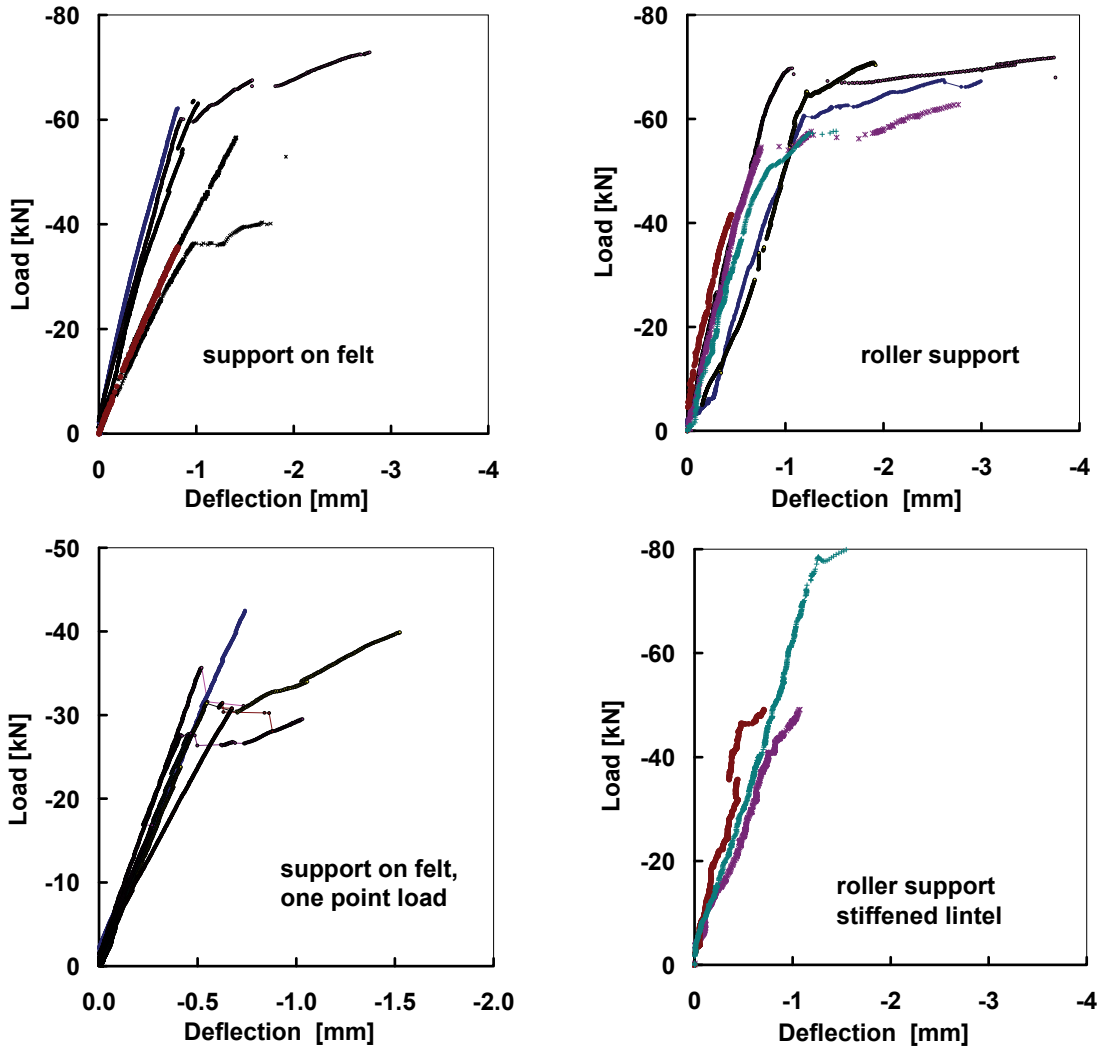
Figure 7 shows the load-deflection diagrams for the three series of six test walls. These deflections of the bottom of the lintel are the measured displacements at mid span corrected for the displacements near the supports. After this correction the behaviour is almost linear until the first cracks appear. Cracking is accompanied by noises and, instinctively, the noise level was an indication for the crack width. In some cases, in the first part of the test, minor cracks were observed in the lintel and masonry but these cracks hardly affected the load-deflection behaviour.

After cracking, the behaviour is less regular and the stiffness becomes smaller than in the earlier phase. However, in this phase, the load first increases but may decrease later on. Finally, the deformation increases rapidly as the test wall (suddenly) fails and large cracks develop. From the walls loaded at four points, one roller supported and four felt-supported test walls collapsed suddenly. A sudden collapse also happened four times in the series loaded with A1P, Figure 7. The load-deflection (F- $\Delta$ ) diagram of each separate test was used to establish the failure and ultimate load. To establish the stiffness factor (k), i.e. the ratio between load and deflection, a linear best fit for the first part in the diagram was used. Table 1 shows the values of k. The mean value is  $k = 60$  kN/mm. Extreme values were found for walls 2.4, 2.5, 2.6 and 3.6 ( $k = 44$  kN/mm) and wall 2.1 ( $k = 75$  kN/mm).

Figure 7: Measured net deflection versus total load for three series of six tests and one additional series of three with stiffened lintel.

In the additional series of three tests (A1,A2 and A3) the lintel was stiffened by four threaded rods. The failure load of one of these tests was almost double the mean value of the other two. The stiffness followed the same trend as the other walls, Figure 7. It is expected that this variation in resistance may have been caused by eccentricities due to the forces in the four stiffening bars.
