## STRENGTH ASSESSMENT OF TYPICAL WALL-DIAPHRAGM CONNECTIONS IN NEW ZEALAND UNREINFORCED MASONRY BUILDINGS

Most unreinforced masonry (URM) buildings in New Zealand consist of solid URM bearing walls and flexible timber diaphragms (floor and roof), and insufficient or absent positive anchorage between URM walls and diaphragms has previously been identified to be the most common reason for out-of-plane wall and gable failures in URM buildings during earthquakes. A series of case studies was performed to determine typical details for wall-diaphragm connections, to ensure that realistic specimens were reproduced in laboratory testing to accurately assess their strength. It was found that typical wall-diaphragm connections in New Zealand were through-bolt anchors, where one end of a threaded steel rod was bolted with a steel bearing plate at the exterior face of the URM wall and the other end was welded to a rectangular steel plate that bolted to the timber joist. This type of anchor was believed to be applied as a retrofit technique to most New Zealand URM buildings following the 1931 Hawke's Bay earthquake. In order to assess the strength and possible modes of failure of the wall-dia

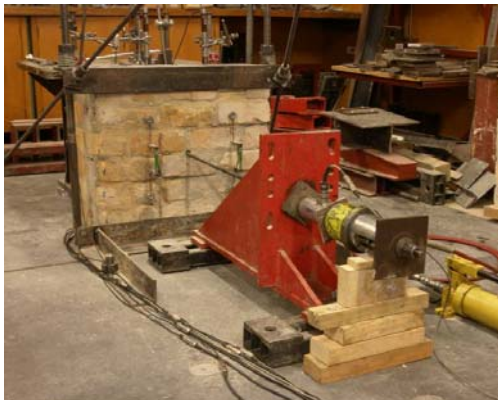
**Figure 4: Pull-out connection test setup**

The pull-out connection testing setup is shown in Figure 4. By assuming the density of masonry to be 19 kg/m<sup>3</sup>, two springs were attached on the top of each specimen to apply an additional vertical stress of 13 kN/m<sup>2</sup> and 15 kN/m<sup>2</sup> to S and T wall specimens, respectively. Thus, a total of 19 kN/m<sup>2</sup> vertical stress in all S specimens was produced to replicate the dead load (overburden) of a 1 m height of parapet, whereas 23 kN/m<sup>2</sup> was generated for the T specimen. The spring was tested in compression to determine the relationship between its load (kN) and displacement (mm). A displacement gauge was attached to the front face of the wall to monitor the crack opening of the wall and wall deflection was measured using five LVDTs that were attached to the back face of the wall specimen as shown in Figure 5. Two LVDTs were also placed on the top of the wall specimen to monitor changes in the applied vertical stress.

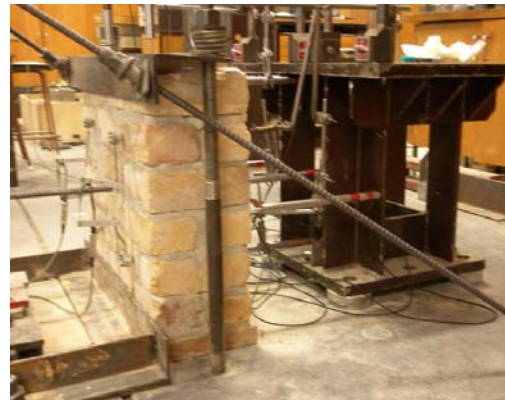
**Figure 5: LVDTs to measure deflection**

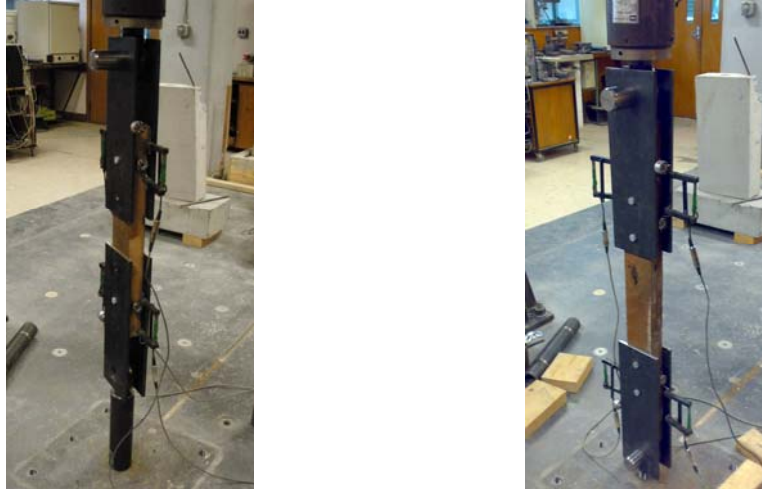
**Figure 6: Typical specimen in testing apparatus: a) one bolt; b) two bolts**

All specimens consisted of three member connections with two steel side plates sandwiching a timber centre piece [10]. The cross section of the timber specimens was 50 mm (thickness) × 100 mm (width). 12 mm diameter ( $d$ ) bolts of 4.8 grade were used in all specimens. The steel side plates were 10 mm thick. Three groups of specimens were tested, where each group consists of five replicates. All groups had a single number of rows ( $n_r$ ), but varied with number of bolts ( $N$ ) and end distance ( $e$ ). The number of bolts varied from 1 to 2, where the connection with 2 bolts had a 100 mm bolt spacing ( $s_b$ ). The timber specimens had a moisture content of 13% at the time of testing. All bolts were finger tight to allow self-alignment [11]. The specimens were loaded in tension parallel-to-grain and were fabricated with an identical connection configuration at each end [10]. A universal testing machine was used to apply the load to the specimens. A monotonic tension load was applied through the side steel plates [11]. Both ends were monitored for load and slip, and the ultimate loads recorded were for the extremity that failed. Two displacement gauges were used to measure the slip of the connection at each extremity. Each load-slip data was collected by a data acquisition system and recorded on a personal computer. Figure 6 shows a typical specimen in the testing frame. All specimens were loaded in tension up to the ultimate capacity of one of the two extremities of the connections.

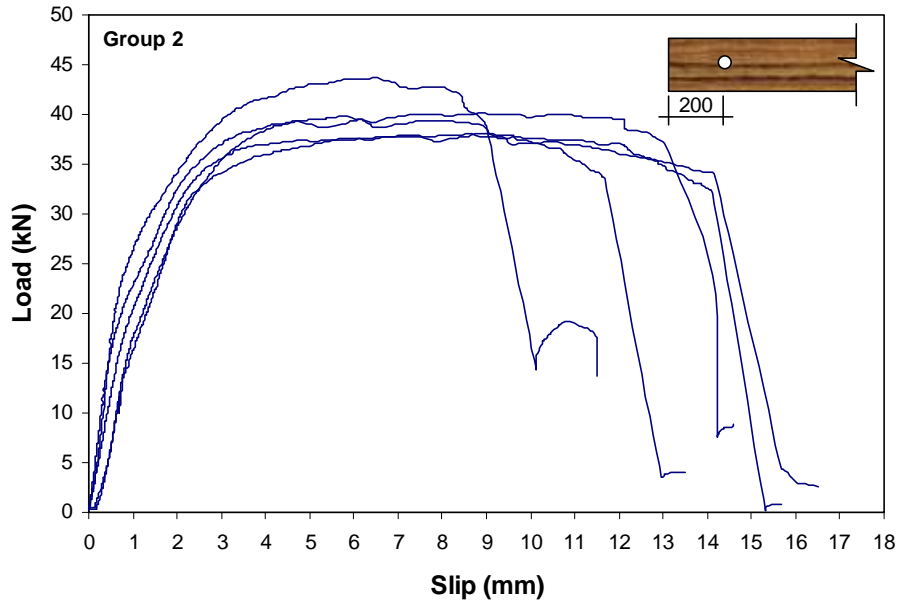
**Figure 7: Typical load-slip curves that exhibit ductile behaviour**

The load-slip curve of each specimen was plotted and the ultimate load and the type of failure were recorded. The experimental results of the three groups tested are listed in Table 3. The 5<sup>th</sup> percentile strength of the experimental values  $R_{5th\%}$  was calculated assuming a normal distribution. From the connection tests, all of the specimens were observed to fail primarily in bearing (ductile behaviour) until a secondary brittle failure such as splitting or row shear-out causes the load to drop suddenly as illustrated in Figure 7. The dominant final mode of failure in most specimens for groups 2 and 3 was row shear-out, where few specimens failed in splitting. However, it is vice versa for group 1. Typical load-slip curves for all specimens in group 2 that exhibited ductile behaviour are shown in Figure 7. In general, the ultimate strength was considerably affected by increasing the end distance from 100 mm to 200 mm. Specimens in group 3 with an end distance of 100 mm had a lower 5<sup>th</sup> percentile value compared to those in group 2 with an end distance of 200 mm by a factor of 0.77. This is consistent with other experimental data available in the literature [10].

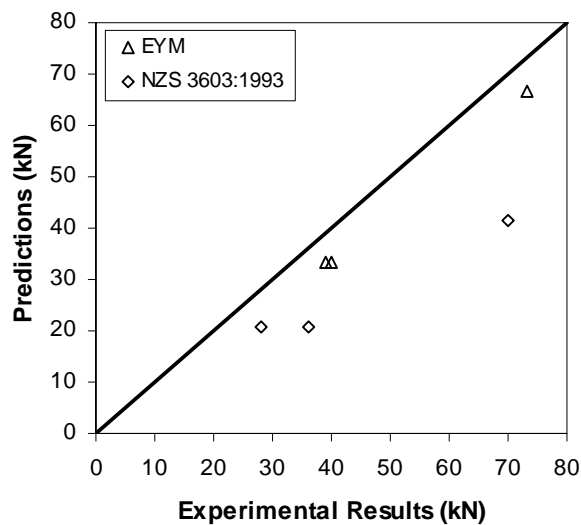
**Figure 8: Predictions vs. experimental results**

In order to compare the experimental results, load-carrying capacities  $R$  of connections were also calculated using the European Yield Model (EYM) [12] and New Zealand timber design standard [13] equations. The EYM equations used were based on Johansen's equations to determine the load-carrying capacity per fastener per shear plane for double shear three member joints. Four equations with respect to four possible failure modes were considered. The equation giving the lowest value of  $R$  identifies the failure mode of the connection. The effectiveness of the EYM and NZS 3603:1993 predictions versus experimental values is plotted in Figure 8. One can see that the current New Zealand code is far too conservative with ratio of the code values to the 5th percentile of the experimental results as low as 0.58. The EYM equations provide better estimation with ratio of 0.91 to the average of experimental results.
