## LARGE SCALE TESTING OF DRYSTONE RETAINING STRUCTURES

C. Mundell<sup>1</sup>, P. F. McCombie<sup>1</sup>, A. Heath<sup>1</sup>, J. Harkness<sup>2</sup> and P. Walker<sup>1</sup>

<sup>1</sup> BRE Centre for Innovative Construction Materials Dept. of Architecture & Civil Engineering, University of Bath

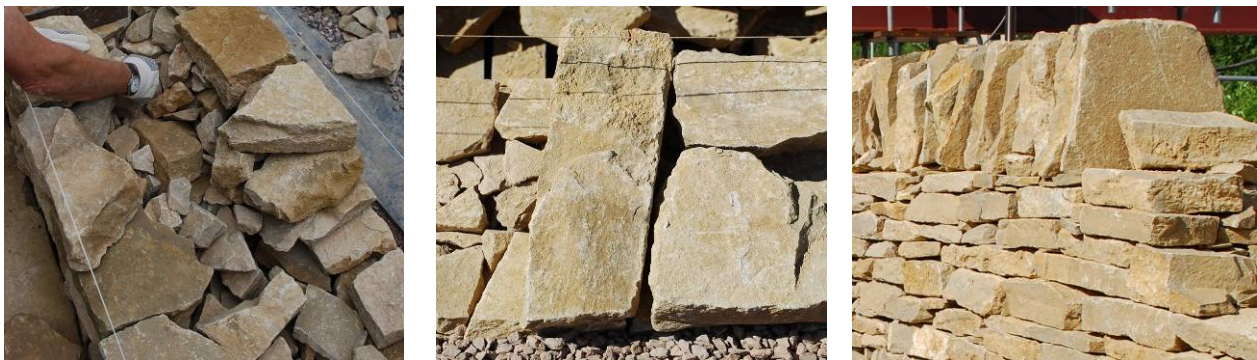
**Figure 1: Typical wall details: a) face and fill; b) through stones; c) coping stones**

If the nature of the stone allows it, drystone walls are typically built in horizontal layers or 'courses', with each course ideally consisting of stones of a 'uniform' thickness, retaining a straight and level appearance. Walls usually consist of a tightly-packed outer face and a core of smaller random material packed behind, sometimes followed by a more roughly built inner face (fig. 1a). 'Tie-stones' span from the outer to the inner face or into the backfill, binding the wall together (fig 1b). Coping stones can act in a similar manner, spanning the entire width of the wall at the crest (fig. 1c), whilst their greater concentrated mass stabilises the stones in the upper levels of the wall.

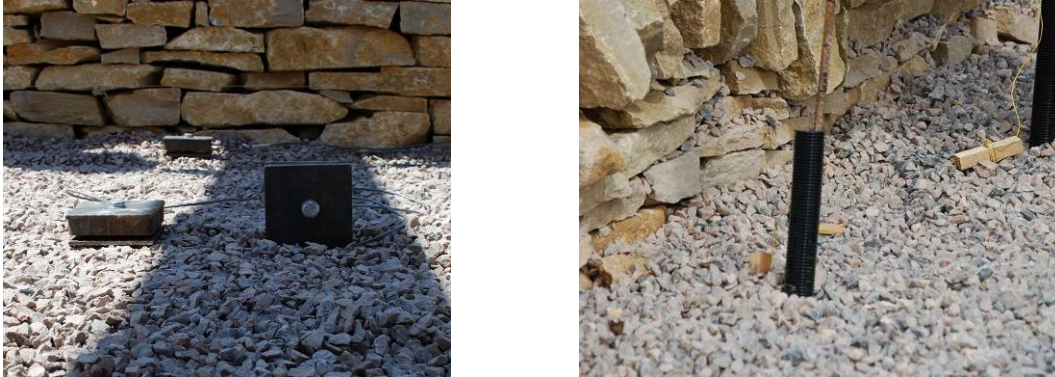
**Figure 4: Instrumentation: a) backfill load cells; b) inclinometer tubes**

The first two tests also utilised small load cells within the backfill. These load cells were sandwiched between 100 x 100mm steel plates and placed at critical locations within the backfill, orientated to record either horizontal or vertical pressures (fig. 4a). The aim was to use this data to help determine the distribution of stress within the gravel arising from the surcharge loading. This form of monitoring was discontinued after the second test wall; results were often inconsistent and erratic, mainly due to the small scale of the steel plates in relation to the size of the gravel. Larger plates were considered, which would give more reliable readings, but these would have a greater impact on the test itself and possibly affect the wall behaviour.

were lowered down the flexible tubes until either the end was reached or an obstruction was found, such as kinks caused by developing shear planes. With similar data from several locations, this method identifies the failure plane quickly and easily during the test, and so was adopted in favour of the time consuming ball bearing approach (fig. 4b).

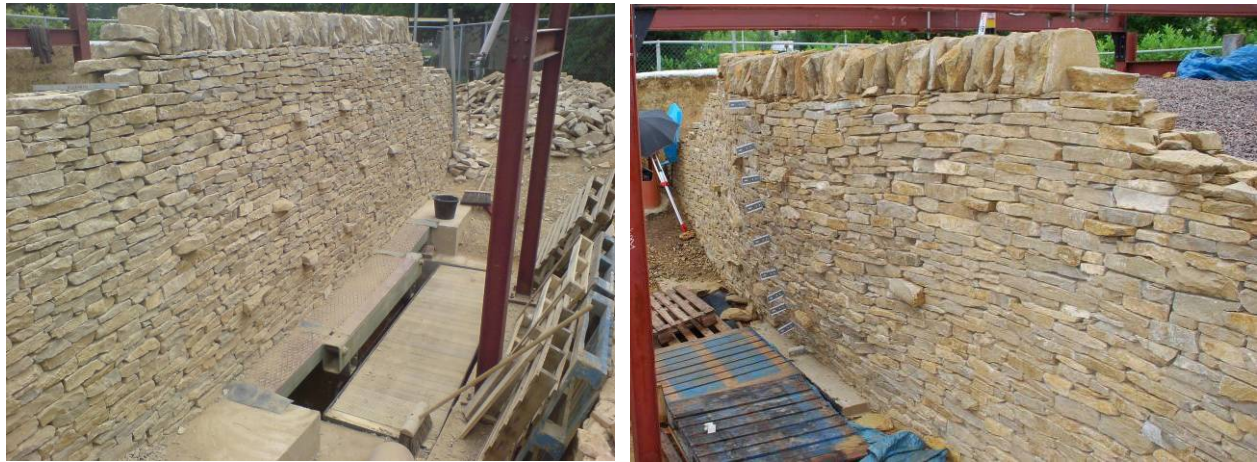
**Figure 5: Test wall 1: a) post construction; b) prior to failure**

The first wall was built in June 2007, constructed over 5 days to a high standard, having tightly packed faces with a well finished appearance (fig. 5a). The overall thickness ranged from

600mm at the base, with a battered front face tapering the wall to 400mm at the coping. Through-stones were incorporated at several levels following standard walling practice.

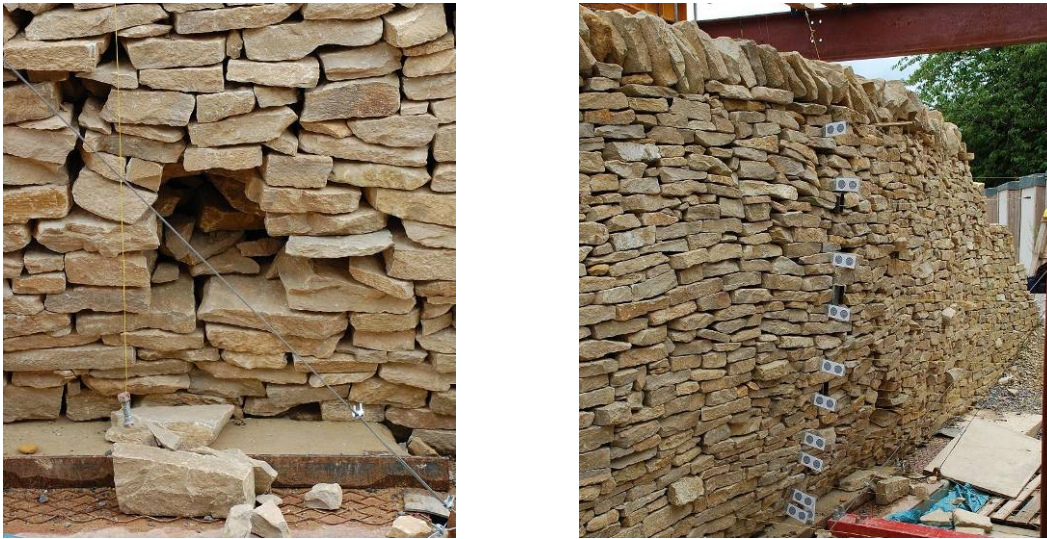
**Figure 7: Test wall 3: a) local failure; b) prior to total failure**

as possible against overturning failures, allowing other mechanisms to develop. The internal make-up of the wall was much different to the first wall, consisting of a much rougher construction, utilising much smaller unfaced blocks ensuring that as few large, slab-like stones were used as possible. The standard practice of pinning the stones to eliminate movement was largely disregarded, giving each block the ability to rock slightly in place. In short, the wall more closely resembled a much older construction, subjected to several years of weathering and erosion. Indeed, once testing began, a small section of the wall failed, leaving a large hole whilst the rest of the wall remained stable (fig. 7a)

The testing procedure remained identical, with an initial platform raise followed by a surcharge at a distance of 1m until the collapse mechanism occurred. A stable bulge quickly developed, forming the distinct ‘belly bulge’ which is commonly found in many in-situ walls (fig. 7b, fig 8a). This bulge continued to develop as the loading progressed, until collapse occurred mainly as a bursting failure.
