**13<sup>TH</sup> CANADIAN MASONRY SYMPOSIUM**  
**HALIFAX, CANADA**  
**JUNE 4<sup>TH</sup> – JUNE 7<sup>TH</sup> 2017**

**INFLUENCE OF OPENINGS ON QUASI-STATIC CYCLIC BEHAVIOUR OF  
PARTIALLY GROUTED MASONRY WALLS**

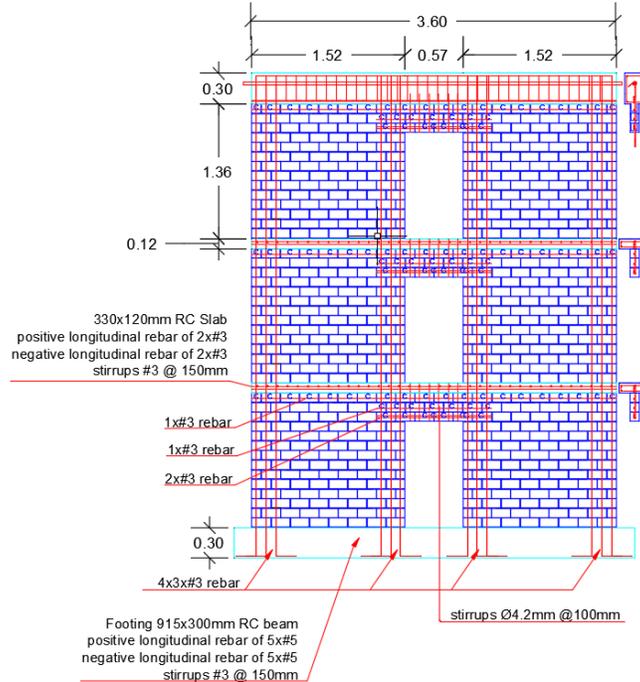
**Figure 1: Schematic of Specimen with walls with doors**

The walls were reinforced with 3 #3 bars ( $d_b = 9.5$  mm) at each end and side of the openings. A two-course beam was constructed over each opening, reinforced with 2 #3 longitudinal bars at the bottom and 1 #3 longitudinal bar at the top. A continuous bond beam, reinforced with 1 #3 bar was constructed over each storey. This bar was hooked at the ends to the vertical wall reinforcement. A reinforced concrete slab, reinforced with 2 #3 longitudinal bars at the top and the bottom and #3 stirrups at 150 mm on centre, was constructed over the 1<sup>st</sup> and 2<sup>nd</sup> floors. The masonry beams over the openings had a #2 bar ( $d_b = 6.3$  mm) closed loop stirrup in every cell. To support the stirrups at the top, an additional #3 bar was placed in the reinforced concrete slab, resulting in the slab having 3 #3 bars at the top. A concrete beam, reinforced with 2 #5 bars ( $d_b = 15.9$  mm) on the top and bottom and stirrups 150 mm on centre, was constructed at the top of each specimen. The vertical bars in the specimens were extended into the beam and hooked around a 38 mm diameter, high strength, threaded bar that extended the entire length of the wall. This high strength bar extended past one end of the reinforced concrete beam to connect the specimen to the actuator. Four specimens (numbers 2 and 3 (door openings) and 5 and 6 (window openings)) had, at each level, a bond beam at the 5<sup>th</sup> course. The beam was reinforced with 1 #3 longitudinal bar. The bar was hooked at the ends to the vertical wall reinforcement. The specimens were constructed on a  $305 \times 1219 \times 4064$  mm concrete footing, which was reinforced with 5 #5 longitudinal bars top and bottom and #3 stirrups at 150 mm on centre.

Six specimens, three with door openings coupled by masonry beams and three with window openings also coupled with masonry beams, were constructed and tested. The configurations were selected to represent actual walls with openings. The overall dimensions of the specimens were  $4.3 \times 3.6$  m, not including the top reinforced concrete beam and the footing. The specimens were thus equivalent to walls on each of three 2.87 m high storeys. The door size was  $1 \times 0.57$  m and the window size  $0.57 \times 0.57$  m. A schematic of a specimen with door openings is provided in Figure 1. The specimens with windows were the same except that they had windows starting after the 5<sup>th</sup> course of masonry from each floor. The masonry was constructed with units half the scale of a standard  $190 \times 190 \times 390$  mm hollow concrete block unit: similar half-scale units have been used by several other researchers (for example, [7]-[9]). The webs of the units were cut to form bond-beam units, which were used for the bond and masonry beams.

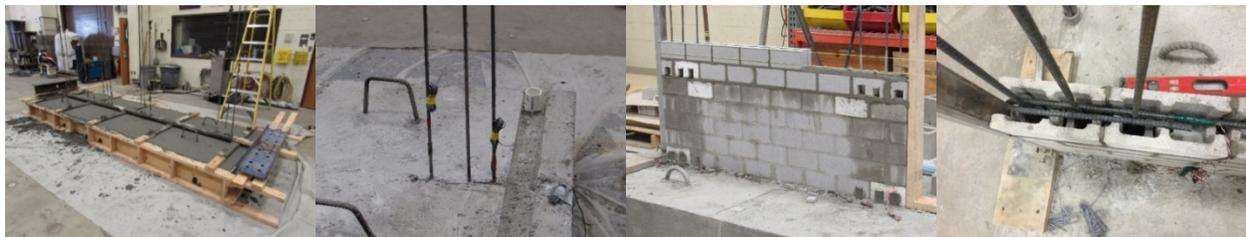
**Figure 2: Specimen construction**

Construction of each specimen began with pouring the reinforced concrete footing, as shown in Figure 2a. The vertical reinforcement was tied to the reinforcement of the footing and protruded from the footing as shown in Figure 2b. The blocks were laid with 5 mm mortar joints. When the masonry was five courses high, the vertical cells containing reinforcement were grouted as shown in Figure 2c. For the walls with a bond beam at the 5<sup>th</sup> course, the horizontal reinforcement was hooked around the vertical bars as shown in Figure 2d. The top of each level, i.e., the 14<sup>th</sup> course, was also formed into a bond beam. Reinforced masonry beams were built under and over the openings. A small reinforced concrete slab was cast-in-place atop the 14<sup>th</sup> course of the 1<sup>st</sup> and 2<sup>nd</sup> storeys. The slab was used to connect the wall to the lateral bracing support of the testing frame. A reinforced concrete beam was cast-in-place atop the 14<sup>th</sup> course in the 3<sup>rd</sup> storey to support the vertical load and to distribute the applied lateral load along the length of the specimens. Two constructed specimens, one of each type, are shown in Figure 3.

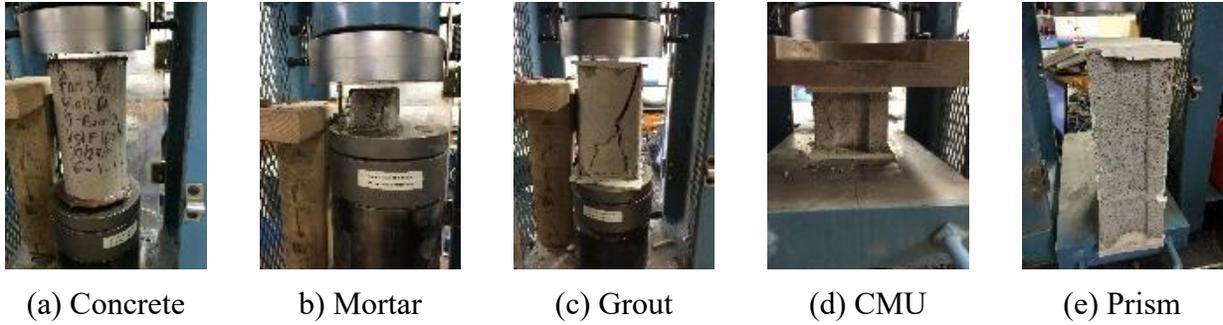
**Figure 4: Testing of the Materials**

The properties of the constituent materials used to construct the walls were determined from standardized testing methods. Concrete strengths were determined by testing three standard 100 x 200 mm cylinders, as shown in Figure 4a at 28 days after casting. The average compressive strength of the foundation concrete was 49 MPa (C.O.V = 7%). The concrete used in the slabs representing the floor at each story was mixed in the laboratory from dry, pre-mixed bags of concrete. For the 120 mm thick concrete slabs, the maximum crushed limestone aggregate size was 10 mm. and three concrete cylinders were tested for each floor slab. The average compressive strength of the concrete used in all floor slabs was 37.7 MPa (C.O.V = 9.8%). The concrete used for the top concrete beam was ready-mix with a specified maximum aggregate size of 10 mm. The 28-day compressive strength of this concrete was 30 MPa (C.O.V = 5.2%). Compression tests were also conducted on mortar cubes as shown in Figure 4b. Several mortar batches were prepared during the construction of each specimen. Type S mortar was used and 24 randomly chosen 40 mm mortar cubes were tested in compression. The average compressive strength of the mortar was 15.7 MPa (C.O.V. = 15.1%). Pre-mixed bags of fine grout were used, with the grout being mixed in the laboratory. The grout was sampled by constructing three grout prisms for each level. The prisms were 89 x 89 x 190 mm as shown in Figure 4c. The average compressive strength of the grout was 35.7 MPa (C.O.V. = 12.8%). Compression tests were conducted on six of the half scale units, as shown in Figure 4d. The average compressive strength of the blocks, based on net area, was 16.9 MPa (C.O.V. = 9%). Three grouted and three hollow masonry prisms were built during the construction of each specimen and tested, as shown in Figure 4e, to determine their compressive strengths. The prisms were three blocks high by one block long. The grout was rodded during grouting of the prisms to ensure complete filling of all cells. The prisms were capped with gypsum prior to testing. The average compressive strengths, based on net area for grouted and ungrouted prisms, were 10.4 MPa and 12.0 MPa, respectively. The reinforcing bars were also tested. The vertical and horizontal bars had a yield strength of 638 MPa and the reinforcing bar used for stirrups had a yield strength of 312 MPa.

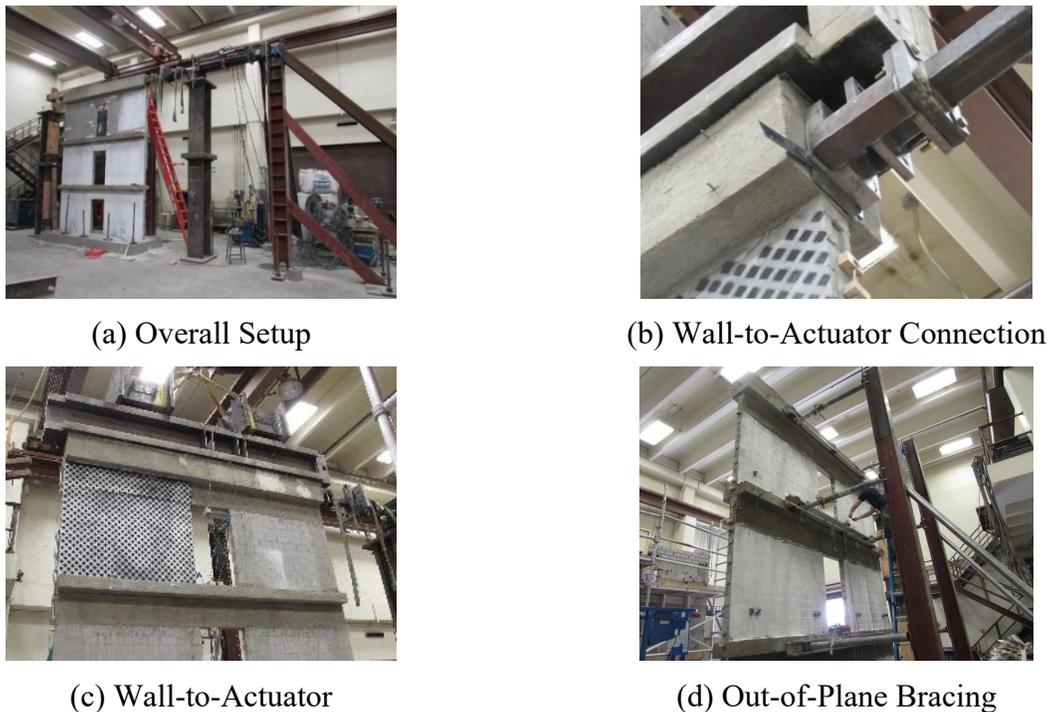
**Figure 5: Specimen test setup**

The test arrangement is shown in Figure 5. Horizontal cyclic loading was applied to the top of the specimen via the concrete beam on top of the specimen. The concrete beam served to distribute the lateral and axial loads along the length of the specimen. The high strength bar embedded in the concrete beam was connected to the actuator as shown in Figure 5b. A set of steel shapes, weighting approximately 50 kN, was placed on top of the specimen to simulate a distributed axial dead load as shown in Figure 5c. The wall was stabilized from moving out-of-plane by a frame as shown in Figure 5d. The out-of-plane bracing system was used to represent the stabilizing influence of rigid diaphragm floors and consisted of three steel beams pinned to a steel frame at each floor level. These beams were connected to the reinforced concrete slabs and to the top concrete beam. The link members at each story were designed to resist out-of-plane displacements while not influencing the in-plane and vertical wall movements.

The concrete footing was fixed to the concrete structural floor by ten post-tensioned Dywidag bars. Lateral in-plane cyclic load was applied using a hydraulic actuator with a capacity of 500 kN and a stroke of  $\pm 250$  mm.

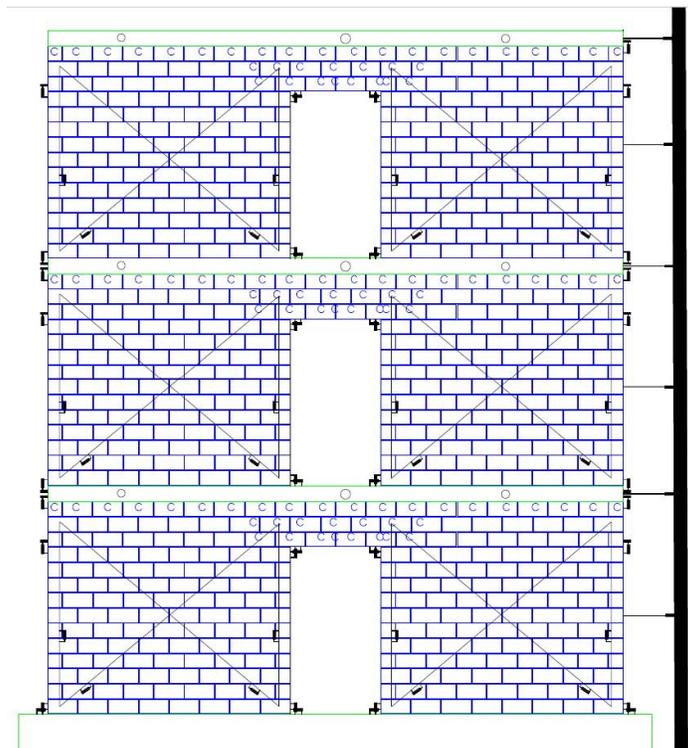
**Figure 9: Specimen Instrumentation**

String potentiometers and Linear Variable Differential Transducers were used to measure horizontal and vertical displacements, as shown in Figure 9. Displacements at the window and door levels, sliding of the wall relative to the concrete footing, and uplift at wall heels were monitored. Movement at the corners of the openings were also measured. String potentiometers attached to an independent column were used to monitor the movement, if any, of the test frame and the concrete footing. String potentiometers were also placed to obtain the shear and flexural components of the wall deformations. The overall in-plane lateral displacements of the walls, along the height of the walls, were monitored using seven horizontally positioned potentiometers. Two additional potentiometers were mounted at the base of the wall to monitor any horizontal slip and vertical uplift that might occur between the specimen and the concrete foundation.

Strain gauges were installed on the reinforcement along the wall height for each floor. Strain gauges were also placed on the two outermost reinforcing bars at the end of each specimen to monitor strain penetration into the RC footing. These strain gauges were located at heights of +100 mm, -100 mm and -1200 mm, relative to the wall-footing interface.

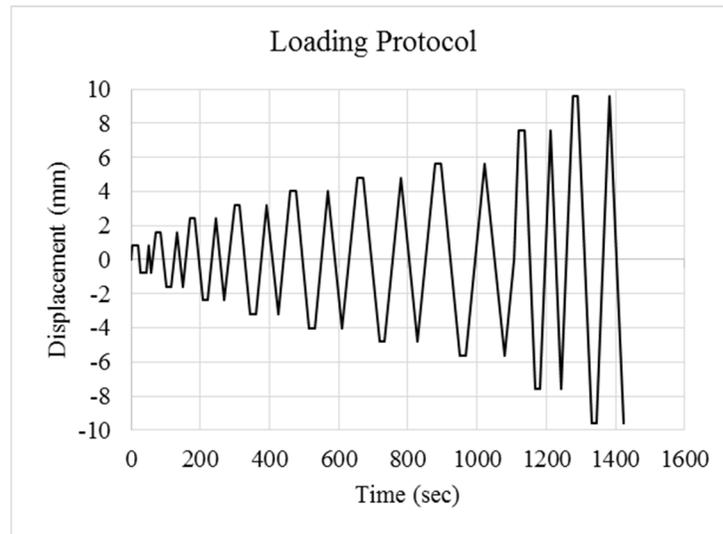
**Figure 10: Specimen Test Protocol**

The walls were tested under displacement control with a prescribed lateral displacement plan, as shown in Figure 10. The displacement-controlled procedure was designed to allow assessment of different targets such as yielding of the reinforcement, the first crack, the end of the linear region, peak load and ultimate load. At each new displacement level the test was paused briefly in each displacement direction (push and pull) to mark and take pictures of the cracks. Failure of a specimen was defined as the point where the lateral resistance dropped below approximately 60% of the measured peak lateral load.

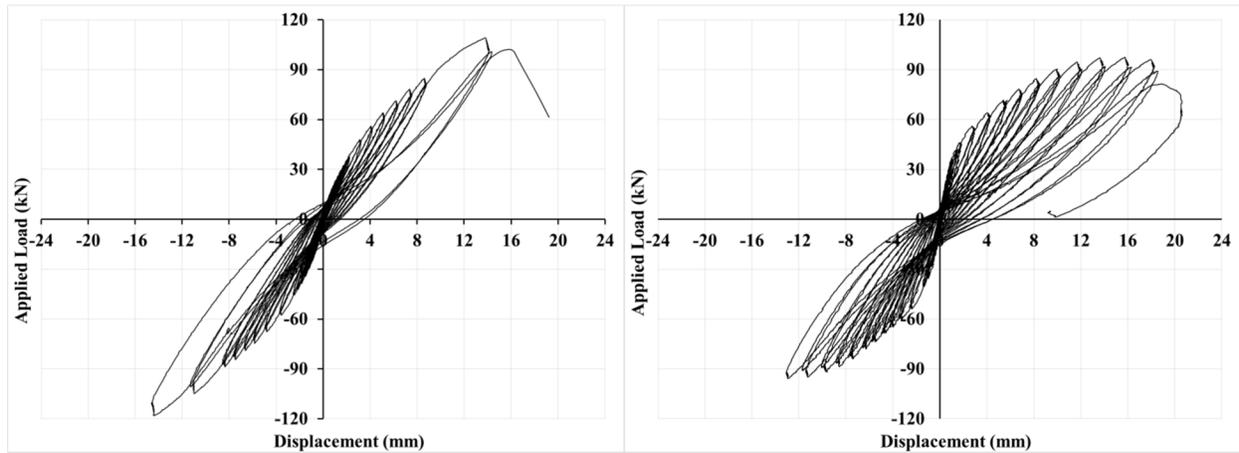
**Figure 11: Response of specimens with door openings**

The hysteresis for specimens 1 and 2 with door openings and 4 and 5 with window openings are shown in Figures 11 and 12, respectively. The response of specimen 3 was similar to that of specimen 2 and the response of specimen 6 similar to that of specimen 5.

The hysteresis curves are symmetrical in general, indicating similar behaviour in both directions of loading until major cracks developed in one or other loading direction. After that, damage concentrated in that loading direction and the response started to become asymmetric. For all specimens a small decrease in strength and stiffness is observed during the second excursion to the same displacement level. At higher displacement levels, bigger hysteresis loops are evident, indicating higher amounts of energy dissipation and increased plastic deformations.

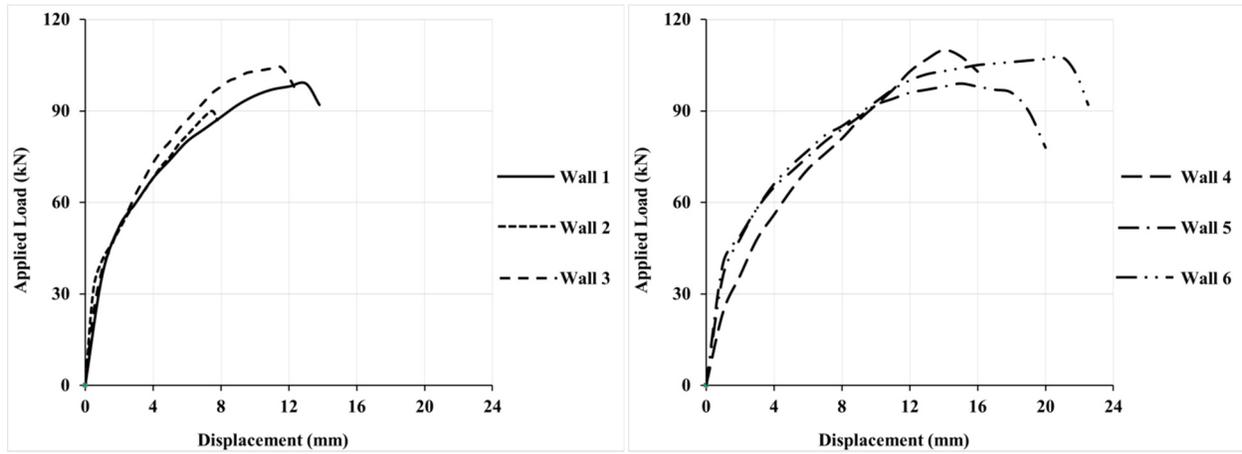
**Figure 13: Envelopment response**

The envelope response of all specimens in the push direction is shown in Figure 13. The walls with door openings presented similar stiffness even after the reinforcement yielded. The responses are similar and apparently the bond beam at the 5<sup>th</sup> course of each storey (specimens 2 and 3) changed neither the behaviour nor the capacity. The capacity of specimen 2, however, is slightly less than that of its counterpart, specimen 3. The test results are being examined in depth

For the specimens with window openings, the response of the specimen without a bond beam at the 5<sup>th</sup> course of each storey is slightly different from that of the specimens with such bond beams. That specimen is slightly more flexible and slightly less ductile. The capacity of that specimen, however, is slightly more than that of the other specimens.

The capacities of all specimens are similar, except that of specimen 2. The specimens with window openings appear to be slightly more ductile than those with door openings.

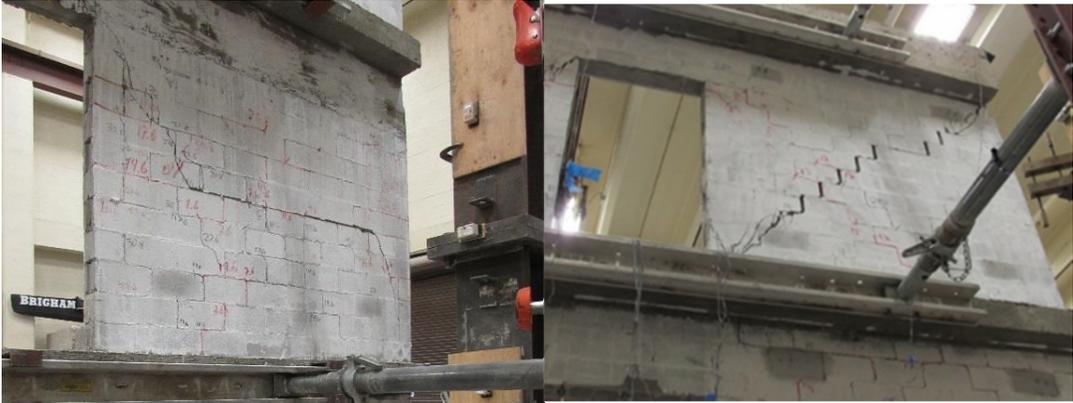
**Figure 14: Specimen with door openings**

Some of the cracks on walls with door openings are shown in Figure 14 and some of the cracks on walls with window openings in Figure 15. Typically, horizontal bed joint cracks were first

observed at an applied displacement of 2.4 mm, which corresponded to approximately 40 to 60 kN lateral load. The cracks formed in the mortar joints between the third and tenth courses in the first, second and third storeys and extended, on average, approximately 800 mm along the length of the wall. As the applied displacement was increased, the cracks widened and propagated. Cracks would then develop at head joints. A step crack pattern would develop, indicating a shear dominant effect. Ultimately, walls failed due to shear as shown in Figure 14.

Specimens 2, 4 and 5 failed in the first storey and specimens 1, 3 and 6 failed in the third storey. Walls experienced slipping along bed joints, a step crack pattern and, at the end of the test, cracking along joints and through units, as shown in Figures 14 and 15. The cracks suggest a diagonal strut infilled within the reinforced masonry regions and a dominant diagonal shear behaviour. It appears that the concrete beams on the top of the walls and the masonry beams
