**13<sup>TH</sup> CANADIAN MASONRY SYMPOSIUM**  
**HALIFAX, CANADA**  
**JUNE 4<sup>TH</sup> – JUNE 7<sup>TH</sup> 2017**

**ANALYSIS OF THE 15<sup>TH</sup> CENTURY BELL TOWER, ST. NICHOLAS CATHEDRAL,  
NEWCASTLE UPON TYNE**

**Righetti, Luca<sup>1</sup>; Corradi, Marco<sup>2</sup>; Lim, Michael<sup>3</sup>; Charlton, James<sup>4</sup>; Dundas, Matthew<sup>5</sup>  
and Amess, Leon<sup>6</sup>**

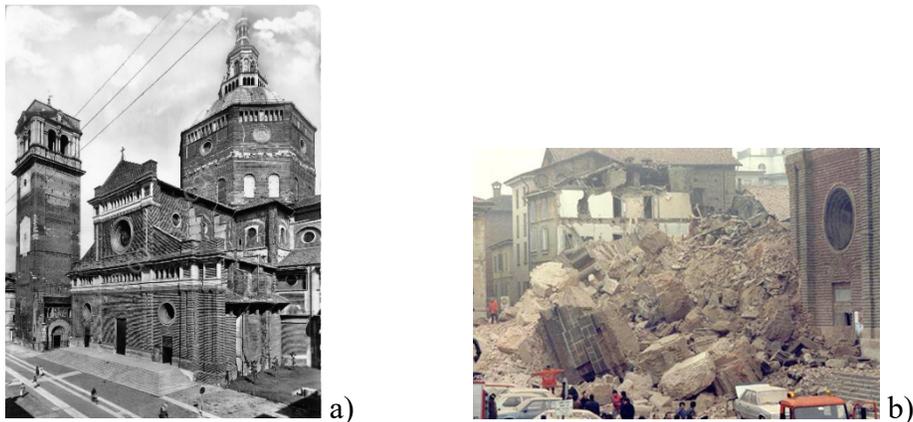
**Figure 1: The Civic Tower next to Pavia Cathedral Collapsed in 1989: a) Before Collapse, b) After**

A significant portion of European architectural heritage is accounted for by religious buildings (churches, monasteries, etc.). Many of these structures were designed to impress, using tall and imposing constructions. In England, the strong association between religion and political power enhanced this effect; religious constructions were not only places to worship, but also public buildings where the authority was demonstrated. Prominent among these structures are bell towers. In Christianity, bell towers were designed to contain one or more bells to be rung to signify time or to call people to worship. Consequently, architects often designed structures close to their limits and limit stresses, utilising relatively low strength materials based on stone masonry and lime-based mortars. Therefore, historic masonry bell towers have often proven particularly susceptible to damage and collapse, not only during catastrophic events (earthquakes, storms, etc.), but also under ordinary loading conditions. On 17 March 1989, the 11<sup>th</sup> century civic tower next to Pavia Cathedral in Italy collapsed into 8000 m<sup>3</sup> of brick, sand and granite rubble, killing four people and injuring fifteen (Fig. 1). The famous bell tower of Pisa is another stonemasonry construction at risk of collapse due to progressive tilt that originated during construction. On Monday 14 July 1902 the bell tower of St. Mark Cathedral in Venice collapsed completely on a calm, sunny summer day (Fig. 2).

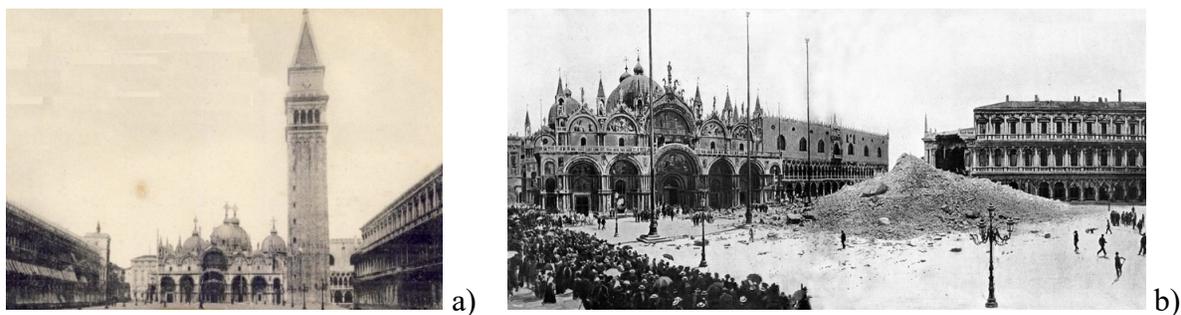
**Figure 2: The Bell Tower Next to Venice Cathedral Collapsed in 1902: a) Before Collapse, b) After**

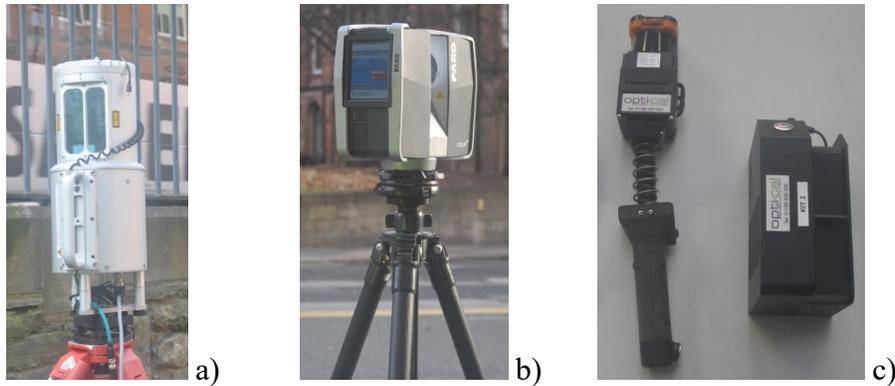
**Figure 4: Scanners Used for the St. Nicholas Cathedral Survey: a) Riegl LMS-Z620, b) Faro Focus3D 20, c) GeoSLAM ZEB1 3D Scanner**

In order to obtain accurate and detailed information on the bell tower's geometry, a 3D geometric survey investigation has been conducted using terrestrial laser scanning. The bell tower contains four stories. At ground level the entire structure rests on four massive pillars. Three terrestrial laser scanning instruments (Fig. 4) have been used for the survey: a Riegl LMS-Z620, a Faro Focus<sup>3D</sup> 20 Scanner and a GeoSLAM ZEB1 3D Scanner. The Riegl was used to capture the long-range external structure of the bell tower. The Riegl laser can measure distances in the range of 2–2000 m, with a claimed accuracy of 10 mm at 100 m and a beam divergence of 0.15 mrad. The scan angle range is 80° vertically from the horizontal plane and 360° horizontally, with a measurement rate of up to 11,000 points/sec. The Faro was deployed to survey the internal structure of the four floors within the bell tower. The Faro Focus can transmit a continuous beam of 905 nm laser light and measures distances in the range of 0.60–20 m, with a measurement accuracy of 2 mm at 10 m and a beam divergence of 0.19 mrad. The field of view covers 305° vertically and 360° horizontally. The narrow spiral stair connections have been surveyed with the GeoSLAM handled mobile mapping system. GeoSLAM is a mobile mapping system with a range distance of 30 m and a relative accuracy of 20-30 mm. Laser wavelength is 905 nm and data acquisition rate of 43,200 points/sec.

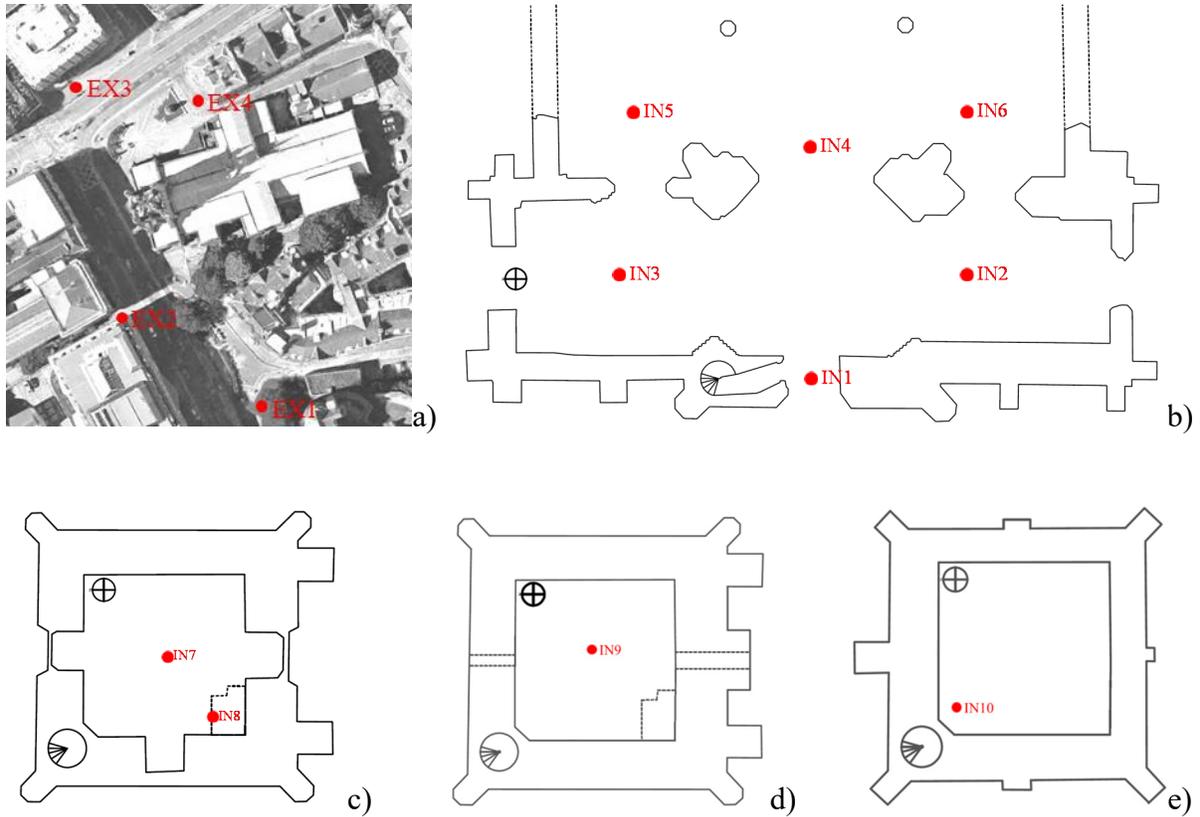
**Figure 5: Scan position: a) Outdoor (EX1, EX2, EX3 and EX4), b) Ground Floor (IN1, IN2, IN3, IN4, IN5, IN6), c) 1st Floor (IN7 and IN8), d) 2nd Floor (IN9), e) 3rd Floor (IN10)**

After an initial analysis, four positions (Fig. 5a) were chosen for the outdoor scans. This was necessary in order to record a full panoramic view of the steeple. Six scans (Fig. 5b) were necessary to capture the geometry of the internal ground floor. Two more were carried out for the first floor (Fig. 5c) and one each for the second (Fig. 5d) and third floors (Fig. 5e). Finally, three scan trajectories have been recorded within the spiral staircase. All survey stations have been selected to optimise data coverage and achieve sufficient overlap to register scans into a coherent model. Table 1 summarises the survey strategy used to model the bell tower. The acquisition and storage of data were performed using the following software: 1) Riscan Pro for the acquisition and

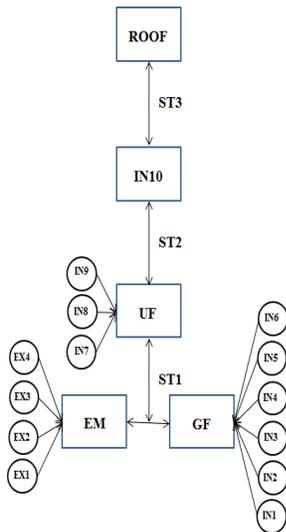
**Figure 6: Outline of the Registration Phase Methodology**

All scans have been manually cleaned of erroneous points not structurally part of the bell tower. The registration process methodology is summarised in Figure 6. The results of the four external scans are shown in Figure 7. Figure 8 shows a view of the registered internal ground floor. The bell tower is 61.24 m high and, at ground level, has planimetric external dimensions of 12.03 x 11.99 m. Above the main tower is a lantern tower (17.65 m in height), supported by pinnacles at each corner. Two openings are present in the west side of the steeple: the doorway (2.53 m wide and a maximum height of 3.85 m) and a large stained glass window (4.40 x 7.2 m) above the door. The spiral staircase is enclosed within the north-west pier and connects the upper stages of the building. It has a nominal diameter of 1.65 m, but varies with height. In the north wall, an iron strap has been bolted to the wall across the whole of the internal width just below windowsill level. There is a similar strap to the south elevation wall but this is a little higher, being part way up the window opening. This also extends into the nave, fixed to the walls just below clerestory windowsill level.

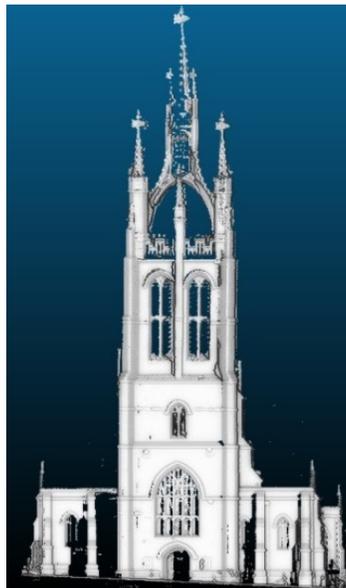
**Figure 7: View of the Registered External Part (EM) of the Bell Tower**

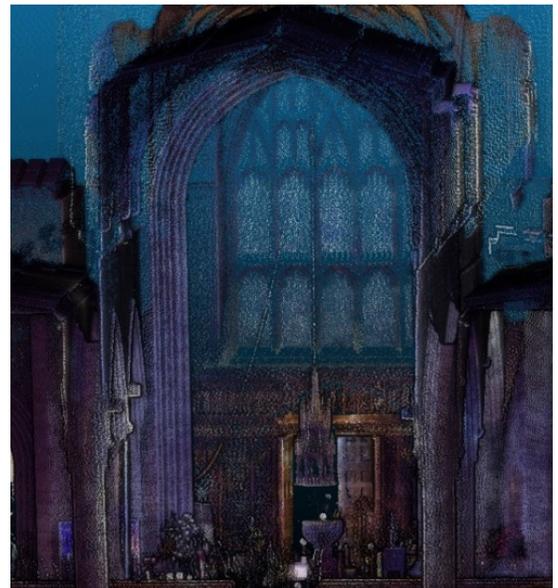
**Figure 8: View of the Registered Internal Ground Floor (GF)**

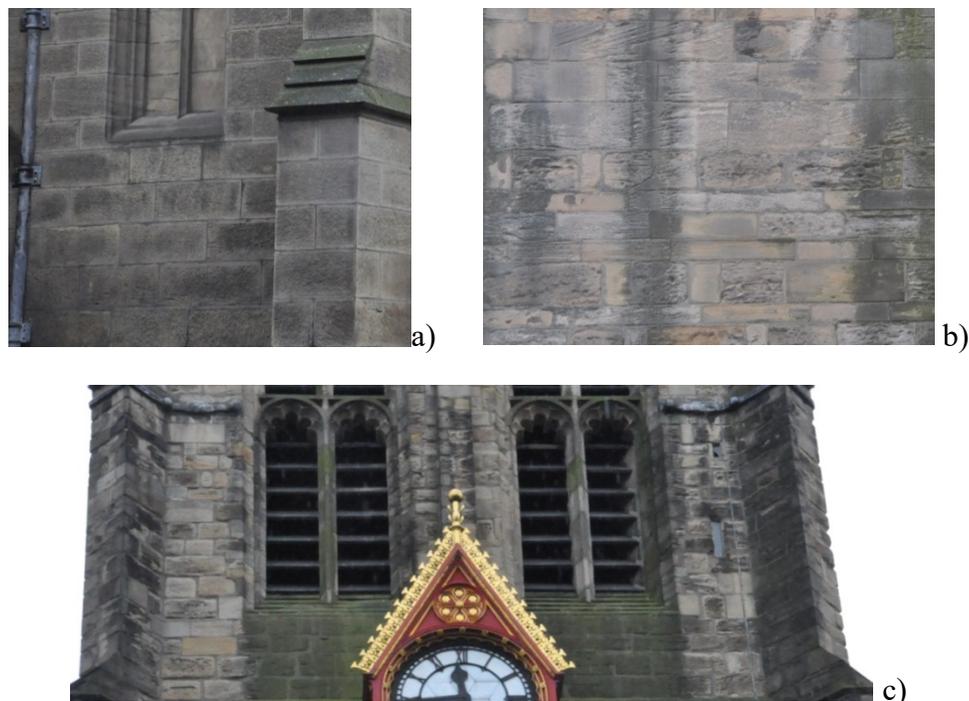
**Figure 9: Typologies of Masonry: a) Ground Level, Typology A, b) Under the Clock Level, Typology B, c) Over the Clock Level, Typology C**

The bell tower of St. Nicholas has been constructed using perfectly cut sandstone blocks. However, variations exist in both the dimensions and in the state of the blocks. The visual analysis has identified three different masonry typologies relating to the ground level, the lower section and the upper section of the bell tower. The quality of the masonry material at the base of the tower is high, and likely to relate to 19<sup>th</sup> century restoration (Typology A). It comprises large and consistently sized blocks (up to 100 cm in width), perfectly cut with no signs of degradation (Fig. 9a). The vertical mortar joints are well spaced and the bed joints are perfectly horizontal. The masonry Typology B is found between the restored base levels and the clock, located at approximately half of the total height of the bell tower (Fig. 9b). It shows signs of degradation, the stones span a range of dimensions and some vertical joints are aligned, resulting in a potential strength reduction. Finally, in the section above the clock is masonry Typology C (Fig. 9c). This phase contains a better arrangement in the stone blocks, which may result in a slight increase in structural and mechanical integrity.

Table 3 shows the numerical values assigned to the seven parameters for all the three loading conditions (V, I and O). By using eq. (1) has been possible to calculate the MQI value (Table 3). High values were found for masonry Typology A. However, it should be noted that this only refers to the visible masonry, added during the 19<sup>th</sup> restoration. It is likely that the restoration only

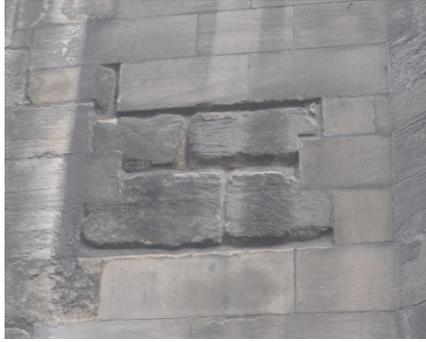
**Figure 10: The Original and New Stone Block Added After 19<sup>th</sup> Century Restorations**

affected the outer layer of external stones and there is a stark contrast between the original and later restored stone blocks (Fig. 10). It is also possible that diffuse cracking caused the out-of-plane rotation noted in the south wall as a result of foundation subsidence. In order to mitigate the subsidence a masonry buttress was added in 1832 (Fig. 11). The blocks of this structural element are inclined of approx.  $26^\circ$  into the subsiding south face of the tower. With regard to the behavior under static compressive loads (V), the application of the method reported in [27] gives an estimated compressive strength of 10.2, 4.8 and 5.8 MPa for typologies A, B and C, respectively.

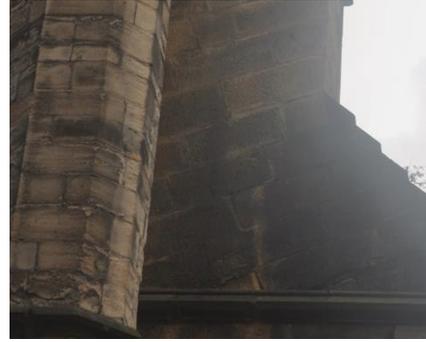
**Figure 11: The Buttress with Inclined Stone Blocks Added to Prevent the Out-of-Plane Mechanism of the South Wall**

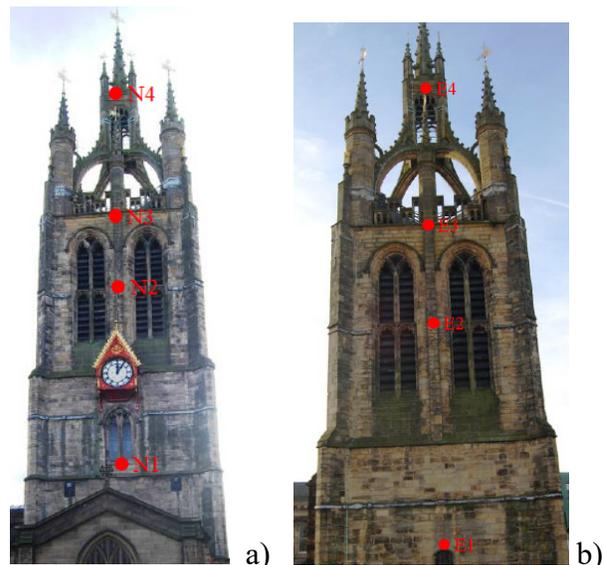
**Figure 12: Points Analyzed Using RSV: a) North Façade, b) East Façade**

The measurements were carried out on the north and east façades. The purpose of the measurement was to study the movement of the structure at several heights (four points for each façade). Because all measurements were carried out at different times, possible changes on the environmental conditions (weather conditions, noise sources, etc.) could happen and affect the displacement amplitude. The key equipment used in the experiment was a RSV. The Polytec RSV-150 single-point scanning laser vibrometer used can measure velocities up to 24 m/s with the maximum frequency bandwidth equal to 2 MHz.

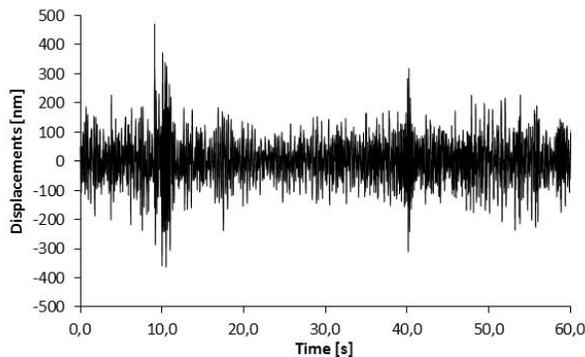
**Figure 13: North-South Direction (N4):  
Time History**

First results of the dynamic tests indicated 6 distinct natural frequencies in the 2 directions North-South and West-East. For North-South direction, natural frequencies were 1.98, 3.87 and 5.76 Hz (Figs. 13-14). For West-East direction, these were 2.64, 7.73 and 8.65 Hz. Measurements were made using the laser vibrometer over an inclination to the horizontal varying from approx. 15° (points N1 and E1 in Figure 12) to 43° (N4 and E4). More analysis is needed for these results before a conclusion can be drawn.

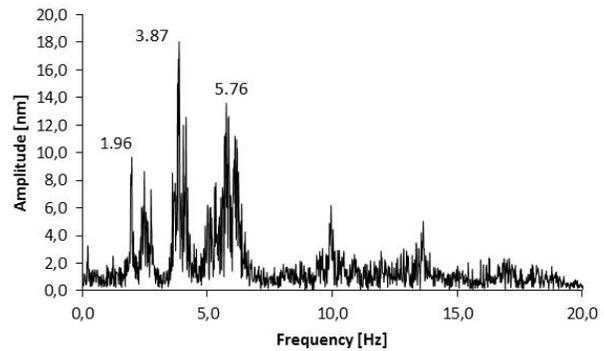
**Figure 14: North-South Direction (N4):  
Fast Fourier Transform**
