IN-PLANE LOADING TESTS FOR CONFINED AND INFILLED MASONRY PANELS IN RC FRAMES WITH ECCENTRIC DOOR OPENINGS

ABSTRACT

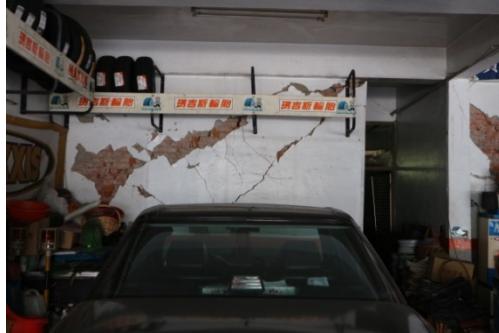
Figure 2: A Street-building Damaged During the 2016 Meinong Earthquake

Figure 1 shows a typical plan for the ground floor of street-buildings in Taiwan. Each single span unit has a main entrance facing the arcade and the street on the west. Therefore, the interior partition walls in the north-south direction usually have eccentric door openings for access. Figure 2 shows an example of this type of partition wall in a street building damaged during the February 6th Meinong earthquake in 2016. Although some of the masonry panels separating two adjacent building units were demolished to create a larger store space, the building was still weaker in the street direction than in the entrance direction. The masonry panels with door openings on the right shown in Figure 2 appeared to be the CM type. A shear crack occurred on the column close to the cracked region on the adjacent panel. This suggests that a panel with an opening can contribute lateral resistance and might affect the behavior of the frame. Figure 2 also shows the strong-beam-weak-column behavior of typical RC buildings in Taiwan. The beams cast along with the slab became relatively stiffer and stronger than the columns. As shown in Figure 2(a), the beam above the damaged masonry panel remained almost intact.

(a) Damaged masonry panel with eccentric door opening

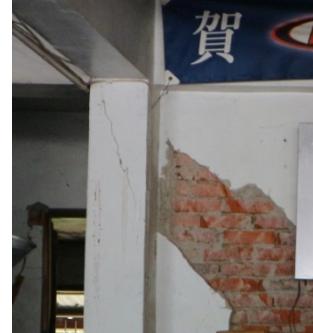
(b) Shear crack on the column
