13TH CANADIAN MASONRY SYMPOSIUM
HALIFAX, CANADA
JUNE 4TH – JUNE 7TH 2017

TORNADO & HIGH WIND SHELTERING WITH MASONRY

McGinley, W. Mark¹; Throop, Diane, B.² and Coulbourne, William, L.³

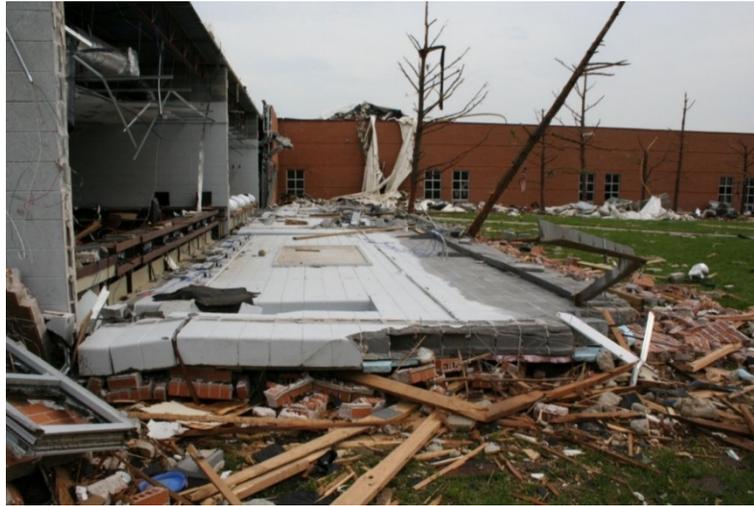
Figure 1: Tornado Wind Damage of a School in Joplin MO

events, and this is especially true in the US. The building damage that often results from these high wind events (as shown in Figure 1) places significant numbers of people at risk.

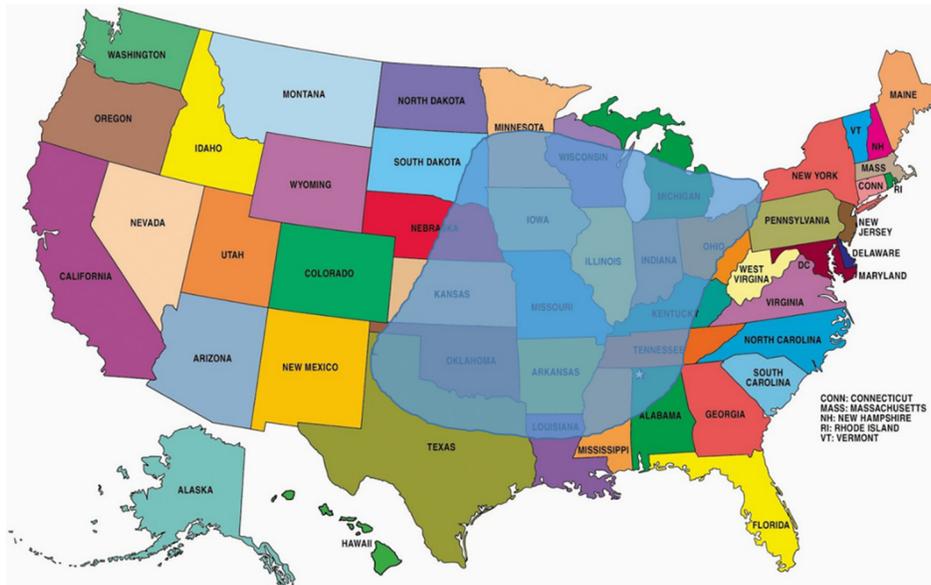
Figure 2: 402 Km/hr (250 MPH) Tornado Shelter Zone (Consistent for ICC 500 [3])

In response to this increasing risk, the 2015 edition of the International Building Code (IBC) [2] requires that most schools and emergency facilities located in a significant portion of the Central US have tornado shelters. This area is shown in Figure 2 and is where tornadoes with wind speeds of at least 402 km/hr (250 MPH) are expected. These shelters must be sized to hold all the building occupants and must meet the requirements of the ICC 500, *Standard for the Design and Construction of Storm Shelters* [3]. Based on the dark area shown in Figure 2, this impacts new construction of schools and emergency facilities as far north as central Minnesota, as far south as southern Mississippi, and stretching east to western Pennsylvania and western Texas to the west.

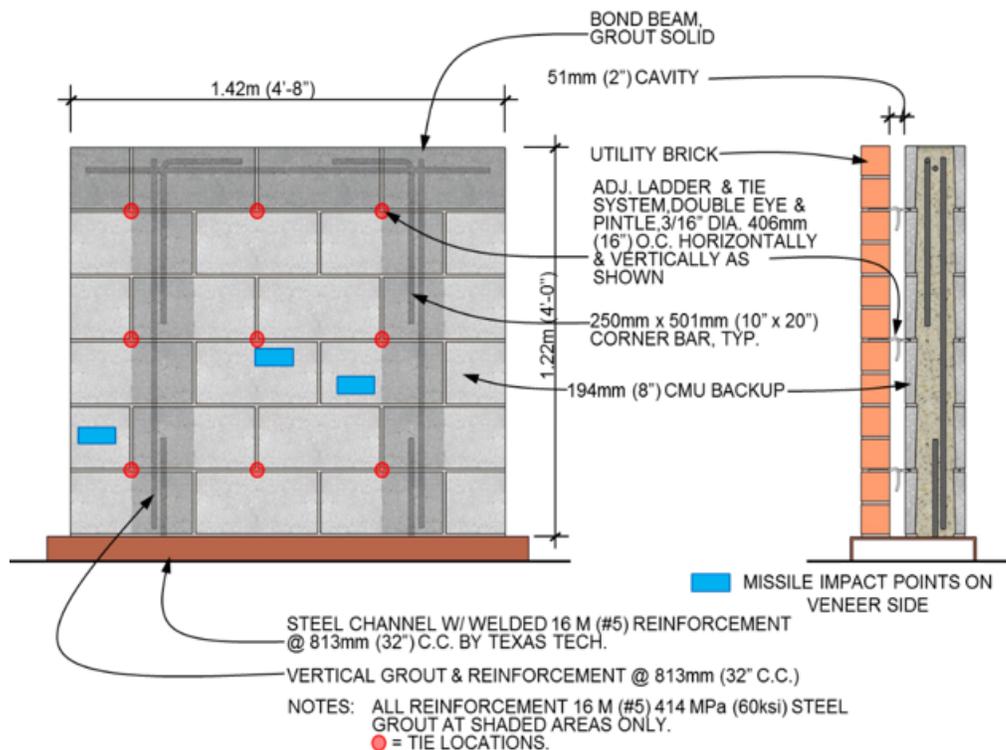
Figure 3: Cavity Wall Specimen 1 Utility Brick

The specimen dimensions were limited by the testing system and construction constraints. Two different wall specimen configurations were developed and designed to be representative of a typical clay brick and CMU cavity walls used in conventional school designs. Figure 3 shows the first specimen configuration. This 1.42 m x 1.22m (4 ft-8inch wide by 4 ft) wall specimen represented a common exterior wall design for schools, with an 89 mm (3.5 inch) utility clay brick veneer over a 51 mm (2 inch) cavity and 203 mm (8 inch) partially grouted CMU backing wall. The CMU backing wall was reinforced with 15.9 mm (#5), 414 MPa (60 ksi) rebar, at 813 mm (32 inches) on center. There was a bond beam cast at the top of the wall to tie the specimen together. A heavy duty, 4.7 mm (3/16 inch), diameter eye and pintle, anchor system was used to attach the brick veneer to the backing wall and these anchors were spaced at (16 inches) both vertically and horizontally. The specimens were constructed using ASTM C 90 [8] CMU units (with an average compression strength of 3930 psi), ASTM C 216 [8] clay units (average compressive strength of 9096 psi) and ASTM C 270 [8] Type S Masonry Cement Mortar. Only fine grout was used and this was site mixed based on the proportion specification of ASTM C 476 [8].

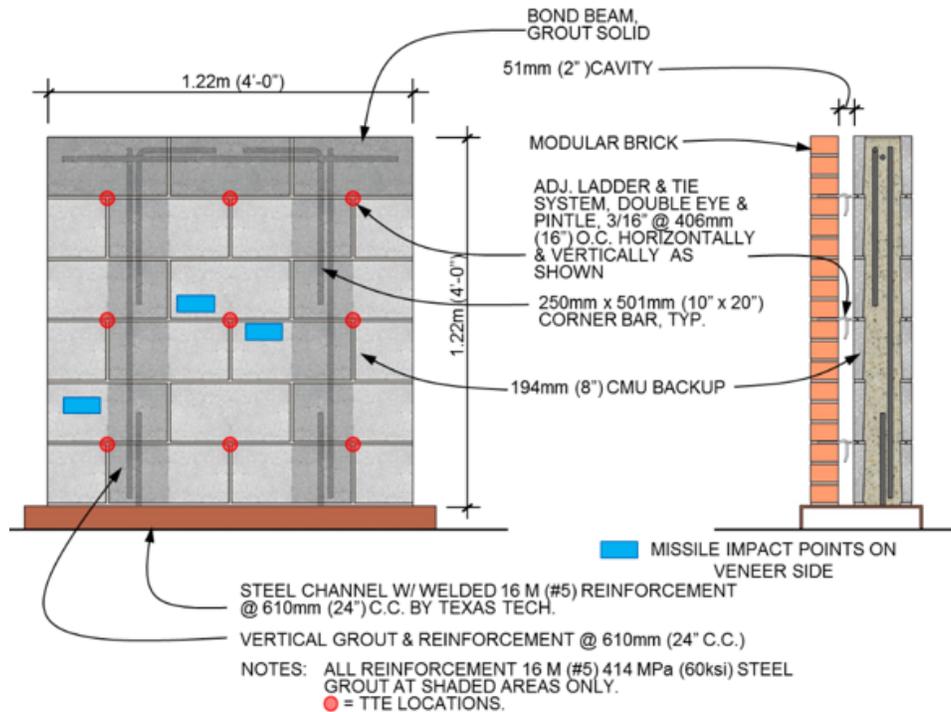
Figure 4: Cavity Wall Specimen 2 Modular Brick

Figure 4 shows the configuration of the second specimen. This specimen was configured the same as the first, except that 92 mm (4 inch) modular clay brick were used in the veneer and the vertical reinforcing spacing in the CMU backing wall was reduced to 610 mm (24 inches).

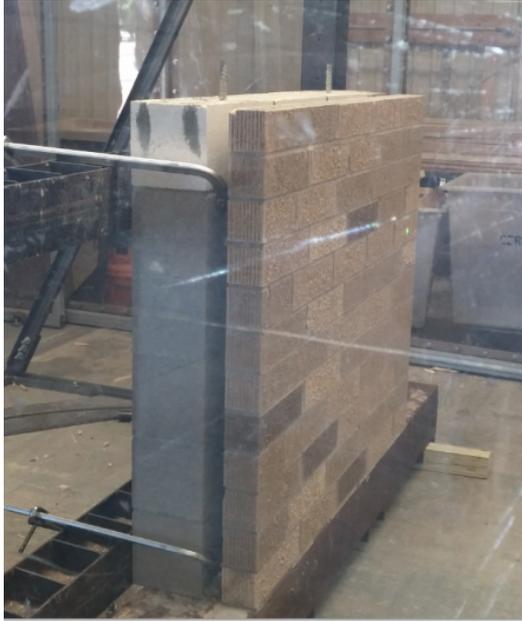
Figure 5: Utility Brick Unit Specimen 1 in Testing Apparatus Prior to Testing

Each of these specimens were tested at the Wind Testing Laboratory at Texas Tech University in Lubbock Texas [9]. The first specimen was placed in the missile testing apparatus (see Figure 5) and a total of three, 15 lb, 2 x 4 wood missiles were fired at the specimen. The missile speed was adjusted to be at least 160.9 km/hr (100 MPH) (the minimum required by ICC 500 for a 402 km/hr (250 MPH) tornado) when it impacted the wall face.

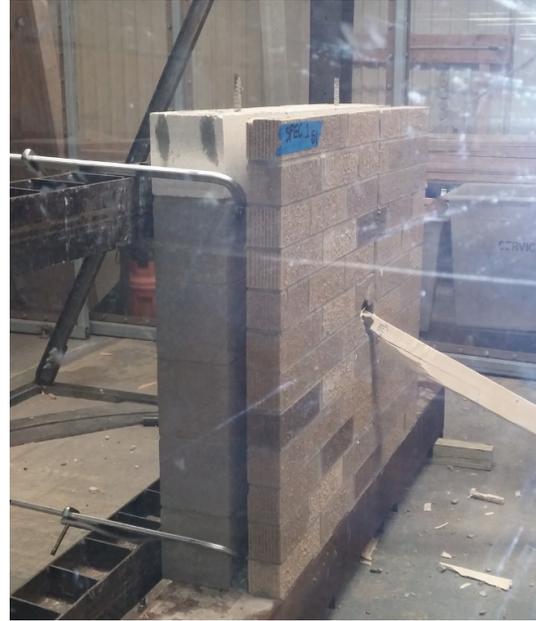
Figure 6: First Missile Strike on the Utility Unit Specimen

The first missile strike was aimed at the middle of an ungrouted CMU core near mid-height and mid-width of the specimen. Figure 6 shows the results of the first missile impact. Upon impact, the 2 x 4 missile shattered the clay brick veneer units on each side of the missile impact location, passed through the brick veneer but bounced off the exterior surface of the CMU backing wall. There were also cracks in the brick masonry veneer wythe radiating from the impact site. Two additional missiles were fired at this specimen; one missile was directed to the lower outer edge of the vertically grouted CMU cores on the right side of the specimen and one missile was directed to the inner edge of the vertically grouted CMU cores on the left side of the specimen.

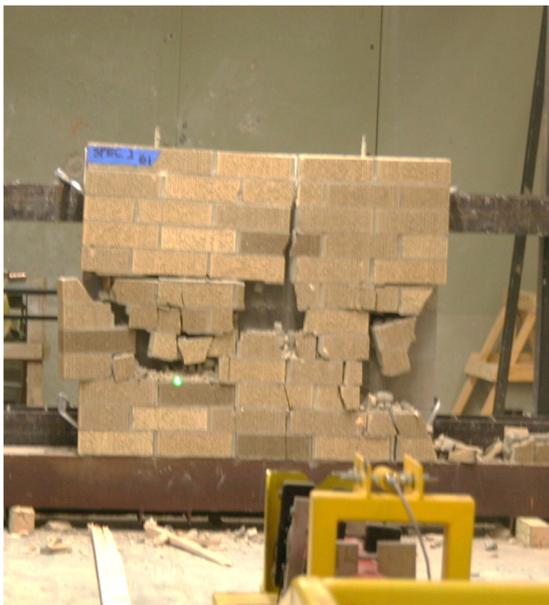
Figure 7: Veneer Damage on the Utility Unit Specimen 1 after Three Missile Strikes

Figure 7 shows Specimen 1 after all three missile strikes. Figure 8 shows that the clay unit pieces were simply pushed against the block face. Similar behavior was observed in all the impacts; with the missile shattering the brick, pushing the brick pieces against the CMU face and rebounding without causing any damage to the CMU wall. There is significant damage to the brick veneer but no visible damage to the CMU backing wall and, most importantly, upon careful inspection, no missile penetration of the interior face of the CMU.

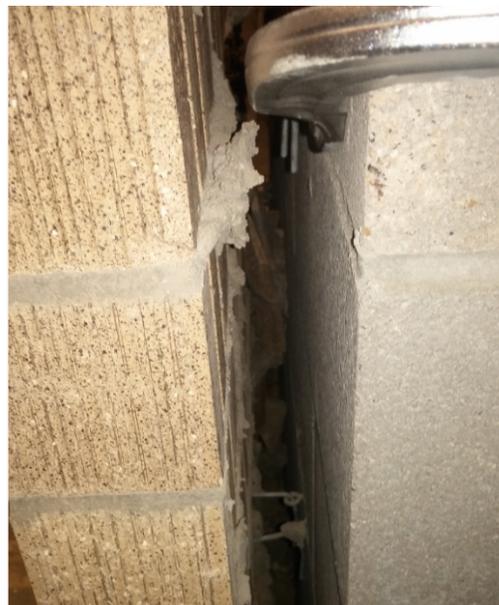
Figure 8: Brick Pieces Pushed Against the Block Face on the Utility Unit Specimen 1

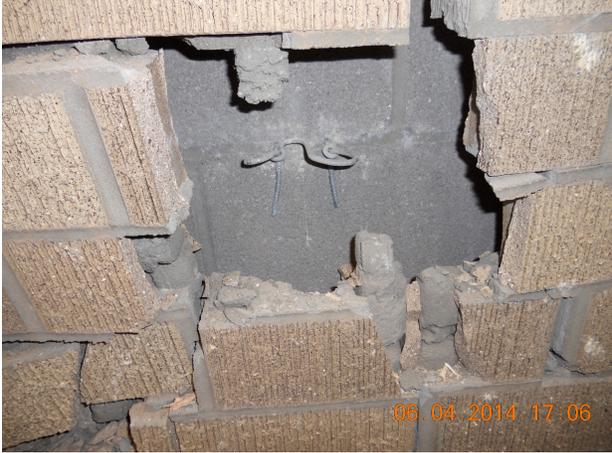
Figure 9: CMU Surface Behind Missile Strike on the Utility Unit Specimen 1 After Testing

Figure 9 shows the front of the backing wall behind the first missile strike area and, although the tie is damaged, there is no visible damage to the exterior surface of the CMU backing wall and no missile penetrations of the face of the CMU. As shown in Figure 10, there was no damage to the interior (back) surface of the CMU backing wall after all three tests. Holes were drilled into the wall at select locations confirming that the backing wall was not grouted at the impact sites (see Figure 10).

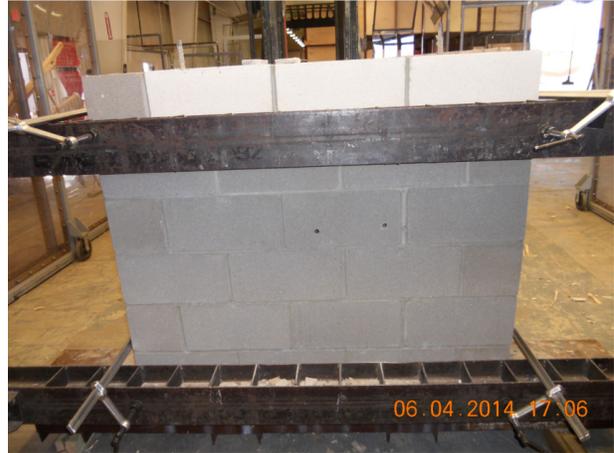
Figure 10: Back Surface of CMU on the Utility Unit Specimen 1 After all Three Missile Strikes

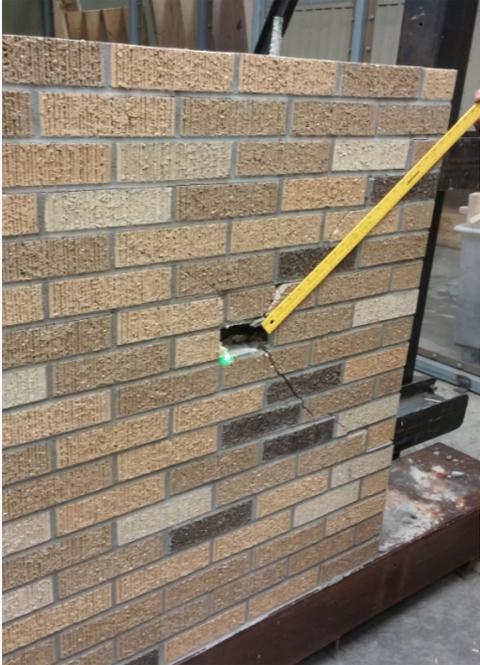
Figure 11: First Missile Strike on Modular Clay Veneer Specimen 2

The above tests were repeated for the Cavity Wall Specimen 2 which had the modular clay brick veneer and closer spaced vertical reinforcement in the CMU. Figure 11 shows the veneer after first impact. During this strike, only one veneer unit was shattered and the missile rebounded from the CMU face, causing no visible damage to the CMU backing wall. Similar behavior was observed for the other two missile strikes on this specimen. Figure 12 shows the veneer damage of this specimen after all three missile strikes. Although there was significant damage, none of the missile strikes caused visible damage to the CMU backing wall on either face (see Figures 13 and 14) and there was no missile penetration of the interior face of the CMU.

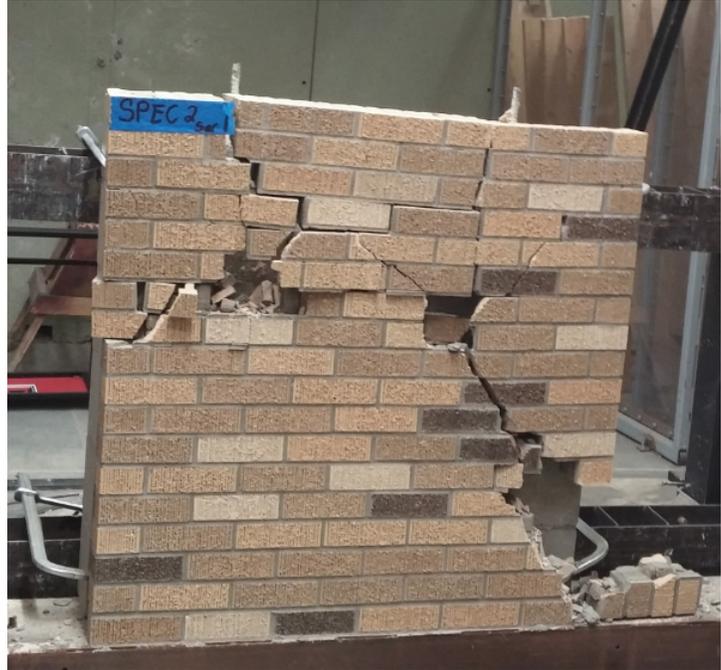
Figure 12: Modular Brick Veneer Specimen 2 After All Missile Strikes

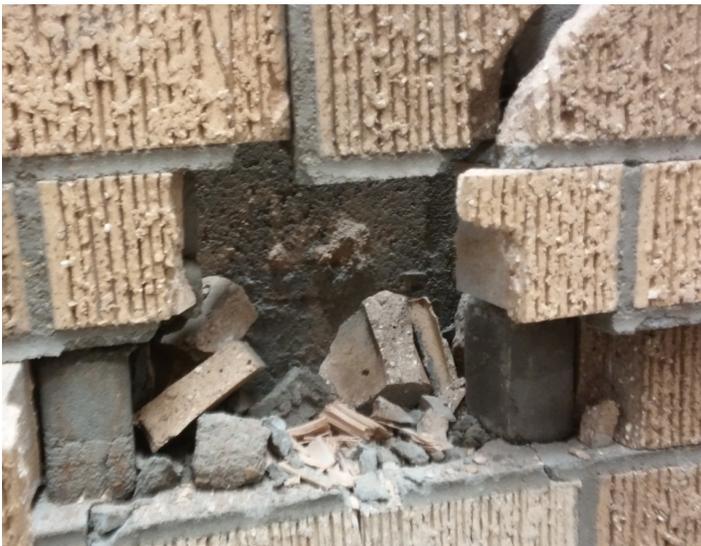
Figure 13: Front face of CMU Wall on Modular Brick Veneer Specimen 2 Behind Missile

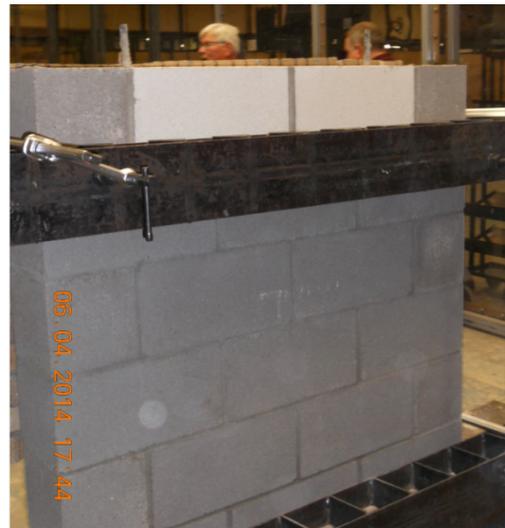
Figure 14: Back of CMU Wall on Specimen 2 After All Missile Strikes

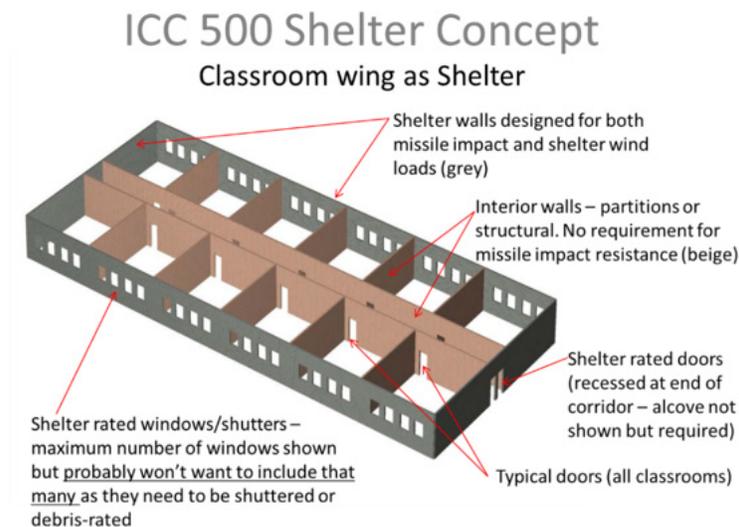
Figure 15: Classroom Wing as Shelter

One way to provide tornado shelters for the occupants of schools is to use a classroom wing shelter as shown in Figure 15. This has the advantage of providing for student comfort with a familiar classroom appearance. It also provides sheltering in place for many, is cost effective, and uses the space for both classroom space and sheltering use. This space also provides restrooms as part of the typical classroom wing design.

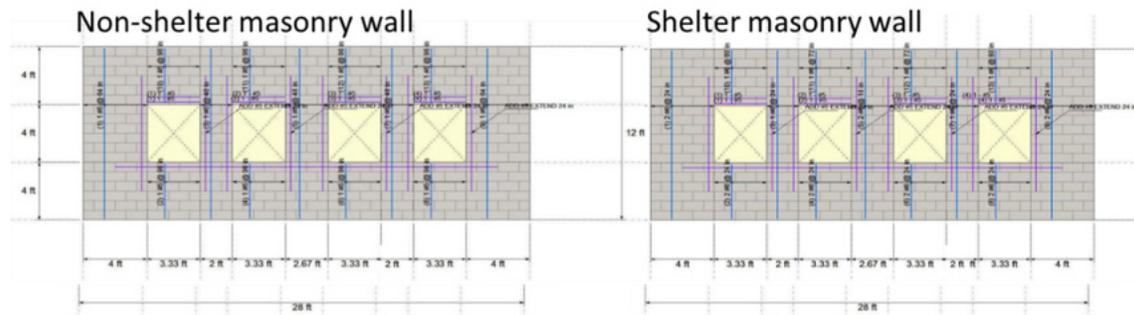
Comparison - Exterior Wall in Ohio

Masonry Option 1 – Solid grouted CMU

194 mm (8") CMU Partially Grouted – Optional Veneer
 16 M (#5) bar ea. jamb 16M/#5 @ 1,626 mm(64")c/c
 Joist roof option
 Foundation lap = 152 mm (6") min.
 L-bar at top bond beam recommended
 Joint reinforcing 406 mm x 610 mm (16" x 24")

194 mm (8") CMU Solidly Grouted – Optional Veneer
 19 M (#6) bar ea. jamb / 19M (#6) @ 610 mm (24") c/c
 'Heavy' roof/second floor or uplift
 Foundation lap = fully developed 1016 mm (~40")
 L-bar or fully developed bar detail at top bond beam required.
 Joint reinforcing 406 mm x 610 mm (16" x 24")

Figure 16: Classroom Wing as Shelter Exterior Wall Configuration

Figure 16 shows a typical design for an exterior load bearing masonry wall using 203 mm (8 inch) CMU walls. A comparison of the wall designs for the classroom wing acting as a shelter versus not acting as a shelter shows an increase in bar size from a 16 mm diameter (#5) to a 19 mm diameter (#6) bar with a decrease in spacing from 1,620 mm (64 inches) to 610 mm (24 inches) (based on typical State of Ohio design conditions).
