13TH CANADIAN MASONRY SYMPOSIUM
HALIFAX, CANADA
JUNE 4TH – JUNE 7TH 2017

DEBUNKING MASONRY MAINTENANCE

Peterson, J. Eric¹ and Treser, Steven²

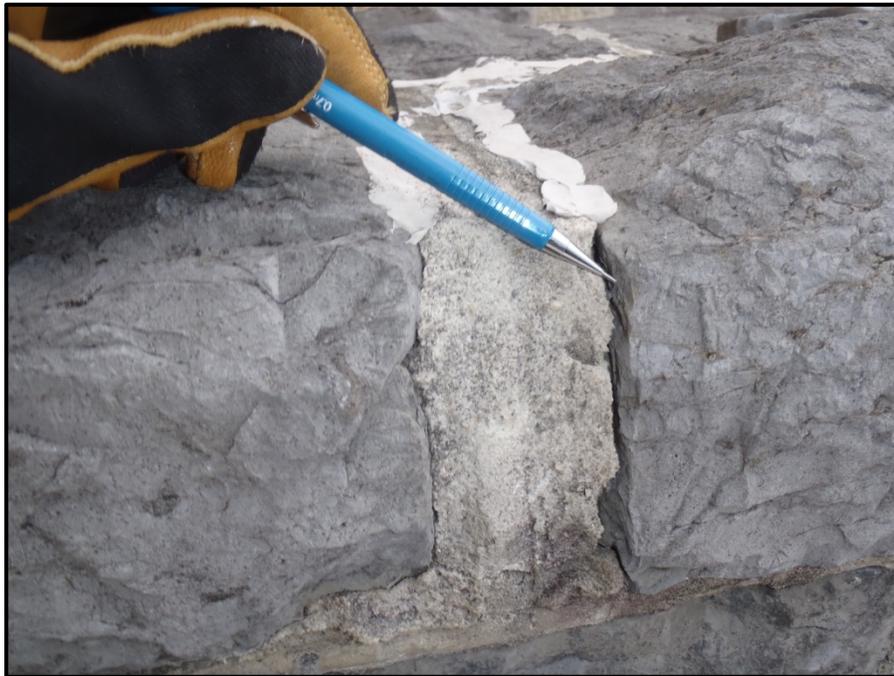
Figure 1: Cracked Mortar Joints

- Cracked mortar joints (Figure 1)
- Cracked masonry units (Figure 2)
- Failed sealant joints (Figure 3)

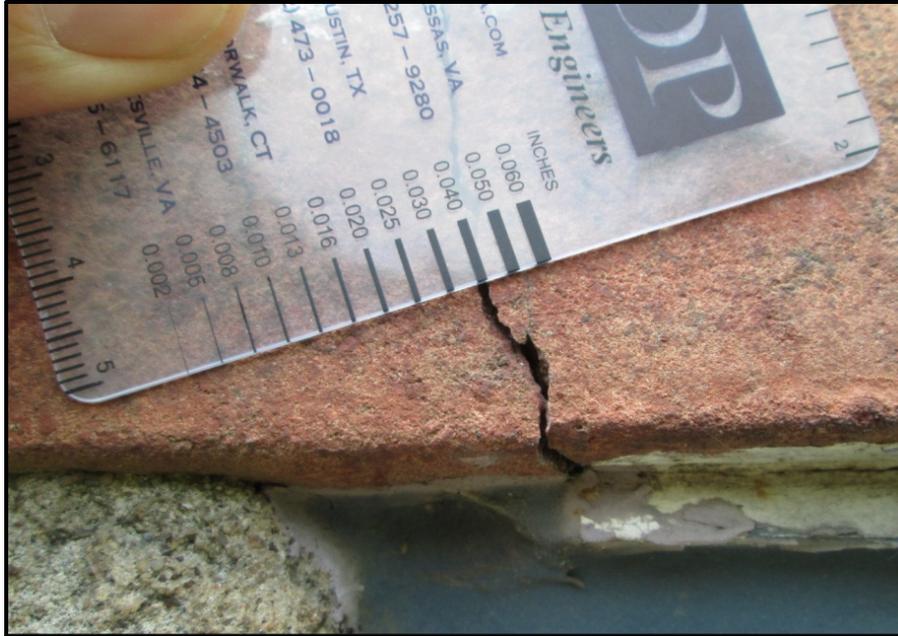
Figure 2: Cracked Masonry Units

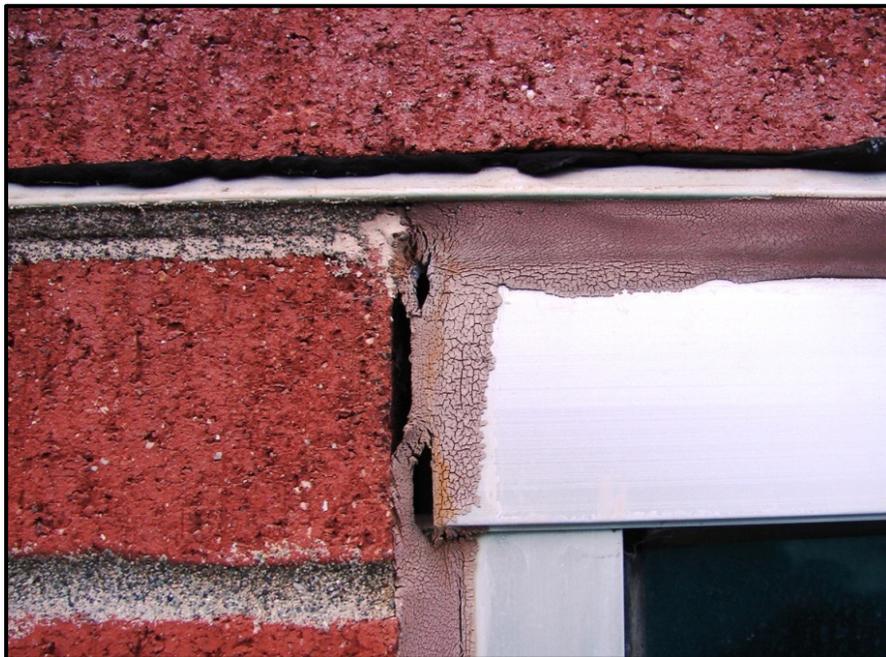
Figure 3: Failed Sealant Joints
