13TH CANADIAN MASONRY SYMPOSIUM
HALIFAX, CANADA
JUNE 4TH – JUNE 7TH 2017

**STRUCTURAL ANALYSIS OF TRANSVERSAL STEEL CONNECTORS APPLIED ON
MULTI-LEAF WALLS**

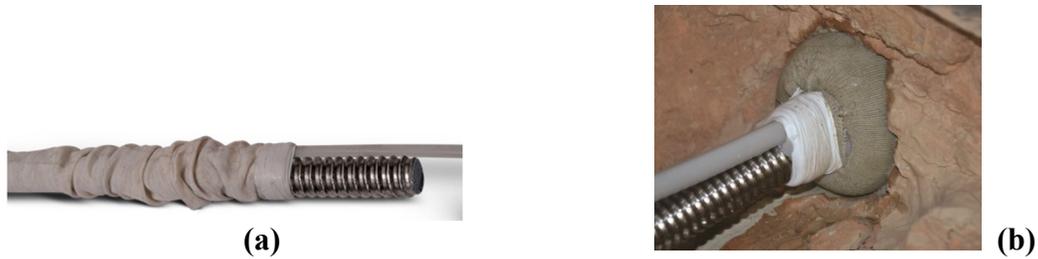
Figure 3: The connector: (a) Before Mortar Injection; (b) After Insertion and Injection

A possible solution is to insert new headers (Figs. 1c, 1d and 3). This could improve the global behavior of multi-leaf walls. This insertion could be made using new stones or bricks, or with steel or RC (Reinforced Concrete) elements. However limited research has been done in this area, mainly for the difficulty in reproducing historic masonry and in performing tests able to measure the effect of the insertion of new headers [20-22]. This insertion is a difficult task since hollow steel tubes (core drills) are often used to drill holes in the masonry material: this causes a stress re-distribution in the area around the hole leaving this area uncompressed. Without an adequate interlocking, the new connector cannot act efficiently and its application could result ineffective.

The artificial connector consists in a stainless threaded rod inserted in a fabric sleeve (Fig. 3a) and injected with a high-strength cement-based grout into holes previously drilled in the wall (Fig. 3b). Rod and a fabric sleeve are then inserted transversally from one side of the wall only. In order to activate a mechanical interlocking between the fabric sleeve and the pre-existing wall, the hole can be countersunk at both ends. Fabric sleeve is typically injected with grout using a pressure of 2.5-5 atm. Steel rods can be also post-tensioned up to a 10-20% of the steel yielding strength in order to confine the wall leaves and increase collaboration.

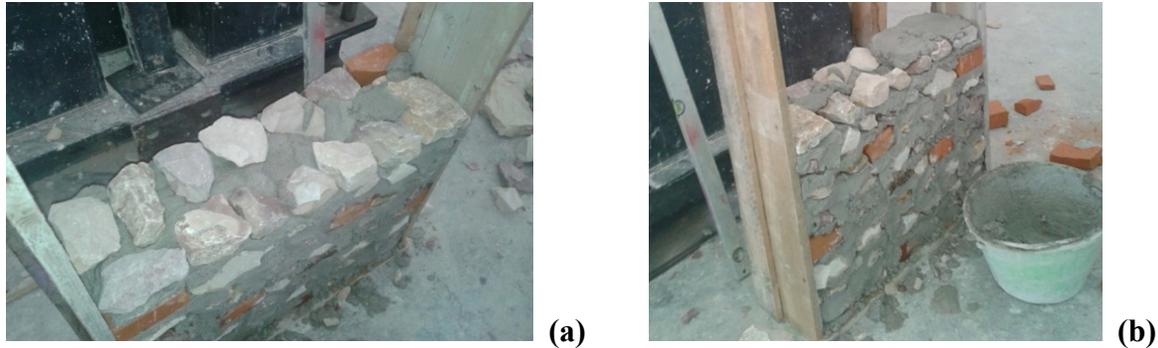
Figure 4: Wall Panels under Construction: (a) Detail of the Horizontal Cross Section; (b) Lateral View

The effect of the application of transversal connectors has been studied by performing in laboratory three compression tests on two double-leaf wall panels, assembled in the structures laboratory of the University of Perugia (Fig. 4). The two full-scale panels had identical dimensions of 0.22 x 0.71 x 1.45 m (thickness x width x height). A H-shaped steel profile (flange's width = 250 mm) was placed over the panel to achieve a uniform distribution of the vertical load along the panel's width. This was applied using two 50-tons hydraulic jacks. The

Three wall panels were tested in uniaxial compression. For the first test (Panel 1Un) a maximum compression load P of 48.6 kN was recorded, corresponding to a compressive stress of 0.312 MPa ($\sigma=P/A$) ($A=220 \times 710$ mm). By analysing the data recorded by the LVDTs it is possible to note that the two adjacent masonry leaves deformed differently: the maximum (vertical) axial strain ($\epsilon=\Delta L/L$ where the gage length was $L=1450$ mm) was 0.0011 for side B, while it was only 0.0006 for side A (Fig. 5a). This demonstrated that the weak connection, assured by the mortar, between the leaves was not able to guarantee a uniform distribution of the vertical load and axial strains. This panel was also repaired using 6 traversal connectors applied according to the scheme in Figure 4.
