**PERFORMANCE OF MASONRY ELEMENTS
UNDER FIRE AND SHELLING DURING THE GULF WAR**

ABSTRACT

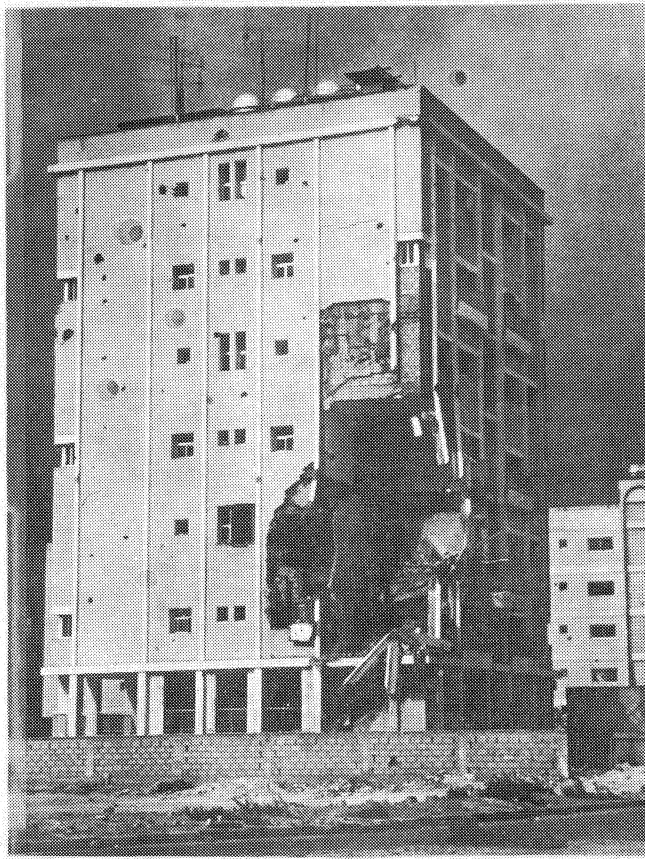
Figures 3 and 4 show a building subjected to direct shelling, during which extensive damage was inflicted on the main structural elements such as columns and beams. Despite the loss of these supporting systems, a redistribution of load took place, in which the masonry walls assumed the weight of the floor slabs and kept the

structure standing, but with extensive cracking. Nevertheless, keeping the building standing made it possible to carry out repair work later, and save lives that otherwise would have been lost if the building had collapsed because of the loss of supporting elements.

Fig. 3: Building Subjected to Direct Shelling, where the Main Structural Elements Suffered Extensive Damage

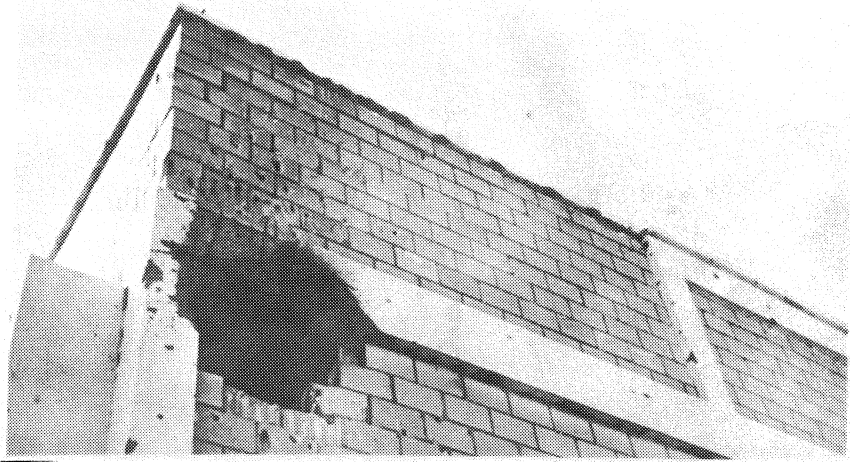
Fig. 4: Another Building Subjected to Direct Shelling
