## THE INFLUENCE OF HYGROTHERMAL CLAY EXPANSION ON HOLLOW BRICK MASONRY PATHOLOGY

### ABSTRACT

In Portugal, hollow clay brick masonry is a very traditional solution for building walls. However, in some recent construction, we have registered some pathologies related with the clay expansion due to hygrothermal actions, particularly in building envelope walls.

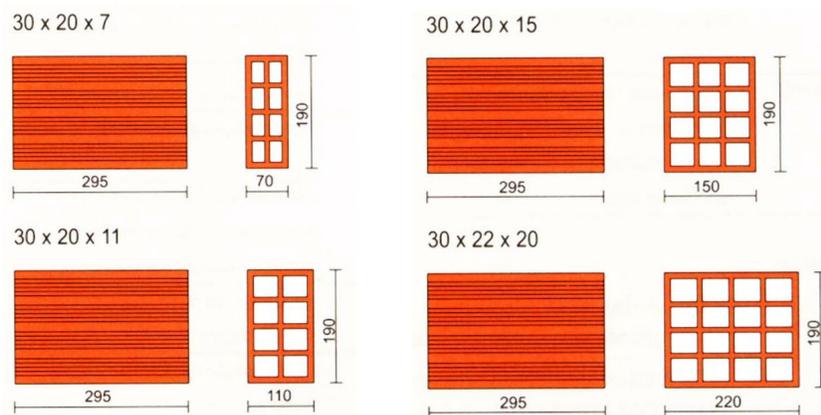
Figure 1. Hollow clay brick formats in Portugal (APICER, CTCV, DEC-FCTUC, 2000).

The most common formats for these elements are those shown in Figure 1. Unlike other European countries, the production of specific units for the execution of singular points, such as wall corners, lintels, etc., is not common.

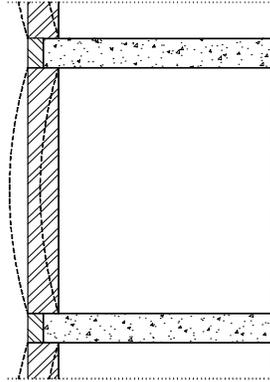
Figure 2. Wall deformation due to the expansion of its components.

- In those cases in which the restrictions to the walls' free movement are small, the deformations can reach values which are incompatible with its resistance, especially in singular points, like wall corners, openings, etc. (see Figure 4, Figure 9 and Figure 12).
- In those cases in which the walls are confined by very stiff elements, the restrictions imposed on the masonries' movement can cause its deformation, if they are too slender (see Figure 2).

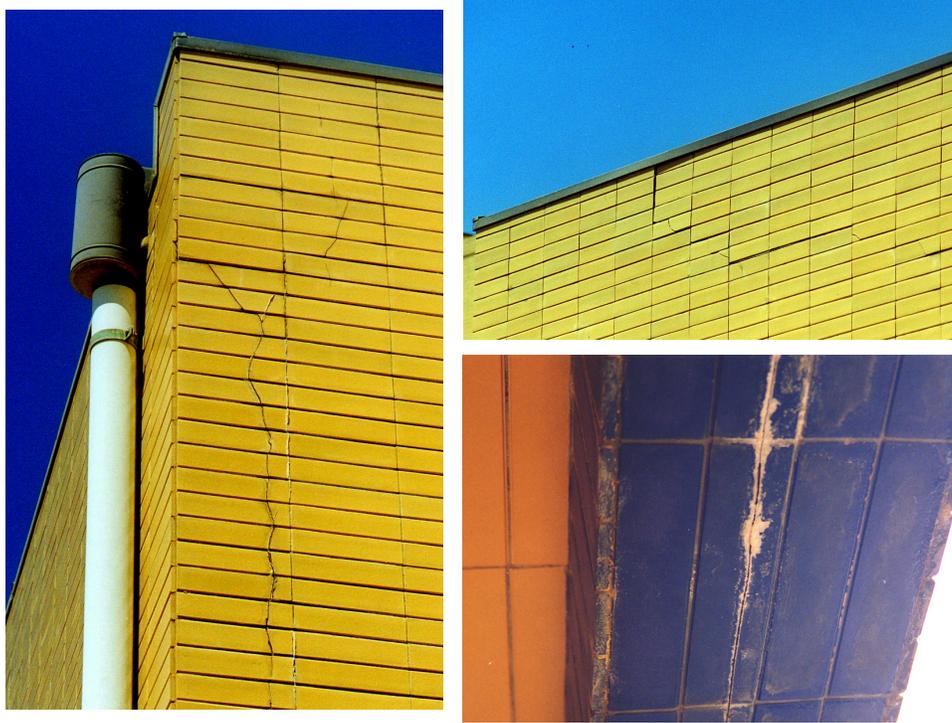
- On the wall corners, where cracks showed a more or less vertical development and next to the base of some roof contours, having that cracking a slightly horizontal development (see Figure 4);
- On the balconies' railings, more or less in the middle of its thickness, especially on the lower part of the railings (see Figure 4);

Figure 4. Hotel's cracking problems.

The hotel that has been studied (about 15 years old) showed an evident cracking on its vertical envelope, on the following areas:

- Appliance of an exterior insulation finishing system (EIFS), after the demolition of the walls' outer cloths.
- Execution of reinforced concrete locking elements (small beams and pillars) conveniently spaced, with posterior appliance of a reinforced outer coating, composed of special mortars with polymers.

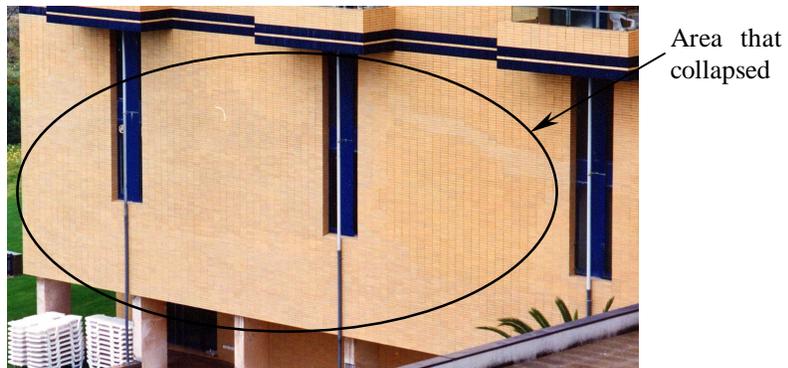
In one of the façades there was even an area of the wall's outer cloth that has collapsed (see Figure 5).

Figure 5. Wall of the hotel that fell down.

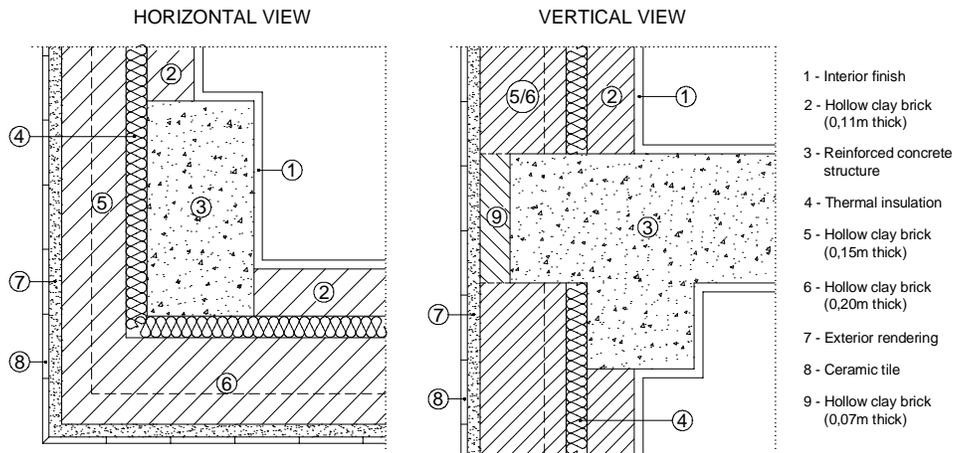
The composition of the building elements in question is shown in Figure 6 and Figure 7, which clearly denote its brittleness. The most relevant aspects of this composition are the following:

- The façades consisted hollow brick cavity walls, being the space between cloths totally filled with thermal insulation.
- The masonry outer cloths, 0,20 or 0,15 m thick, as well as the insulation layer, completely covered the vertical elements of the resistant structure (columns), of reinforced concrete.
- On the floor levels, the thermal bridges correction was sorted out with the resort to hollow brick, 0,07 m thick, having been placed as sheathing before the concrete covering, in order to form an outer "lining" of the top of the slabs.

Figure 6. Composition of the hotel's exterior walls.

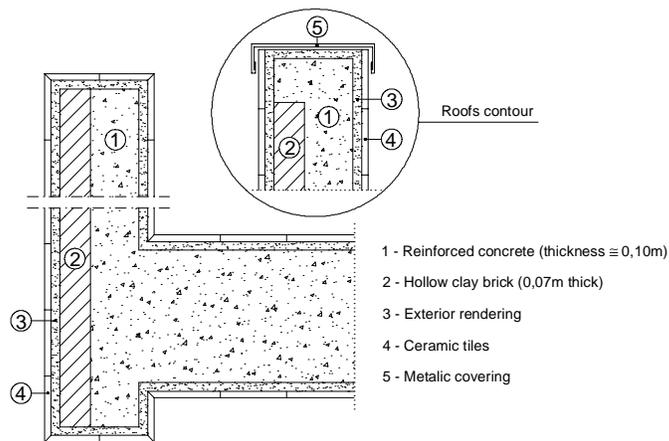
- Figure 8).
- The balconies' railings and the roofs contours consisted of a reinforced concrete wall, about 0,10 m thick, and of a hollow brick outer "lining", 0,07 m thick, placed as sheathing before the concrete covering.

Figure 7. Composition of the hotel's balconies and roofs contour.

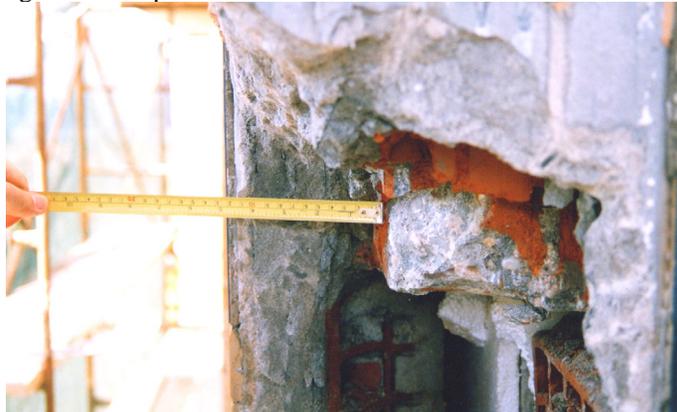
Prospectings carried out have shown that the composition of the walls, in those areas, did not exactly correspond to the project specifications. For instance, the bricks that composed the "lining" of the top slabs not always were complete, and the coating mortar reached high thicknesses (see

Figure 8. Prospecting carried out at the hotel to confirm the composition of exterior walls.

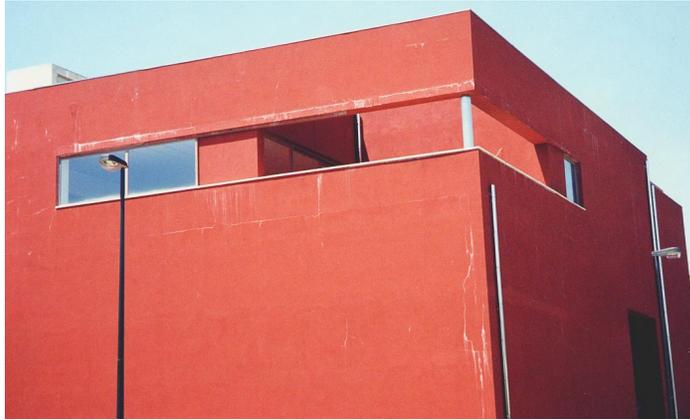
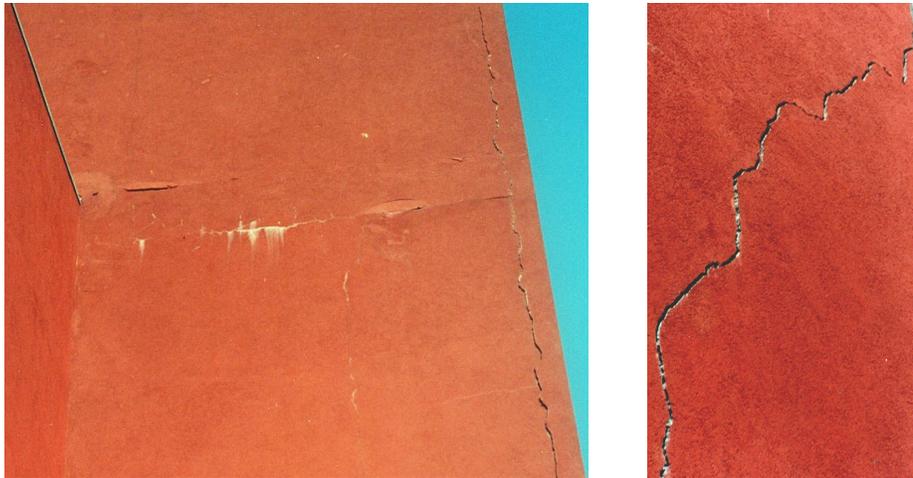
In the case of the theatre that we had the opportunity to study (about 3 years old), the situation was even more expressive, with the cracks reaching a more significant intensity and opening (see Figure 9). Besides the cracks next to wall corners, several others have been detected next to openings and in the masonry cloths' holding areas.

Figure 9. Theater's cracking problems.

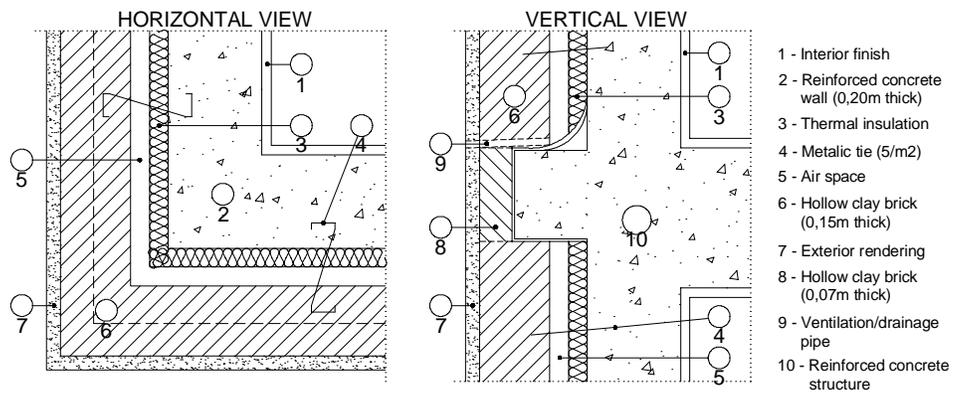
In Figure 10 and Figure 11 we can see the building's vertical envelope composition, of which we would like to point out:

- The façades consisted of a reinforced concrete inner wall, 0,20 m thick, covered on the outside by a hollow clay brick veneer wall, being the space between them partially filled with thermal insulation.
- Movement joints of brick veneer wall have not been considered.
- On the top of the slabs, the holding of the veneer walls was partially achieved by short corbels, of reinforced concrete, coated on the outside with hollow clay brick, 0,07 m thick. These elements were applied only during the execution of the masonries, that is, after the execution of the concrete structure.
- In the lintels, the holding of the masonry outer cloths was also achieved by small horizontal elements of reinforced concrete.

Figure 10. Composition of the theater's exterior walls.

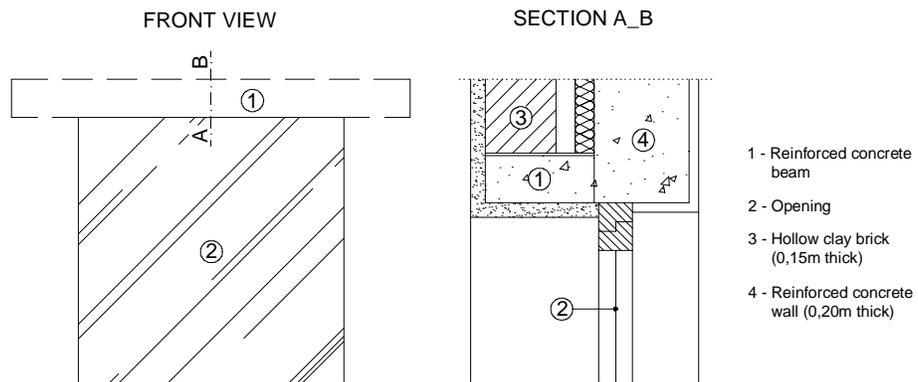
Figure 11. Theater's exterior walls near openings.

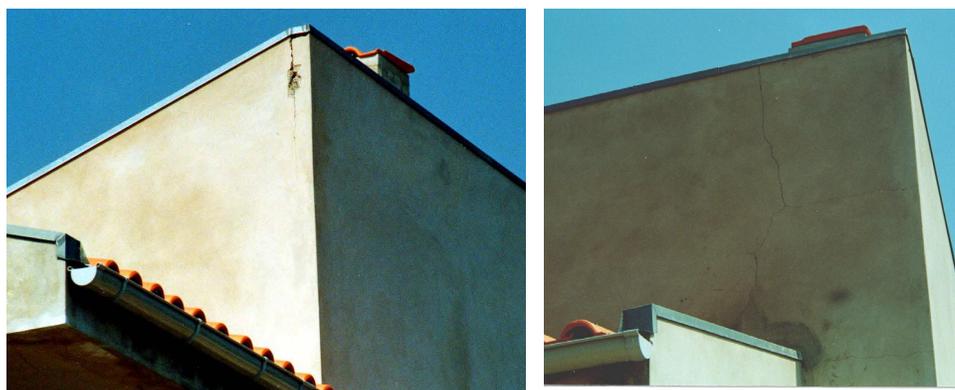
Regarding the cottage complex (still in construction), the situation was similar to that of the above described buildings. Figure 12 and Figure 13 illustrate the studied problems.

Figure 12. Cracking problems in the cottage complex.

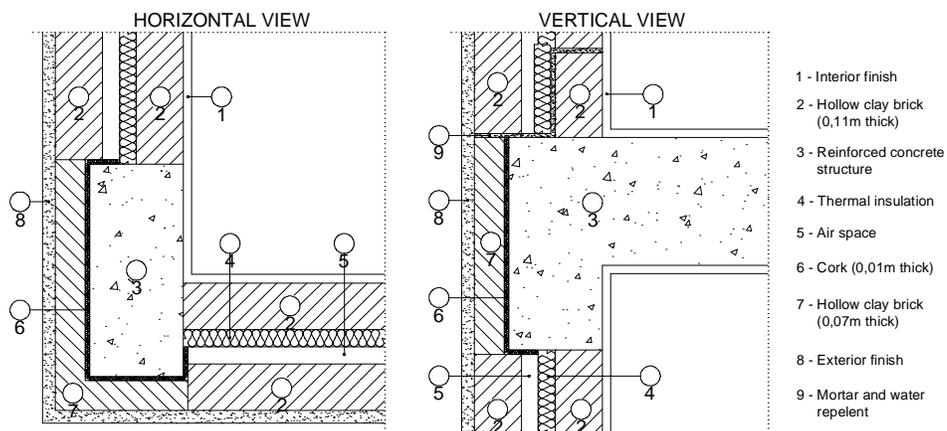
Figure 13. Composition of the exterior walls of the cottage complex.

As precaution, several recommendations for the adequate correction of this problem have come up, having in common the general principle of attempting to perform its treatment from the outside. A solution which has been initially proposed, inclusively by the RCCTE (1990), consisted in the appliance of not very thick brick "linings" from the outside of the structural elements, i.e., columns, beams and top slabs (see Figure 6, Figure 10 and Figure 13). This solution has been adopted to the image of the building practice of other European countries.
