DESIGN OF MASONRY SUBSTRATES FOR EXTERIOR INSULATION AND FINISH SYSTEMS IN HOT-HUMID CLIMATES

Charles W. Graham, Ph.D., AIA¹

ABSTRACT

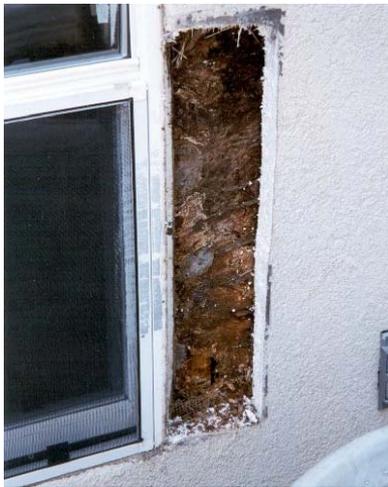
Figure 5. Water Damage Behind Surface Barrier EIFS without a Drainage Plane

Figure 5 shows what happens when water gets past the rain screen of a surface barrier design wall cladding that does not have a drainage plane behind it. In this case, a surface barrier EIFS is shown. Water that got behind the insulation boards was absorbed in the oriented strand board wall sheathing and after only 18 months rotted the sheathing. This level of decay can greatly reduce the structural capacity of structural framing and sheathing if widespread.

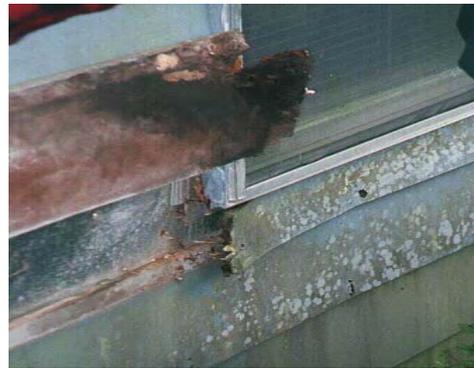
Figure 6. Water Damaged Hard Board Siding

Figure 6 illustrates what happens when another type of surface barrier cladding, in this case, hard board lapped siding, gets water behind it at the lower corners of a window, a common leak location. Thirty pound felt paper was installed behind the siding and although the siding itself rotted, the rot did not advance into the structural sheathing and framing behind it because the moisture barrier blocked its penetration into the wall system. This is a surface barrier design cladding system with a redundant drainage plane behind it.
