EXPERIMENTAL EVALUATION OF BRICK-TIE-WOOD SUBASSEMBLIES

Young-Hwan Choi¹ and James M. LaFave²

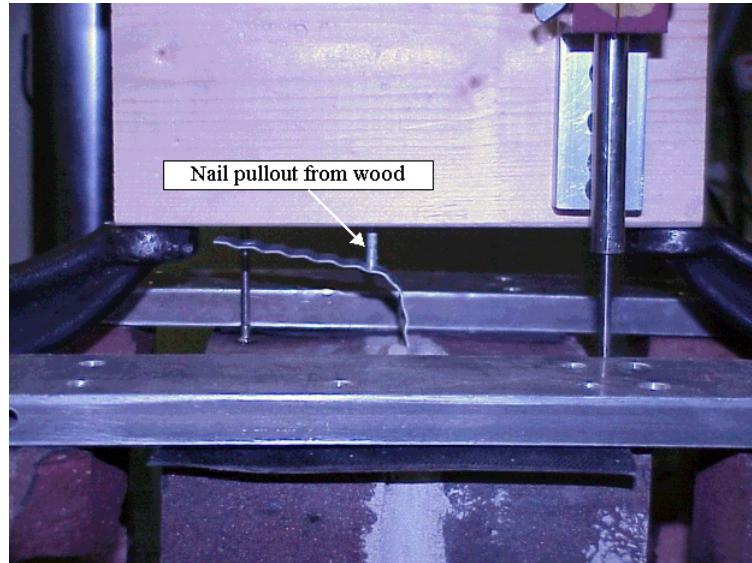
Figure 4. Tension Failure Mode: Nail Pullout from Wood in Type NSTE Specimen

A total of 36 specimens were tested in tension, 20 of type NSTE, 10 of type SSTE, 3 of type NOTE, and 3 of type SOTE. All type NSTE specimens failed by pullout of the nail from the wood stud. For type SSTE, seven specimens failed by loss of bond strength between mortar and brick, typically resulting in tie pullout or test specimen collapse. Two specimens showed the loss of bond strength between mortar and tie, resulting in a pullout of the tie from the mortar without separation of the masonry units. In one specimen, the screw was pulled out through the tie due to yielding around the tie hole. In each case, type SSTE specimens showed brittle failures (albeit at relatively high loads, as noted below). For type NOTE, two specimens failed by pullout of the nail from the wood stud, and one specimen showed loss of bond strength between mortar and brick. For type SOTE, all specimens failed by loss of bond strength between mortar and brick, resulting in tie pullout or test specimen collapse. These failure mode classifications are similar to those of ASTM (ASTM 1994). Pullout of the nail from the wood stud in a type NSTE specimen is illustrated in Fig. 4.

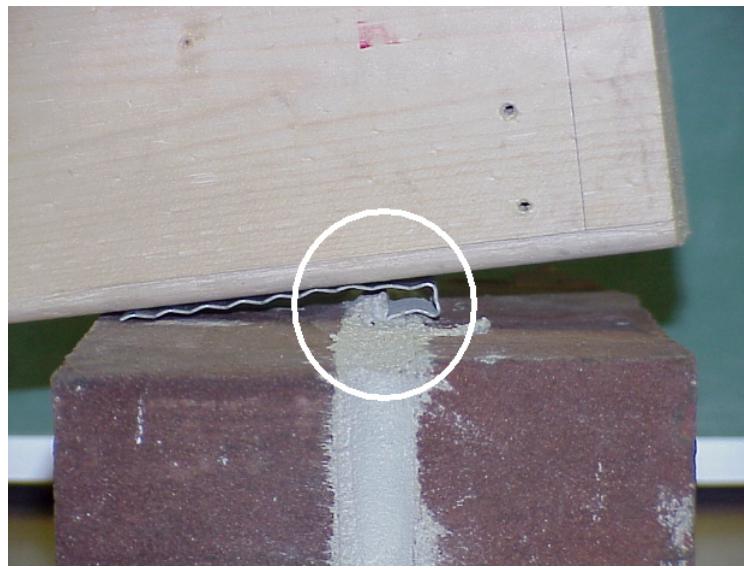
Figure 6. Compression Failure Mode: Buckling of Tie in Type NSCO Specimen

A total of 23 specimens were tested in compression, 10 of type NSCO, 5 of type SSCO, 5 of type NOCO, and 3 of type SOCO. Unlike the tension test specimens, which had a different failure mode for each type of specimen, the behavior in the compression tests were quite consistent. All specimens failed by buckling (or bending) of the tie regardless of the type of specimen. Buckling of the tie in a type NSCO specimen is illustrated in Fig. 6. The use of a screw instead of nail did not have much effect on the behavior of the specimens. From this, it was reasoned that the failure mode in the compression tests was
