BEDJOINTS STRUCTURAL REPOINTING OF HISTORIC MASONRY STRUCTURES

L. Binda¹, C. Modena², A. Saisi¹, R. Tongini Folli¹, M.R. Valluzzi²

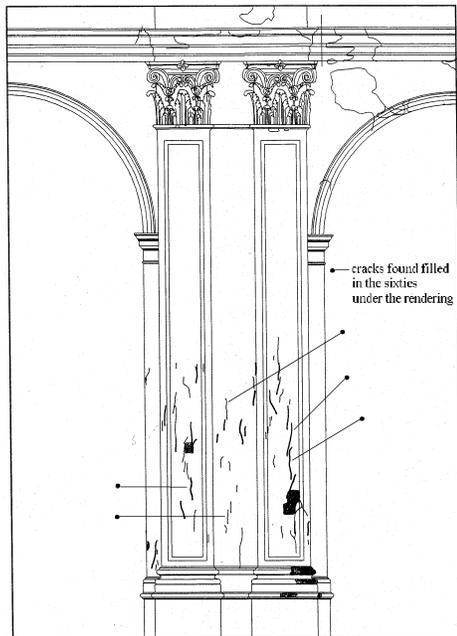
Figure 1. Prospect of a pillar of the Noto Cathedral (Italy) and survey of the crack pattern

Several case histories show that significant crack patterns, clearly due to vertical compression (dead load), often appear on the walls of ancient towers or on church pillars, indicating structural damage (Fig. 1). Tower, as well as particularly slender or heavily loaded elements like columns, pillars, etc., turn out to be overloaded by heavy persistent compressive stresses. Moreover, significant concentrations of stress can take place in some portions of the material due to non-uniform stress distributions.

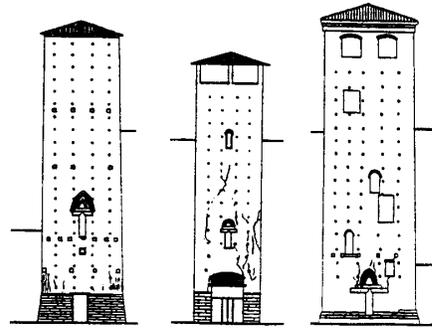
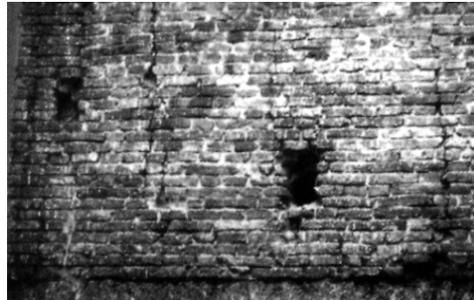
Figure 2. a) Torre Galluzzi, b) Torre Alberici, c) Casa-torre Uguzzoni in Bologna (Italy) and detail of the crack pattern of Torre Galluzzi

Sometimes around major cracks there may be a net of vertical flaws, cutting the bricks, or stones, and proceeding through the mortar joints (Fig. 2). Unfortunately, they these are in most cases considered superficial and not particularly worthy of care.

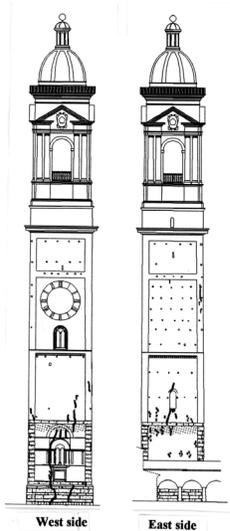
Figure 3. Crack pattern survey of the Bell Tower of Monza (Italy)

The Bell Tower of the Cathedral of Monza is a XVI century building made of solid brick masonry. Its walls, show passing-through large vertical potentially dangerous cracks on the West and East sides (Fig. 3), which are slowly but continuously opening. These cracks were certainly already present in 1920 since they were roughly monitored in 1927. Wide cracks are also present in the corners of the tower up top 30 m. Furthermore, a damaged zone at a height of 11 to 25 m with a multitude of very thin and diffused vertical cracks is present which demands structure repair (Fig. 4). In order to assess the structural condition of the tower, an in situ investigation using non-destructive and slightly techniques was carried out (Binda, 1998).

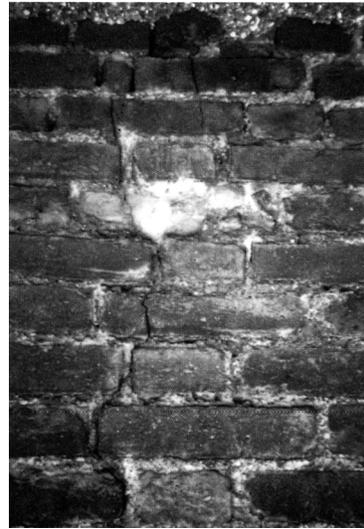
Figure 4. Thin cracks on the wall

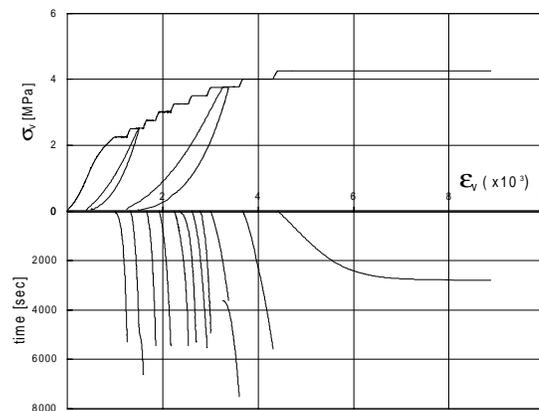
In Fig. 5 the vertical stress vs. vertical strain and the vertical strain vs. time are shown. Creep strain can be clearly observed when the load is kept constant, with the appearance of tertiary creep in the last load step.

Figure 5. Result of a test with subsequent load steps carried out on a prism (200x200x500) mm belonging to the crypt of the Cathedral of Monza (Italy)

collapse occurs due to excessive deformations, corresponding to the tertiary creep phase (Fig. 5).

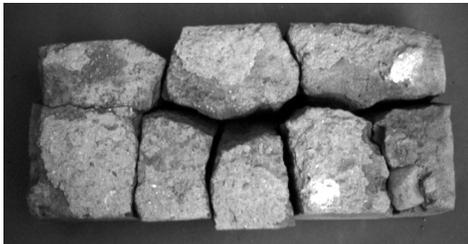
Figure 6. Cracked brick sampled inside the damaged wall

Figure 7. Crack pattern inside the wall

In the case of masonries damaged in compression, a further basic problem is encountered. The typical crack pattern is characterised by diffused parallel vertical fissures, with no transversal connection (Fig. 6 and 7). In this case, the injected grout can not diffuse inside the masonry.

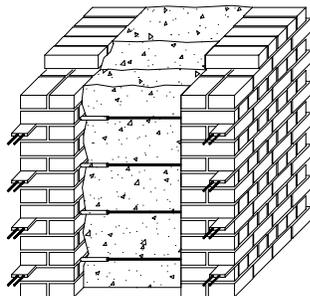
Figure 8. General scheme of the technique

The reinforcement of the mortar bed joint in brick masonry structures has been recently considered for the strengthening and repair of historic brick structures exhibiting the typical creep damage as described above. Such technique is performed by removing an external layer of the joints (up to about 6-8 cm), and placing into the groove one or two small diameter reinforcing bars (to that aim stainless steel or FRP bars can be adopted). The intervention (Fig. 8) can be executed somewhat easily and using very common tools, at one or both sides of the wall, depending of the in situ structural and accessibility conditions. In both cases, the use of transversal short pins, inserted into drilled holes successively sealed, can be appropriate to improve the confining action of the bars (Fig. 9), both in the longitudinal and in the transversal directions, especially when multi-leaf masonry are considered.

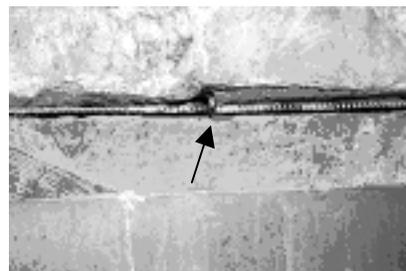
Figure 9. Detail of arrangement of the bar and the tie into an excavated joint

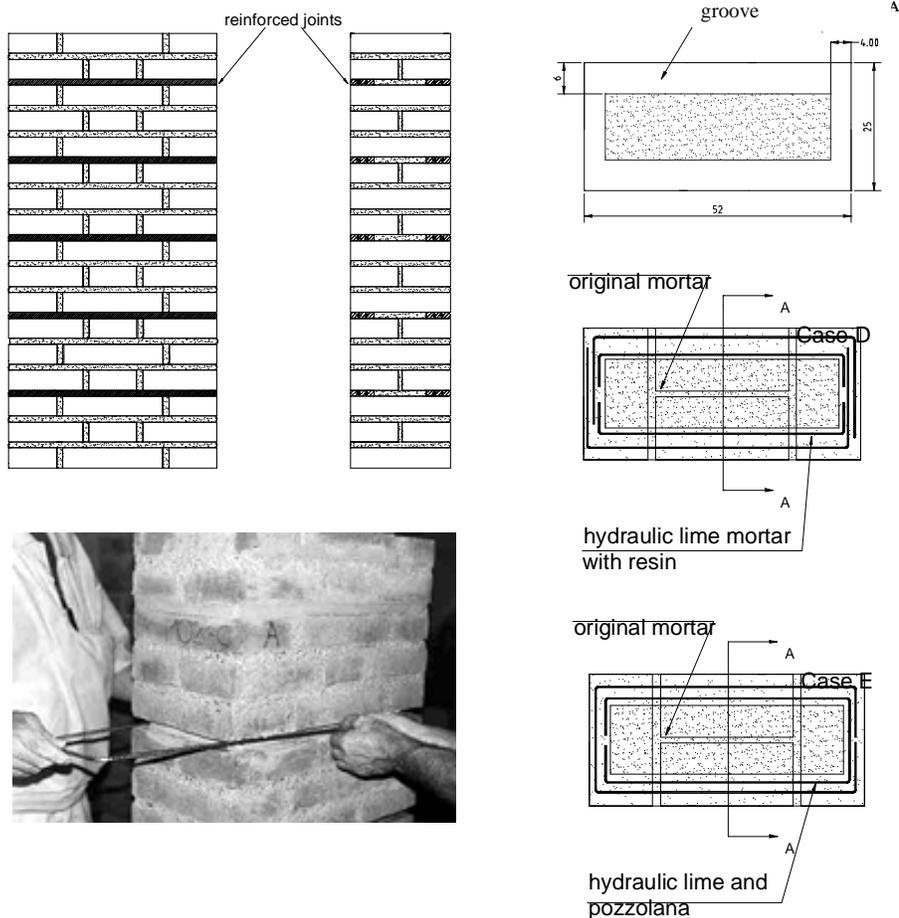
Figure 10. Reinforcement position and bonding in the reinforced prisms.

The experimental program for the second series is reported in Tab. 1. For the second series of tests, two prisms were subjected to creep loads without any strengthening, and two strengthened prisms were tested under monotonic and creep loads. In Fig. 10 the reinforcement position and bonding are shown.

Fig. 14 to 16 show the crack pattern after the creep tests of three samples in different conditions: the first one is non reinforced while the other two were joint reinforced. The considered sides (A and B), corresponding to the larger dimension of the wallettes, better identify the masonry. In fact, for the sides C and D the behaviour was affected by the presence of the bar connection, as it is possible to observe in Fig. 10, concerning the geometry of the reinforcement.

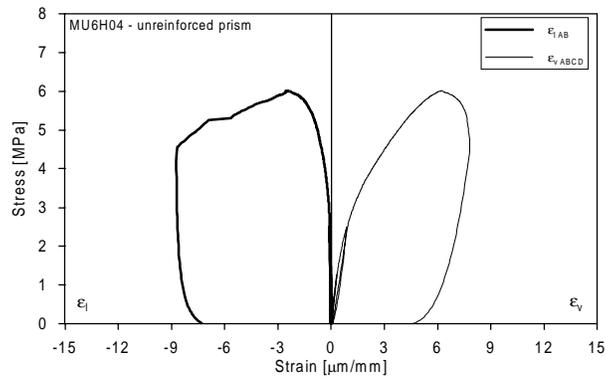
Figure 11. Stress strain diagram of the unreinforced prism MU6H04

The second series of tests, the scheme of loading was able to show a crack pattern very similar to the typical observations in the real structures. The typical diagrams obtained by the monotonic and creep tests are given in Fig. 11 to Fig. 13 for the series of samples, together with some images of the wallettes after failure.

In particular, Fig. 11 to Fig. 13. show the results of the monotonic tests carried out on the

unreinforced and reinforced prisms. The first observation can concern that the reinforcement has not any influence on the peak strength. The reinforcement, instead, acts on containing the transversal deformation. The prism M04, reinforced by the bar disposal called D, shows the lower transversal deformation, especially in the A and B sides.

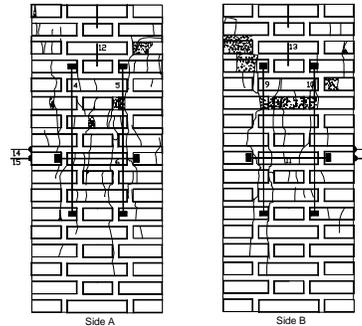
Figure 14. Crack pattern of the unreinforced prism MO1 after the test.

The non repaired prism shows clearly diffuses fissures, not recognisable in the other two cases. This particularity is considered important to qualify the effectiveness of the repair. As it is possible to observe, the techniques seem able to prevent the damage mechanism previously identified.

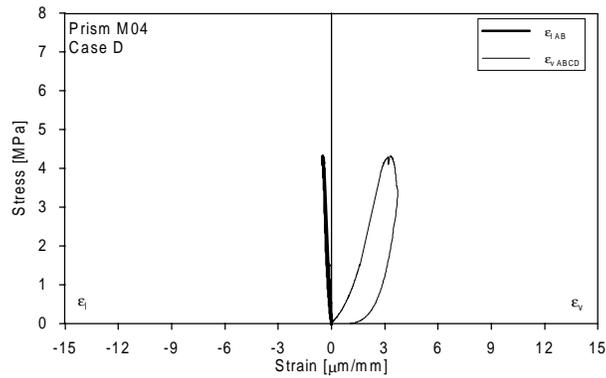
Figure 12. Stress strain diagram of the prism M04

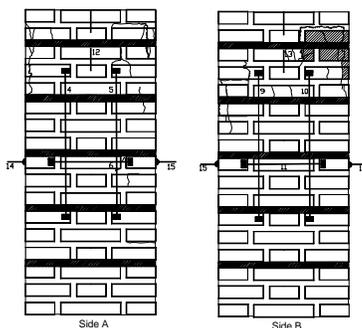
Figure 15. Crack pattern of the reinforced prism MO2 (Case E) after the test.

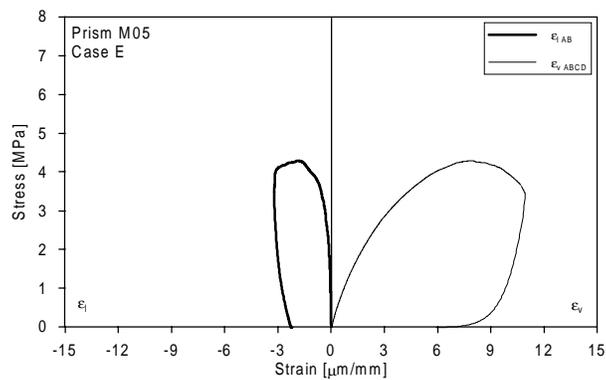
Figure 13. Stress strain diagram of the prism M05

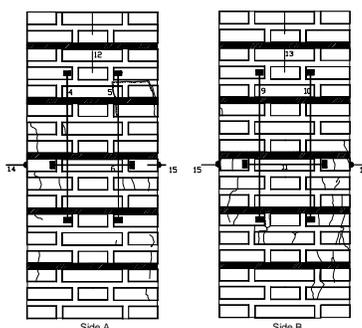
Figure 16. Crack pattern of the reinforced prism MO6 (Case D) after the test.

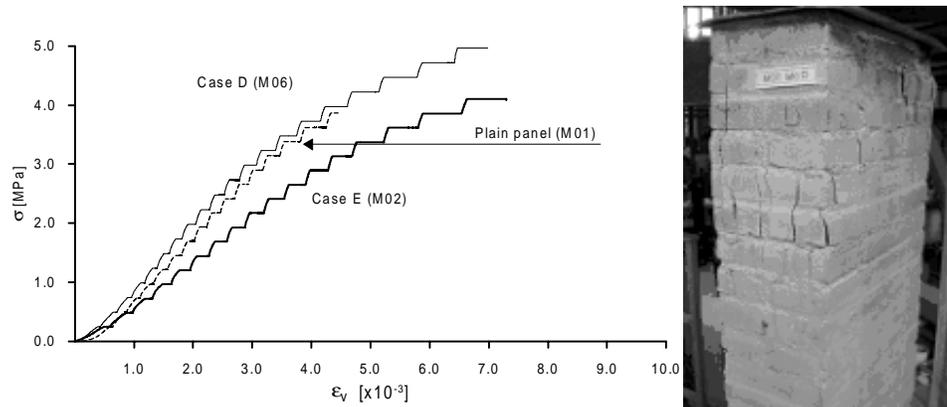
Figure 17. Results of the second series of tests and typical failure of the wallettes.

Fig. 17 shows the vertical deformation vs. stress diagram of the three prisms. This parameter is not very representative. In fact, the reinforcement has not influence in the deformations in this direction. Furthermore the strength of the reinforced prisms was only

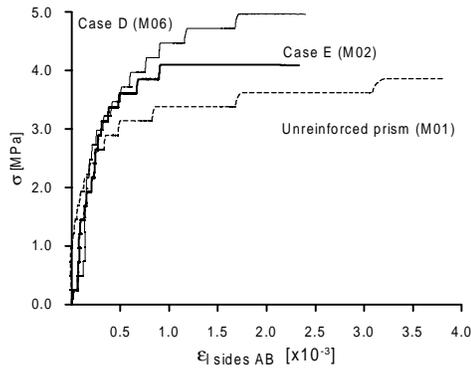
Figure 18. Horizontal deformation of the sides A and B of the wallettes

A clear change in the wallettes mechanical behaviour, instead, is readable in Fig. 18, where the horizontal deformation vs stress is represented. The plot concerns the deformation of the sides A and B.

As in the previous case, the higher dilation was detected in the transversal sides rather than in the longitudinal ones for the original prisms, whereas the opposite happens in the strengthened prisms. This demonstrates the reduction of a potential crack pattern in the main faces of the wall, as verifiable at the end of the tests.

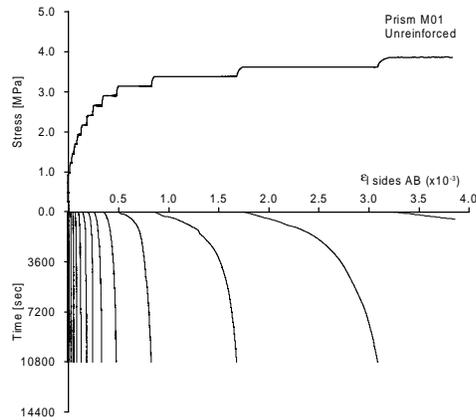
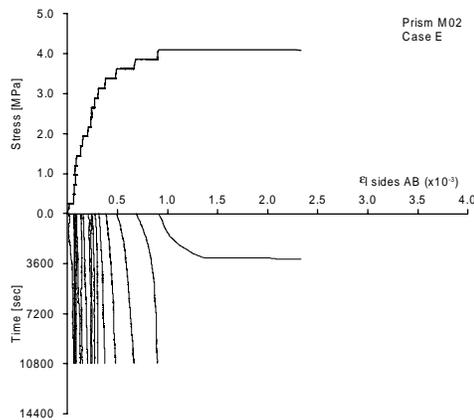
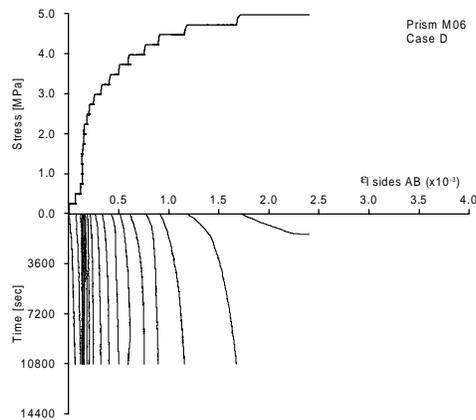
Figure 19. Stress strain plot of the unreinforced prism M01

Figure 20. Stress strain plot of the prism M02

Figure 21. Stress strain plot of the prism M06

By confronting the increasing of the deformation in time, represented in the plots of Fig. 19-21, it is possible to observe a first phase of similar behaviour of the prisms until $\epsilon=0.3 \times 10^{-3}$.

Following this, the unreinforced prism deformation quickly increases. In the reinforced prisms, instead, the deformations are controlled by the confinement effect of the bars. This effect allows to obtain slightly higher levels of stress, as well.

The reinforcement was able to reach the tertiary creep conditions at deformations higher than the 70% of the original case; moreover, in such ultimate phase, the prisms reinforced by the technique D, showed also an increment of about the 20% in the strength.

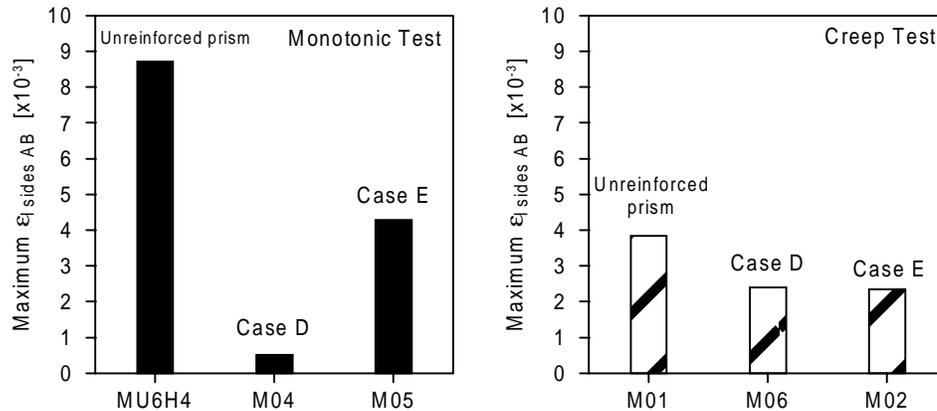
Figure 22. Maximum transversal deformation measured during the monotonic and creep tests

Fig. 22 compares the maximum transversal deformation of the monotonic and creep tests. The dilatation containing of the reinforcement is clearly readable.
