PERFORMANCE OF BRICK PAVEMENTS SUBJECTED TO HEAVY VEHICULAR TRAFFIC

Brian E. Trimble, P.E. ¹

ABSTRACT

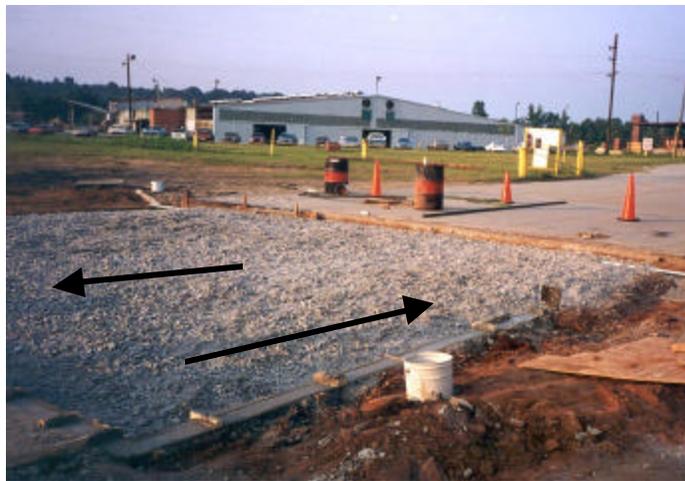
Columbia, SC Test Site, Area #1
Figure 1

Table 1 provides the approximate sizes of the paved areas. Figs. 1 and 2 show the two monitored test sites and the typical traffic flow patterns. At the South Carolina site, two areas were installed: a truck loading and unloading area (Area #1) and a truck unloading area (Area

#2). Area #1 also had two different bond patterns: stack bond and herringbone. Area #2 used only a herringbone pattern, but a thicker unit was used. The Ohio location was a load tie-down area for all trucks leaving the plant. It used two different pavers within the same test section: a wirecut flashed paver and a smooth unflashed paver.

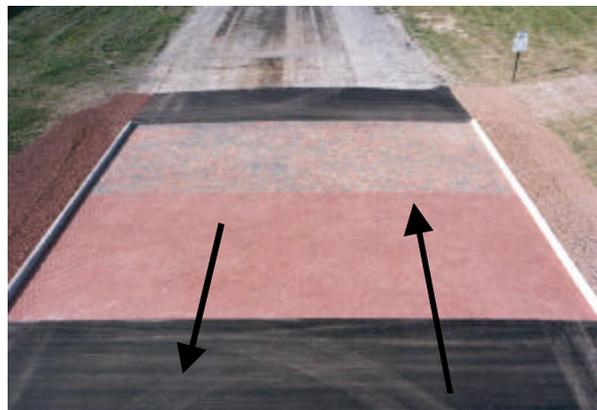
Sugarcreek, OH
Figure 2

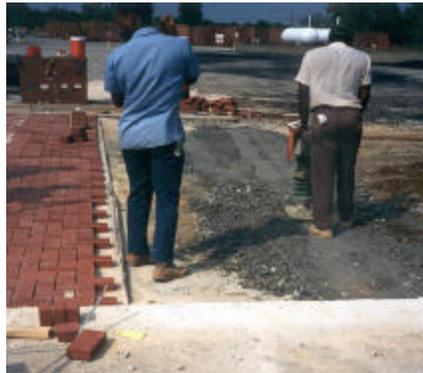
Figure 3

Compaction of Base, Area #1

Installation procedures were followed as prescribed in the BIA (1991). Area #1 used a 152 mm (6 in.) layer of compacted crushed stone. A fine silica sand was used for the setting bed in both Areas 1 and 2. The setting bed was 50 mm (2 in.) thick. Two bond patterns were used in Area #1: stack bond and herringbone. Stack bond was used to verify the recommendation of using a herringbone pattern in vehicular areas. Area #2 used a thicker paver which was laid in a herringbone pattern. After the pavers were laid in the appropriate pattern they were compacted into place with a plate vibrator. The vibrator did not have a rubber pad. Figs. 3 and 4 were taken during installation of the test areas.

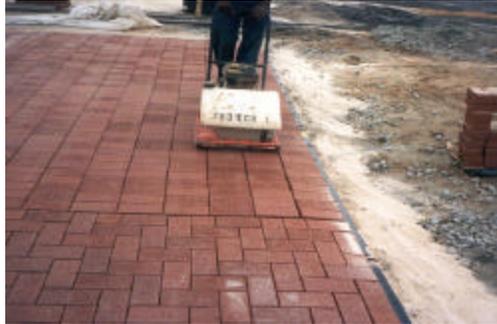
Vibration of Stack Bond, Area #1
Figure 4

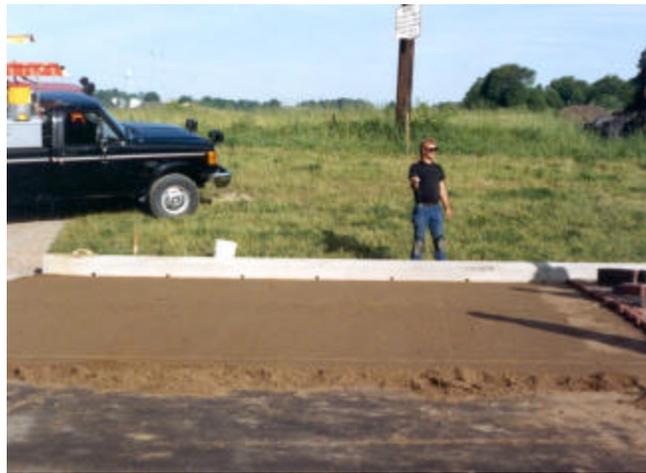
This installation also followed BIA (1991). A concrete curb was poured along the sides of the test area. A 50 mm (2 in.) sand setting bed was used on top of the existing road. Two pavers, a smooth paver and a wirecut flashed paver were used. The pavers were compacted into place after laying. Figure 5 shows the thickness of the sand setting bed and weep holes in the concrete curb. The weep hole were thought necessary to drain water from the pavement.

Installation of Setting Bed
Figure 5

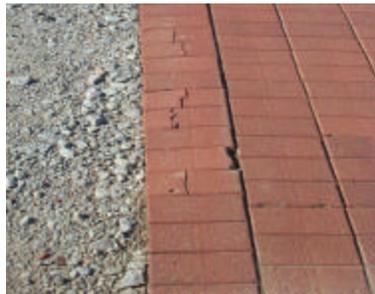
A flexural failure occurred in some pavers along an edge as shown in Fig. 6. This is likely the result of a poorly compacted base directly beneath the edge units. Fig. 7 is an example of chippage due to loss of interlock and subsequent movement of the pavers. Notice the major movements of the units, even though the surface has stayed relatively flat.

Cracking along edge, South Carolina Area #1
March 2001
Figure 6

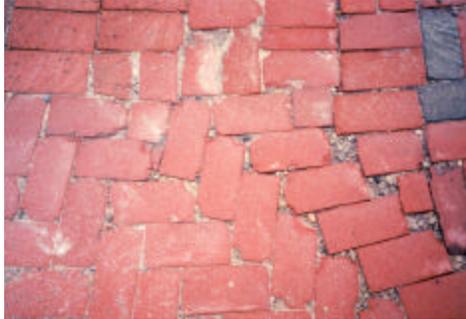
Edge Chippage, Ohio
August 2000
Figure 7

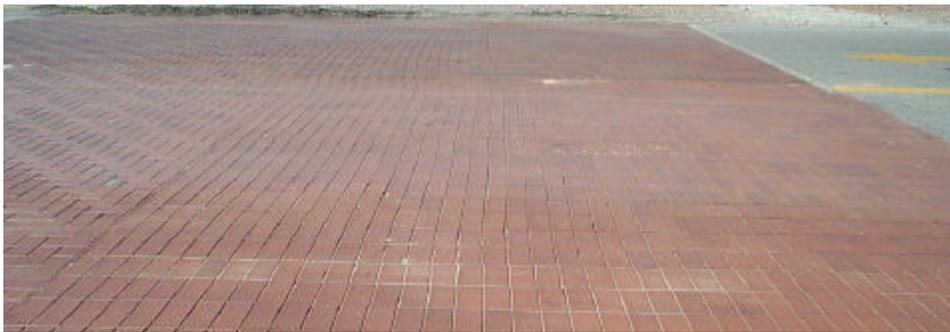
In vehicular areas, especially in flexible pavements, a herringbone bond pattern is recommended. This bond pattern allows forces due to accelerating, braking and turning to be spread out to adjacent pavers more evenly. As seen in the South Carolina location a stack bond pattern was used as a variant. Creep or movement of the pavers occurred soon after the pavement was installed. There was not a catastrophic failure, but created uneven bond lines and opened up an area along the leading edge of the pavement as shown in Fig. 8. Creep also occurred in Ohio even though a herringbone pattern was used. This could be attributed to joint tolerances.

Creep of Bond Pattern, South Carolina, Area #1
March 2001
Figure 8

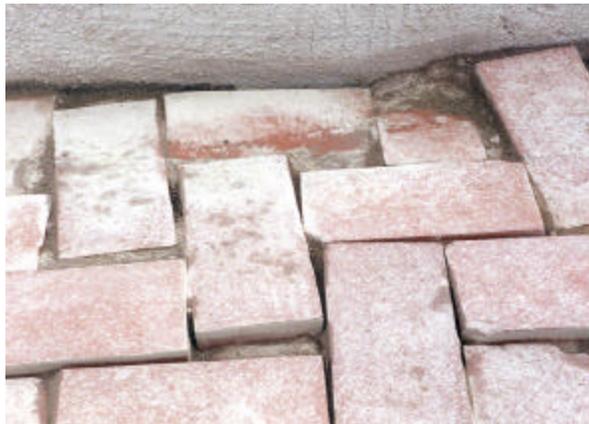
Figure 9

In the Ohio location, weep holes were used in the concrete curb to allow water to be drained from the pavement. Unfortunately, the weep holes were large, 25 mm by 25 mm (1 in. by 1 in.), and they were located at the same level as the sand setting bed. This allowed the sand to flow out of the weep holes. Loss of sand allowed the pavers to shift out of place and undulate as shown in Fig. 9, resulting in loss of interlock. Removal or filling of the weep holes, or use of a geotextile in front of the curb would have kept the sand in place.

Loss of interlock due to sand loss through weep holes, Ohio

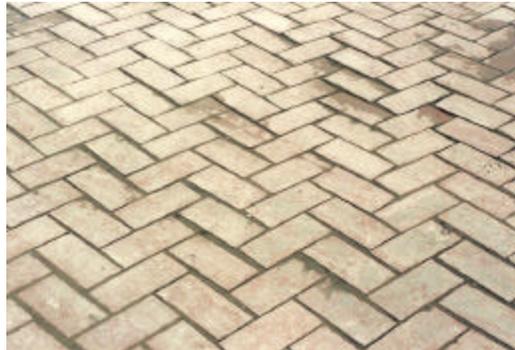
be a greater need for realignment of the pavers. Large dimensional tolerances will also allow sand to be lost from the joints between the pavers over time. The pavers conformed to Application PS as noted earlier. ASTM C 1272, Type F (those used in a flexible pavement) requires all pavers to meet Application PX requirements. Application PX requirements are almost half that of Application PS. An example of movement is shown in Fig. 10.

Figure 10 Movement of Pavers, Ohio December 1992

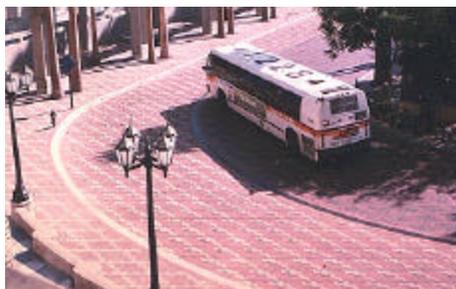
The flexible brick pavement is located at multi-node transportation center and was constructed in 1995. The brick pavement receives over 2,000 passes of bus traffic per day. The system is a concrete slab situated over a parking area with a waterproof membrane, a sand setting bed and brick pavers. Several trial areas were constructed to determine the performance under accelerated traffic of different pavers. A unit from the United Kingdom was chosen because of its close dimensional tolerances and chamfered edges. The paving uses three colors of pavers set in unique patterns. These patterns help define pedestrian and vehicular areas as shown in Fig. 11. The pavers are laid in a 45 degree herringbone pattern. Interlock is well developed and the pavement has retained a high level of serviceability.

Figure 11 Gateway Center, Los Angeles
