SEISMIC REINFORCEMENT OF EXISTING WALLS MADE OF HORIZONTALLY-HOLLOW BRICKS

A. San Bartolomé¹, D. Quiun², T. Araoz³ and J. Velezmoro⁴

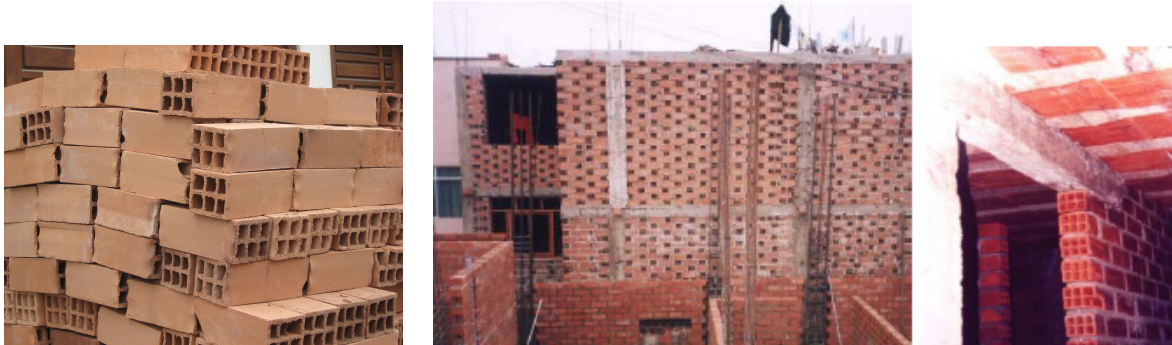
Figure 1: Horizontally hollow bricks used in self-constructions for bearing walls in Peru

Many people in Peru and other countries under development build houses by self-construction. Due to economic reasons, regardless the safety or regulations, this people usually choose the cheapest materials. In Peru, horizontally hollow clay bricks (called “pandereta”, see Figure 1) are used for bearing walls, although such brick units were conceived for use in non structural walls. They are forbidden for use in bearing or structural walls by the Peruvian Masonry Code (“Norma E.070” in Spanish); however, people use it, despite the vulnerability involved. This paper deals with a reinforcing methodology for existing structural walls made with horizontally hollow bricks. The 2007 Pisco earthquake in Peru (M8.0) showed the fragility of such walls and the need to prevent collapses of such walls in future events (San Bartolomé and Quiun, 2008).

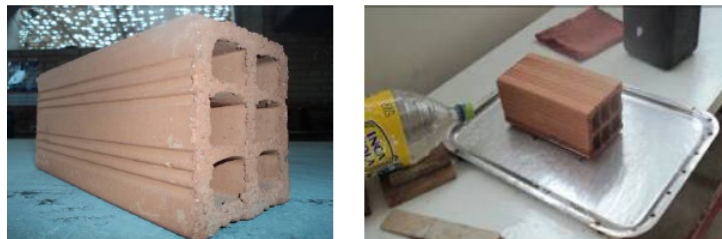
Figure 2: Horizontally hollow bricks and suction test

The mechanical properties of the construction materials are shown hereafter. The bricks were industrial horizontally hollow clay units, 90x110x230mm size, with channels at the sides as observed in Figure 2. The dimension variation was 4.6%, warping was 0.3 mm, compressive strength f'_b was 5.6 MPa, absorption reached 46% and the natural suction was 46 gr/(200 cm²-min). In order to reduce the suction prior to laying, the bricks were wetted for 30 minutes about 10 hours prior to be laid.

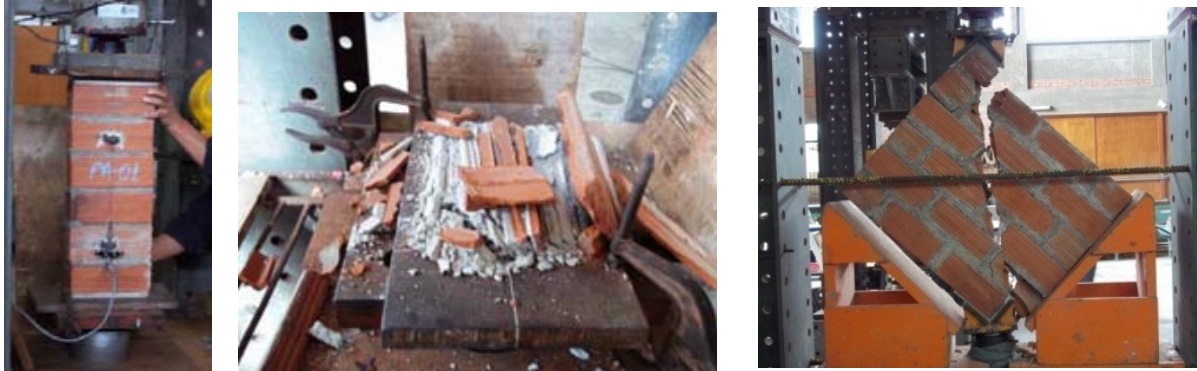
Figure 3: Tests performed in prisms and wallets.

Small masonry specimens of prisms and wallets of these horizontally hollow bricks were constructed and tested. Four prisms of 110x230x600 mm were subjected to axial compression tests, leading to a compressive strength of 2.4 MPa. The failure in all cases was very fragile and

explosive, which show us how dangerous is the use of such bricks in bearing walls as shown in Figure 3. Also, four wallets of 110x600x600 mm were built and tested under diagonal compression, reaching a shear strength of 0.93 MPa. The same kind of fragile and explosive failures were observed (Figure 3).

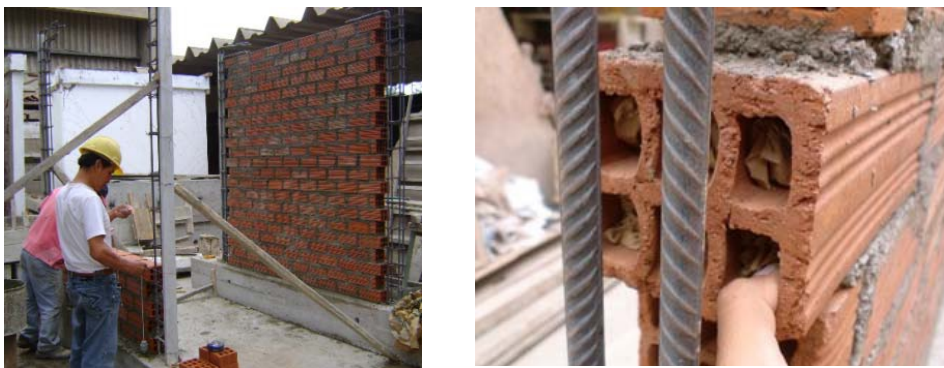
Figure 6: Construction of walls W1 and W2.

Besides using the same materials, hand labor and confinement reinforcements, the construction specifications for both walls were as follow. The bricks were laid so that the wall thickness was the smaller side of the bricks. The mortar mix proportion was 1:4, cement - sand. The horizontal and vertical joints were of 15mm thickness. The bricks were wetted for 30 minutes, 10 hours prior to the construction. The connection between columns and walls was toothed; the horizontal holes of the bricks were covered with paper, leaving 20mm for the concrete of the columns to enter as shown in Figure 6. The masonry wall was erected in two days, then the concrete of the columns was poured, and finally the collar beam was poured. The concrete was water cured once a day for one week. After 28 days of construction the walls were ready for testing.

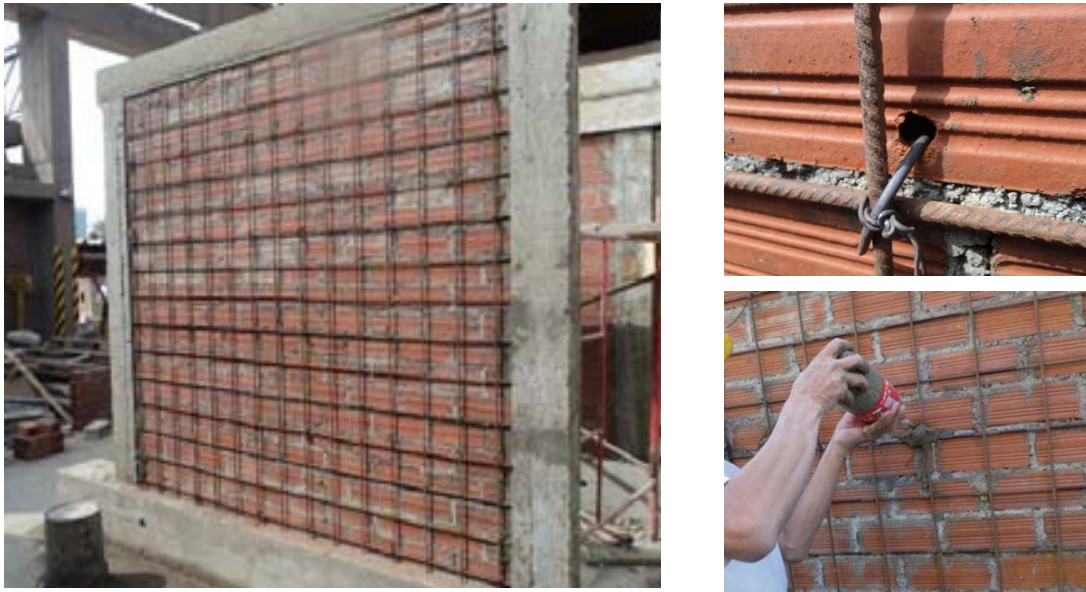
Figure 7: Wire meshes added to W2, detail of connection wire and filling the perforations

In the already constructed wall W2, the wire mesh was installed on both sides (Figure 7). The bricks were perforated for the connection wires #8 every 450mm, which is 3 times the wire spacing. The connector wires were bent 90° and tied to the meshes with smaller wires. The perforations were then filled up with grout of cement-fine sand in 1:3 by volume. The final cover was completed in two steps, with mortar of cement-sand in 1:4 by volume (Figure 8).

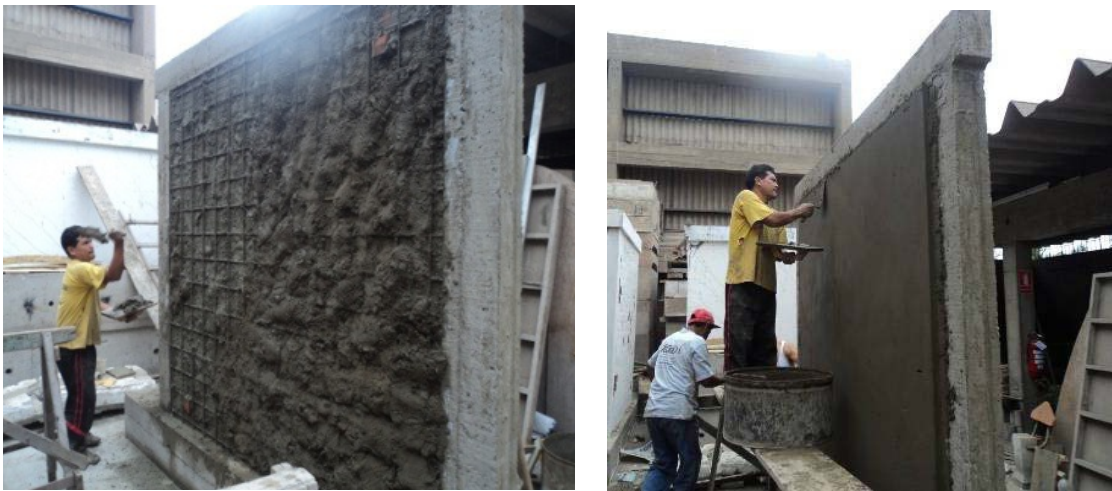
Figure 8: Cover of wire meshes in W2, done in two steps

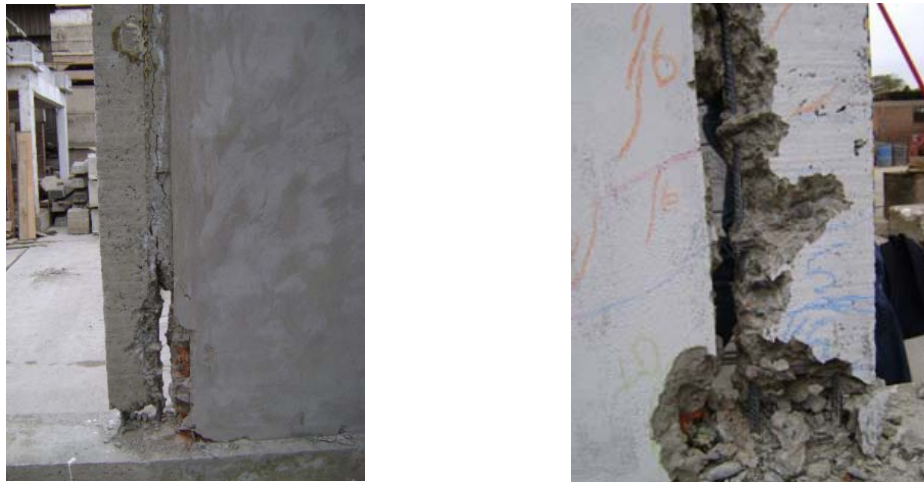
Figure 11: Wall W2 inspection after the tests

After the end of the test, for wall W2 an inspection was conducted by exploring the connection between the masonry and the right column. The vertical crack that appeared was located in the cover of the longitudinal internal bar (Figure 11). Therefore, when this bar lost its bond with the concrete, it was not able to resist the lateral load effects. The damage also included the concrete crushing at the base of the columns and the already mentioned sliding at the base, all of which contributed to the degradation of shear force capacity of this wall.
