THE HISTORY AND SIGNIFICANCE OF CORING MASONRY WALLS

John Chrysler¹ and Kurtis Siggard²

ABSTRACT

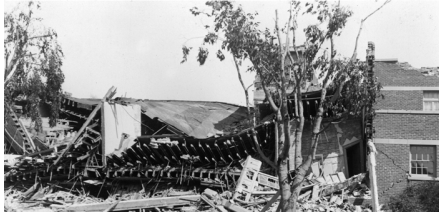
Figure 1: Jefferson Junior High School, Long Beach, California

Damage to schools was substantial with 300 schools experiencing minor damage, 120 schools with major damage, and 70 schools were entirely destroyed as depicted in Figure 1. If not for the event occurring at 5:55PM on a Friday evening, the loss of life would have been devastating. It was reported that there were more than 120 fatalities. [1]

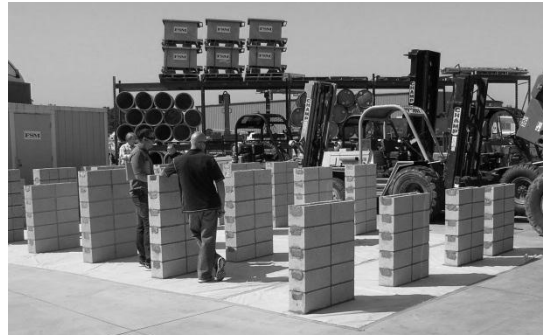
Figure 3: Masonry panels prior to grouting (bond beams mortared to restrict grout)

Panels were constructed in a stack bond configuration, 2 units in length, 6 or 7 courses (40 or 48 in.) in height. Bond beams were used to aid horizontal grout flow and the bond beam opening of the units at panel ends were mortared to confine grout. Reinforcement, which would have

interfered with the core location selection, was not used in the panels. After construction, the panels were cured for 5 days before grouting. Figure 3 shows the panels prior to grouting.

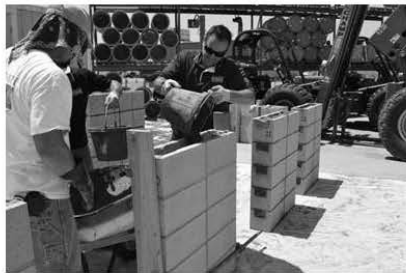
Figure 4: Bucketing Grout into Sample Panel

Grout was transported by wheelbarrow from the ready mix truck and buckets were used to grout the test panels as shown in Figure 4.

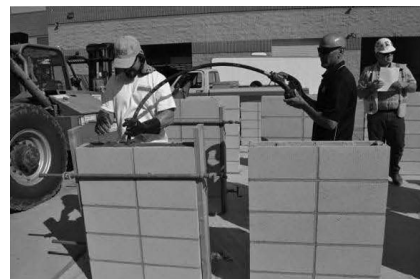
Figure 5: Consolidating Grout

grout from blowing out the mortar infill of bond beams at the ends of the sample panels. Grout was mechanically consolidated and reconsolidated as shown in Figure 5 using a battery powered vibrator designed for consolidation of masonry grout. Reconsolidation was performed shortly after the initial consolidation and prior to the grout taking a plastic set. Due to ambient temperature, the time between consolidation and reconsolidation was relatively short.

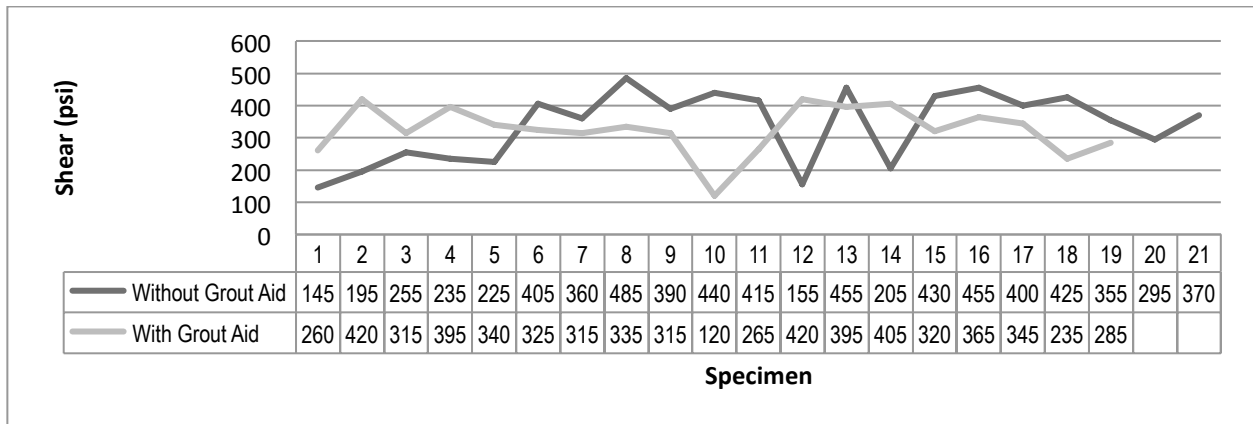
Figure 6: 7-Day Core Shear Test Results

The above results were analyzed and graphically sorted by core age, Figures 6 through 8. Although the shear values vary significantly, results show that the vast majority of shear values exceed the minimum requirement of the California Building Code. The value required by CBC Section 2114.9.3 or 2104A.4 is a shear bond equal or exceeding $2.5\sqrt{f'_m}$ psi, which correlates to 0.67 MPa (97 psi) when the f'_m is 10.3 MPa (1,500 psi). For sample panels 17 through 24, the f'_m was 14.5 MPa (2,100 psi) which requires a minimum shear bond value requirement of 0.79 MPa (115 psi).

Although grout aid is an expansive agent, the test results indicate that the presence of grout aid had very little effect on the shear bond between grout and masonry face shells.

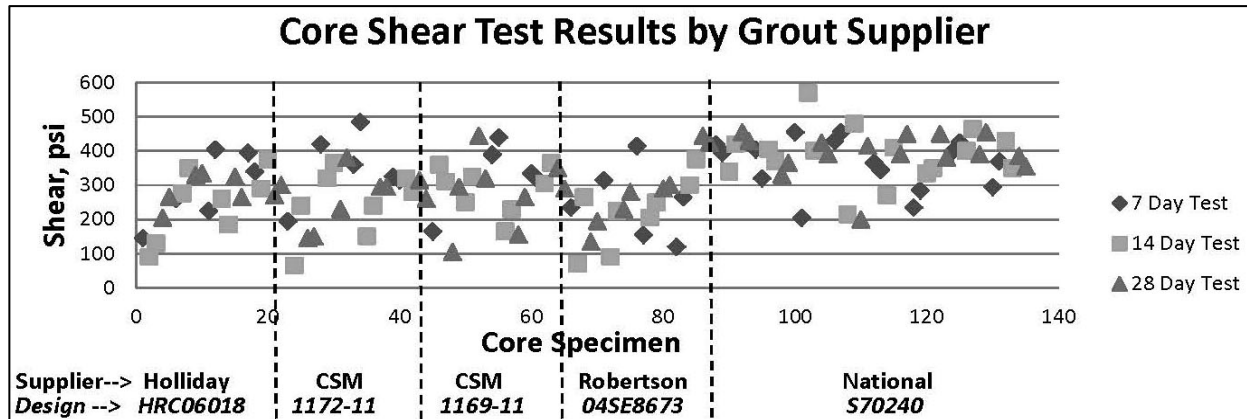
Figure 9: Core Shear Test Results by Grout Supplier

The data was also sorted by grout supplier, Figure 9, to see if there was any significant difference. Nearly all results were above 0.69 MPa (100 psi) with a significant majority above the 1.38 MPa (200 psi) level. Four of the five grout suppliers had similar results; however National Ready Mix had all results at or above 1.38 MPa (200 psi) shear value. Additionally, there were 48 core specimens representing National Ready Mix and of 96 face shells, 3 separated for a successful test rate of 97%.
