INVESTIGATION OF STAINING OF HARD-SET SANDSTONE MASONRY PAVERS

ABSTRACT

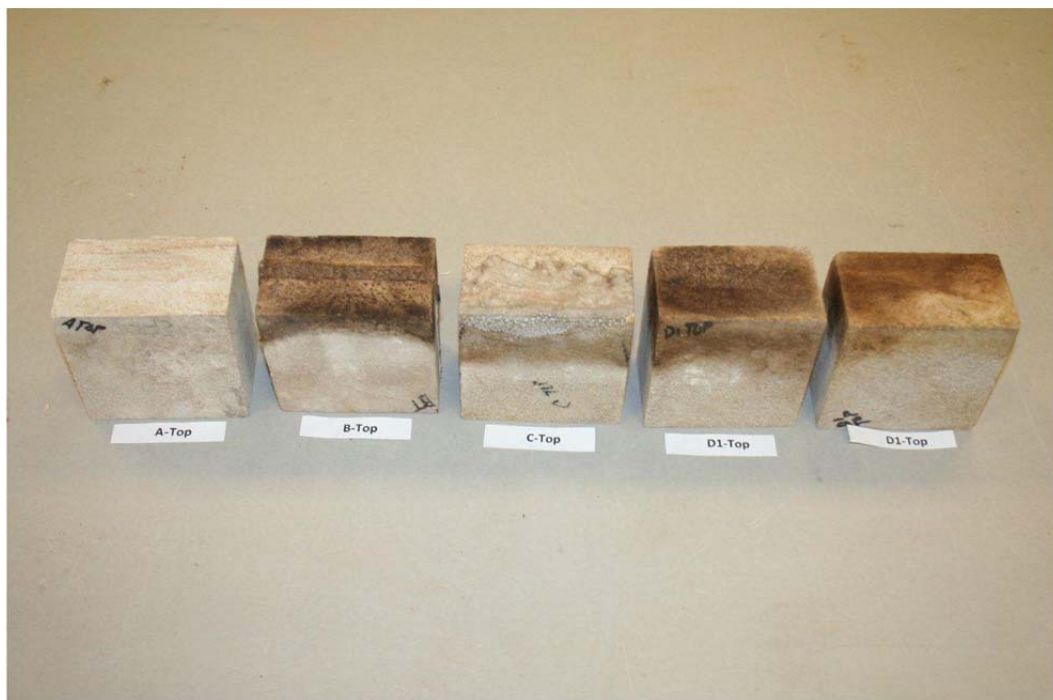
Efflorescence testing was performed on samples of stone removed from the original installation as well as samples of previously uninstalled pavers (“attic stock”). Of the five previously installed samples tested, four experienced brown staining after seven days of testing (Figure 2). Subsequent testing on attic stock which had never been placed into service did not result in staining over the same period of time.

Figure 2: Four out of five previously installed paver samples effloresced

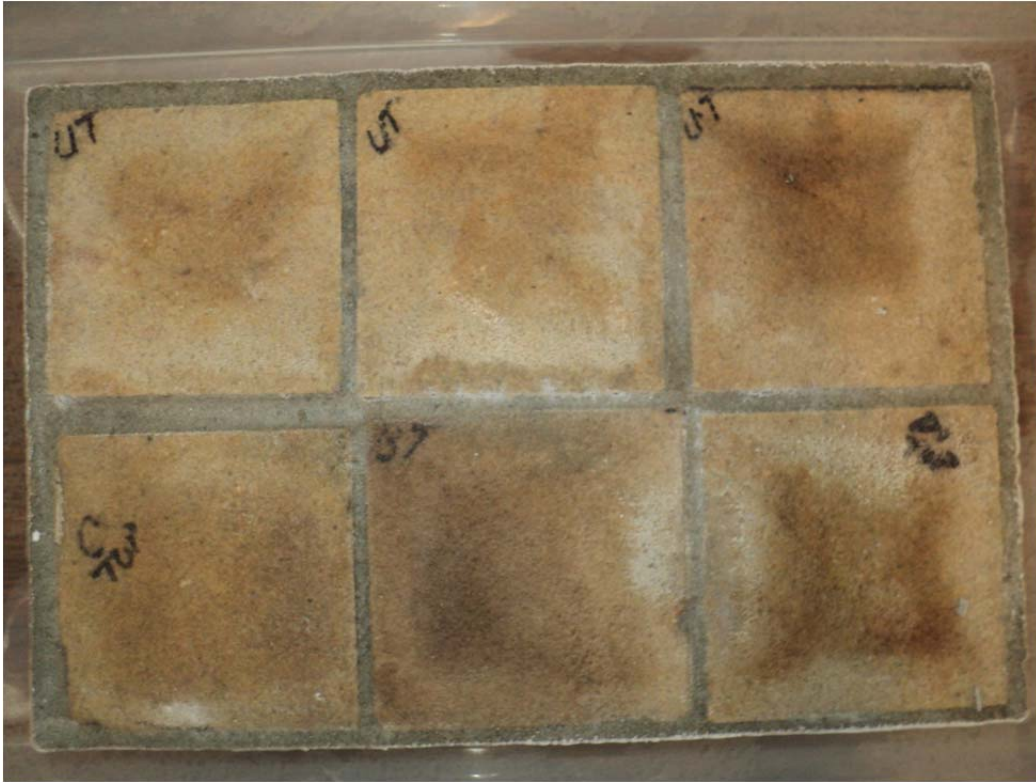
After approximately two days of exposure, the dry-pack mock-up (Specimen A) began to evidence a crystalline efflorescence deposit on both the previously installed and attic stock pavers. After one week, all of the pavers in Specimen A were also experiencing significant brown staining (Figure 3). Similar staining was observed after one week’s exposure on all of the pavers of the mock-up created with the gray Type M cement (Specimen C) and the previously installed pavers in the flexible pavement mock-up (Specimen B). Interestingly, no staining was evident on the attic stock pavers in Specimen B even after six weeks of exposure (Figure 4), indicating that the formation of brown stains on the sandstone was related to its exposure to cement.

Figure 3: Brown staining on all pavers of Specimen A (approximately one week exposure)
