CYCLIC RESPONSE OF TRADITIONAL AND CONFINED MASONRY HAITIAN WALLS

ABSTRACT

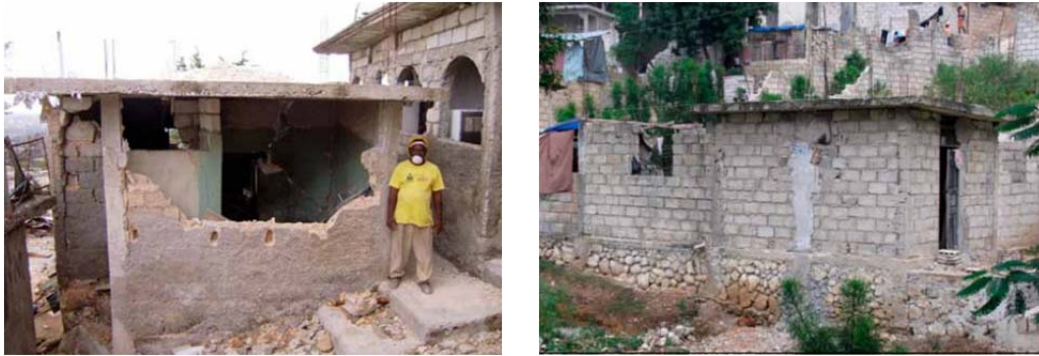
Figure 1: Earthquake destruction in masonry houses in Haiti [2]: a) Out of plane failure; b) Lack of column at corner

No seismic detailing, informality and poor construction techniques were responsible for most of the damage on poorest people housing. Traditional construction consisted of small dimension, weakly reinforced concrete frames infilled with low quality, hand made, concrete block masonry units (CMU). This system, used in most houses and multi story buildings in Haiti, had undesirable seismic behaviour as can be appreciated in Figure 1 [2].

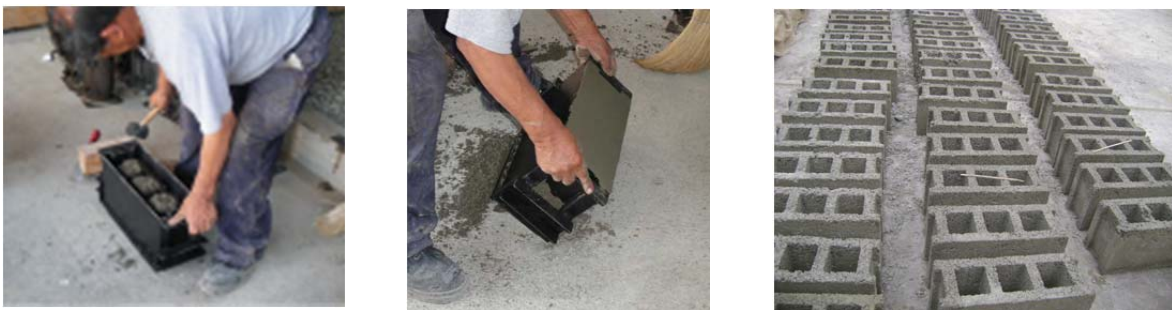
Figure 2: CMU preparation: a) Metallic form; b) Solid surface; c) Drying

The concrete masonry unit used in the project had the same dimensions as the typical Haitian CMU, 150 x 200 x 400 mm, with three square openings as shown in Figure 2. However, the openings did not pass through the other side, which finished in a continuous 25 mm thick layer. A metallic form was designed and fabricated with these specifications, and 800 blocks were hand made for the whole project.

Materials used for the concrete mix of the units were Portland cement, coarse sand with F.M. 2.86 and tap water in a volume ratio of 1:9:2. This concrete mix gave 8.2 MPa concrete cylinder strength at 7 days. The compression strength of CMU was tested at 90 days giving a gross

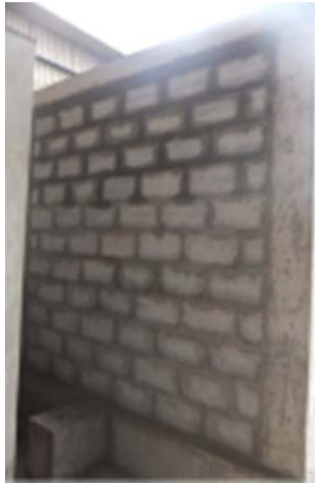
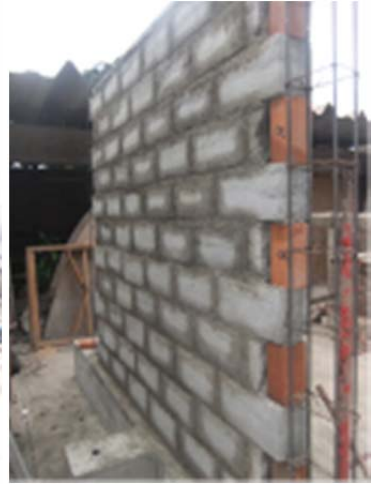
Figure 4: Wall construction: a) Overall dimensions; b) Infilled masonry in RC frame; c) Confined masonry

The main difference between both walls was the construction process. W1 simulating Haitian construction was built with CMU laid without previous treatment. The concrete columns and the top beam were built first as a normal RC frame, and later, CMU were infilled to the frame. W2 was built with CMU wetted superficially prior to laying. The masonry wall was built first, leaving the ends toothed. After the masonry wall was finished, the end columns and crown beam concrete was poured producing a confined wall. Figure 4 shows the overall dimensions of the walls and the difference in the construction sequence of each wall.

Two masonry walls were built varying the construction sequence of RC columns and masonry wall. Each wall was built over a RC foundation beam of dimensions 300 x 400 x 3900 mm. Columns cross section was 150 x 250 mm. Reinforcement consisted of 4 Φ 9.5 mm (3/8") bars for both walls. Stirrups of 6 mm with 90° hook were spaced uniformly every 250mm for Wall 1 (W1) and for Wall 2 the hook was 135° and they were spaced 1@50mm, 4@100mm and the rest @250mm. Crown beam cross section was 150 x 200 mm. It was reinforced with 4 Φ 9.5 mm (3/8") bars and stirrups of 6 mm spaced uniformly every 250mm for both walls.

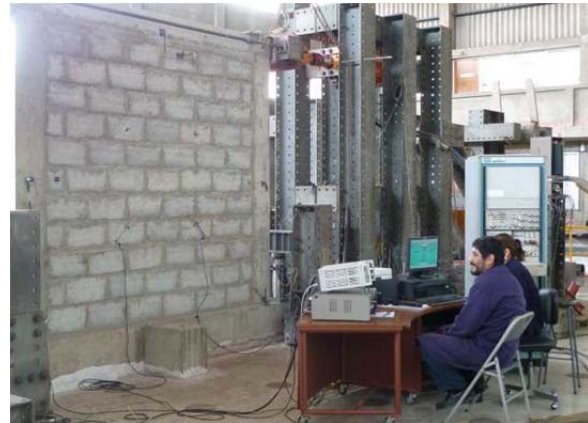
Figure 5: a) Wall instrumentation; b) Testing set up.

Instrumentation consisted of 10 LVDT's as shown in Figure 5: D1 was used for test displacement control, D2 and D3 recorded the diagonal elongation at the centre of the wall, D4 and D5 recorded the vertical separation between column and foundation beam, D6 and D7 measured total diagonal elongation of the wall, D8 and D9 monitored horizontal separation between wall and columns and D10 monitored horizontal movement between the wall and the crown beam.

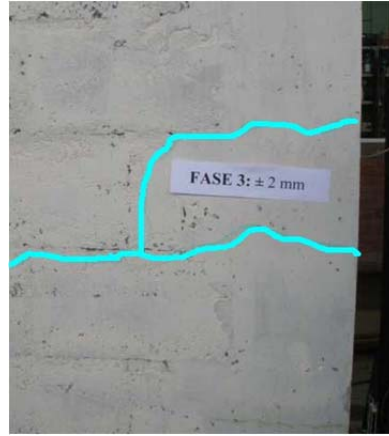
Figure 6: Step 3 for: a) W1; b) W2.

Wall W2 had no visible cracks in step 1, and starting step 2, it developed tension flexure horizontal cracks in the columns which extended to the wall joints. Figure 6 shows crack detail of both walls at step 3, where the different behaviour is observed. At step 4 many diagonal cracks appeared, which developed in stairways through the joints. Neither vertical nor horizontal wall separation cracks appeared in W2 during the test.

Failure pattern was different in both walls. Wall W1 developed fine vertical separation cracks (0.15mm) between the masonry wall and RC columns in step 1. This separation process advanced to complete vertical separation from columns (step 2) and horizontal separation from both the foundation beam (step 3) and the top beam (step 4). At this point, average separation crack width was 0.5 mm. At step 6, separation cracks were 3 mm wide and during step 7, cracks passed through the wall. It was only in step 8 that diagonal shear cracks started to appear in W1.

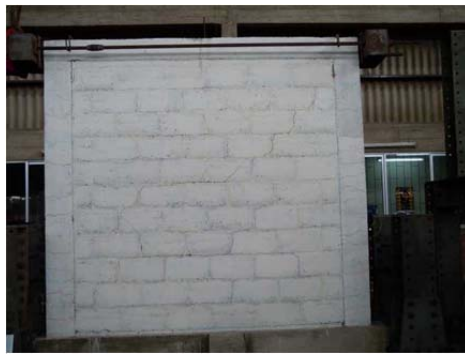
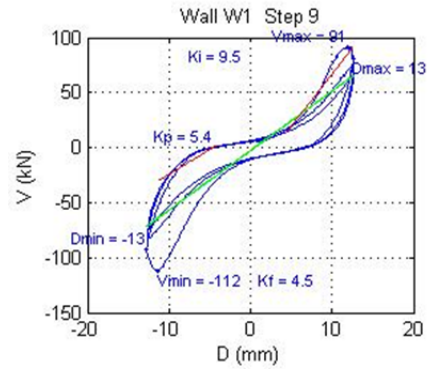
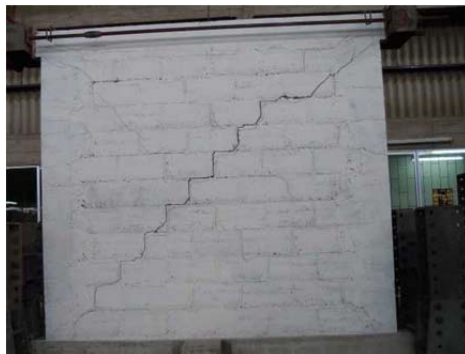
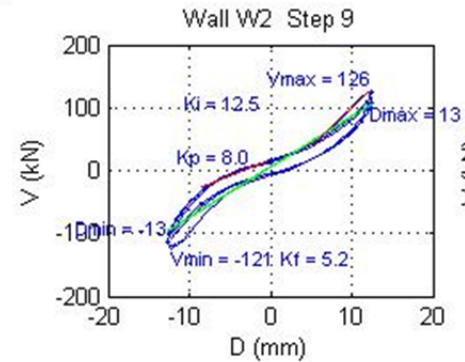
Figure 7: Step 9 for: a) W1 and hysteretic curves; b) W2 and hysteretic curves

The Peruvian Seismic Code [6] establishes that the maximum drift for a masonry structure should be limited to 0.005 (1/200), which corresponds to step 9 of this test sequence. However, further steps were carried on to observe the final failure mode of each wall. Thus, Figure 7 shows the walls at the end of step 9 and Figure 8 presents the walls after step 13.

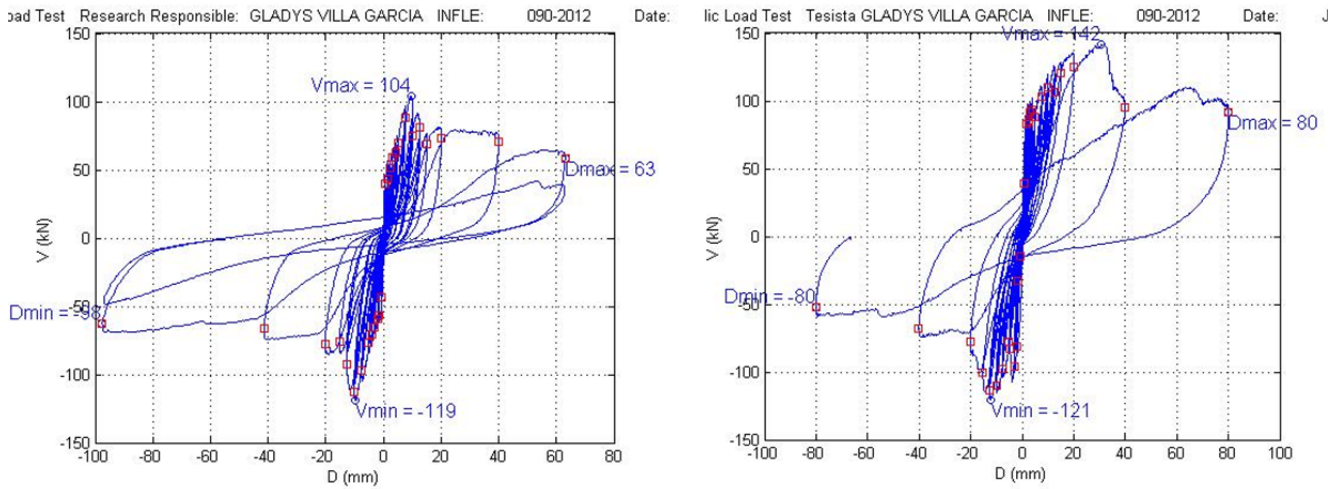
Figure 9: Hysteretic loops for: a) W1; b) W2

Table 4 compares the peak values and Figure 9 shows the complete hysteretic loops of lateral force vs. lateral displacement for both walls.
