SEISMIC STRENGTHENING AND REDESIGN OF OLD MASONRY BUILDINGS: FOLLOWING THE NEW TRENDS

M. Tomažević

Professor, Slovenian National Building and Civil Engineering Institute; Ljubljana, Slovenia
miha.tomazevic@zag.si

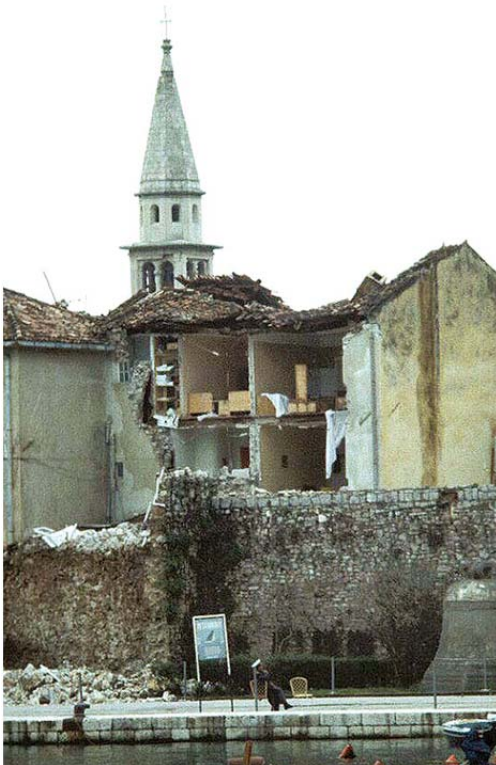
Figure 1: Out-of-plane Collapse of Walls

The connection between the structural elements of historic buildings is adequate for gravity loads, but the elements which would ensure the monolithic behavior of the structure when subjected to seismic loading, like wall ties and rigid floors, are frequently missing. Masonry buildings are typical box-type structures, so that structural integrity should be ensured to utilize the available resistance of structural walls when subjected to lateral loads. If the walls are not well connected together, they separate at vertical joints and the walls orthogonal to the direction of earthquake motion start vibrating out of their planes. In some cases, vertical cracks in the walls develop due to out-of-plane bending as a result of large spans between the bracing walls. In the others, however, parts of such walls or the walls as a whole overturn and collapse because of the loss of stability (Figure 1).

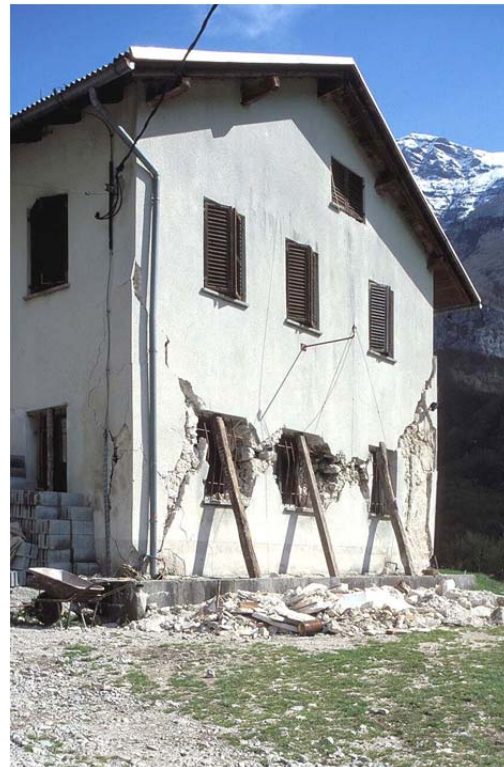
Figure 2: Shear Failure of Walls

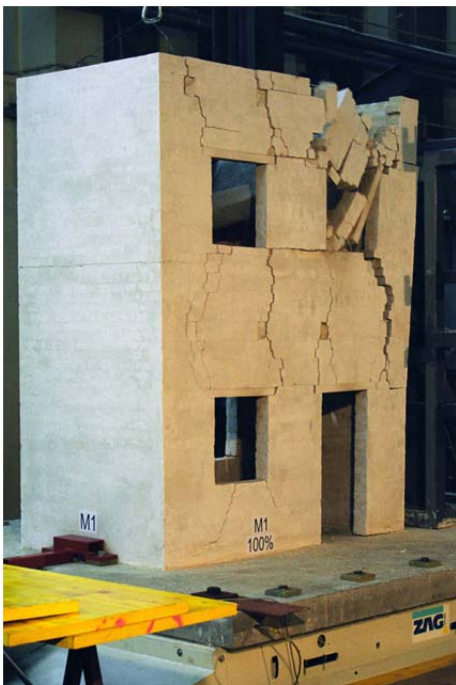
Figure 3: Upper Corner Failure and Separation of Walls of Model Without Wall Ties [19]

Recent experiments indicated the possibility of replacing steel ties with reinforced polymer laminate strips (Figures 3 and 4 [19]). By confining the models of building with vertically and horizontally placed strips, separation of walls and out-of-plane collapse was prevented. As a result, the available resistance and displacement capacity of the structure has been fully utilized (Figure 5).

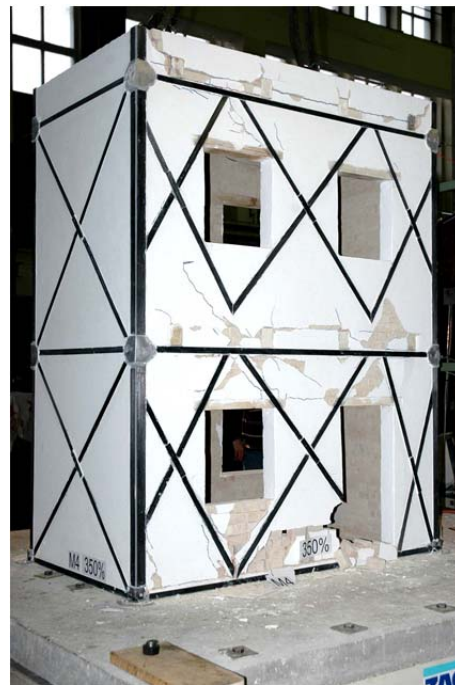
Figure 4: Model with CFRP Ties Resisted 3.5-times Stronger Earthquake [19]

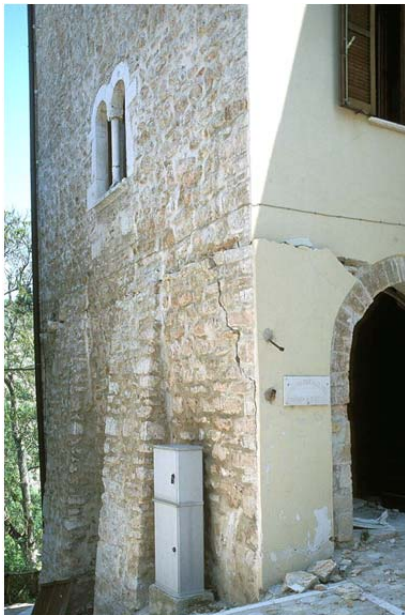
Figure 6: Rigid R.C. Sheared and Delaminated Stone Masonry Walls at Supports [10]

Theoretically, the replacement of wooden floors with massive reinforced concrete slabs represents the optimum solution for improving the structural integrity. Horizontally rigid slabs ensure good connection of the walls and prevent excessive out-of-plane vibrations. However, experimental investigations and post-earthquake observations indicate, that the replacement of wooden floors with rigid r.c. slabs sometimes adversely affects the seismic response [10, 18]. There have been numerous cases observed where the inadequately anchored and connected new slabs caused severe damage to existing structural walls, by shearing the walls and causing the delamination of stone masonry (Figure 6). The same kind of mechanism has been observed also in the laboratory (Figure 7). To prevent negative effect, new floor slabs should be sufficiently supported and adequately anchored into the walls.

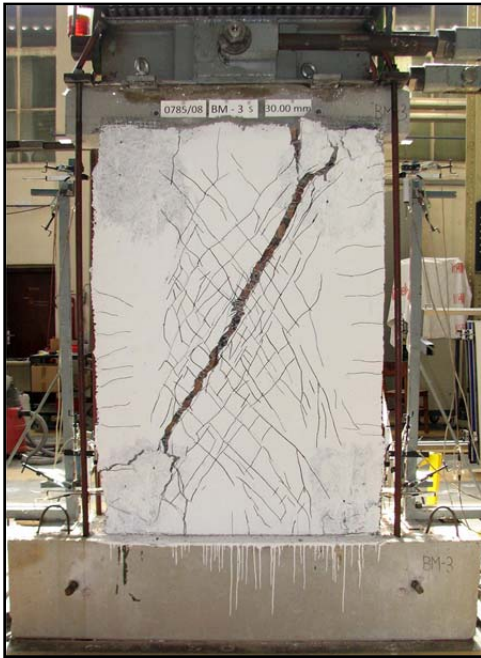
Figure 14: Brick Masonry. Diagonally Placed GFRP Grid Reinforced With Vertical Boundary Grid Strips [26]

In the case of the brick masonry walls, the in-plane resistance was improved by 20–130 %, depending on the strengthening type. In the case of diagonally placed grid with vertical boundary reinforcement, shear rupture of the coating took place (Figure 14). In all other cases, the delamination and buckling of coating or strips was critical. The phenomena of premature delamination have been emphasized in the case of strengthening the walls with rigid CFRP strips/plates, directly glued to the masonry (Figure 15). Because of delamination, the displacement capacity was not significantly improved. Typical lateral load-displacement hysteretic relationships are shown in Figures 16 and 17.

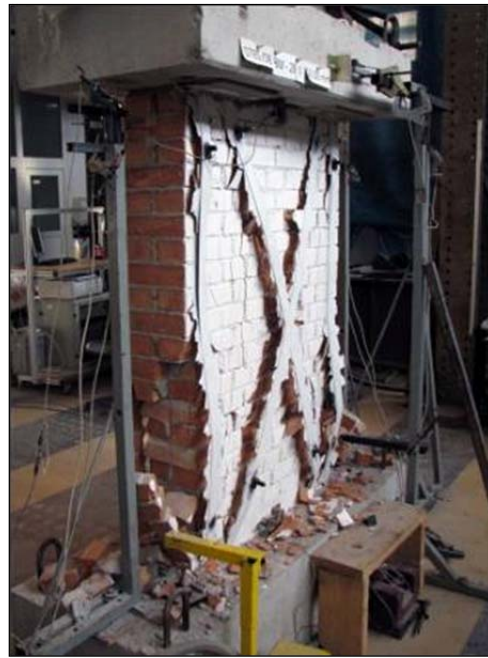
Figure 15: Brick Masonry. Delamination of CFRP Strips at Ultimate State [26]

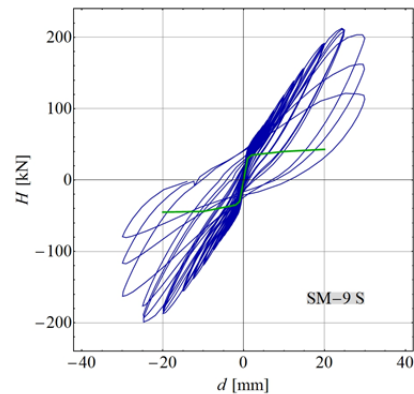
Figure 19: Stone Masonry. Strengthening With CFRP Coating is Efficient. Green: Control Wall [27]

The application of coating on only one side of the wall, although anchored in the corners, improved the resistance to a lesser degree than the application of coating on both sides of the wall. In addition, such solution did not improve the displacement capacity. However, the way of anchoring the coating, at least in the corners of walls, is important. Typical damage pattern of a coated stone masonry wall is presented in Figure 18, whereas lateral load-displacement relationships for the same wall are shown in Figure 19.
