14<sup>TH</sup> CANADIAN MASONRY SYMPOSIUM  
MONTREAL, CANADA  
MAY 16<sup>TH</sup> – MAY 20<sup>TH</sup>, 2021

OVERCLADDING TO MEET THE NEEDS OF CONTEMPORARY HOUSING IN  
TORONTO

Maschke, Ken<sup>1</sup>; Vezzoli, Daniele<sup>2</sup> and Burzynska, Katarzyna<sup>3</sup>

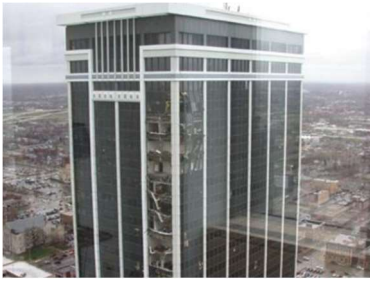
**Figure 5: One Indiana Square. Wind damage from microburst wind event.**

Wind speeds can exceed 100 mph (160 km/hr) due to microburst wind events, even in areas far from hurricane regions (ASCE-7, 2017). Figure 4 illustrates wind effects on a highrise in Indianapolis, IN. Wind codes have developed substantially in the last half-century to better reflect climate patterns and pressures at different heights and locations around a building. The overcladding attachments must therefore be designed to meet the worst case condition or reflect regions of varying design pressure.

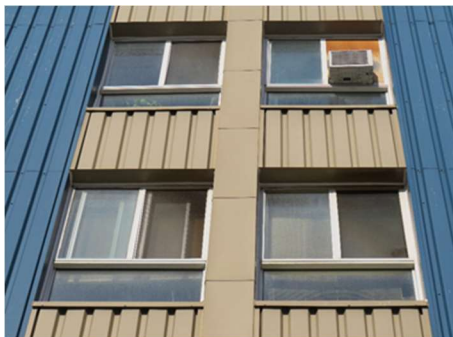
**Figure 6: St. Clair Birchmount I. Metal rainscreen assembly in front of existing brick veneer.**

However, the challenge with the metal rainscreen approach is in the detailing of all the joints and interfaces with adjacent walls and windows. At St. Clair Birchmount, we observed loose trim pieces at the parapets and at joints between sheets. There was no weather barrier above the windows lapping the joint between the insulation and the metal flashing, giving potential for moisture to accumulate behind the assembly. The cladding may have held moisture within the assembly against the face of the existing porous masonry, potentially leading to ongoing, concealed deterioration.

The rainscreen is attached to the façade with mechanical anchors. At this project, field testing yielded low breakout capacities in the backup block. The number of anchorage points would need to double the typical spacing recommended for the metal panel and porcelain rainscreens. Elsewhere we were concerned about inconsistencies in the as-built placement of anchors, and had budgeted for installation of helical ties at such conditions.

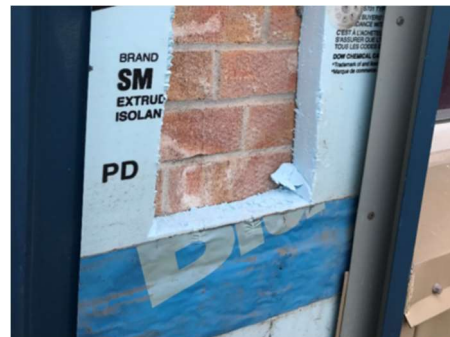
**Figure 7: St. Clair Birchmount I. Probe in existing rainscreen overcladding revealed insulation added to increase the thermal performance of the building.**

Rainscreen assemblies often include insulation and a vapour barrier which is adhered to the substrate wall. The additional insulation helps achieve the desired U-value of the exterior walls thus improving the energy efficiency of the building envelope. Vapour barrier type can be selected based on hygrothermal performance requirements as determined by the building envelope consultant. Examples of rainscreen systems include Ceramitex Sintered Compact and Sobotec SurFlex panel systems.
