EFFECTIVENESS OF POLYMER FIBERS FOR IMPROVING DUCTILITY IN MASONRY

Thomas Hervillard¹, David McLean², David Pollock³ and Cole McDaniel⁴

Washington State University, Pullman, WA 99164-2910 USA

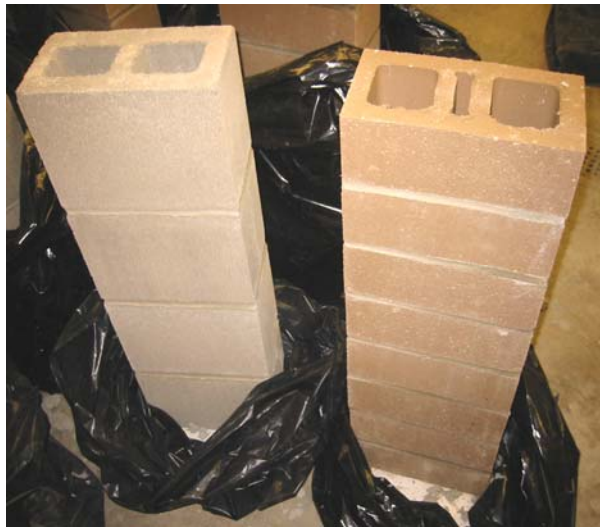
Figure 1 – Prism construction

All tests prisms were constructed by qualified masons. Bagged Type S mortar was used. Each prism was constructed on a leveled plywood board placed inside a large plastic bag used to retain moisture during curing. Grouting of the prisms was performed the day following the laying of the blocks and hollow bricks. The grout used was a bagged coarse grout conforming to ASTM C476 [5]. Grout was placed in the cells of the prisms in two lifts and received a single pass per lift from a 25 mm (1 in.) diameter vibrator to achieve consolidation. For the specimens with fibers, the fibers were added to the grout during the mixing process. No special handling, mixing

or consolidation procedures were used for the grout containing the fibers. After the vibration of the grout, the tops of the prisms were leveled and the prisms were contained in the plastic bags and allowed to cure indoors for a minimum of 28 days. Figure 1 shows a picture of the prisms during construction.

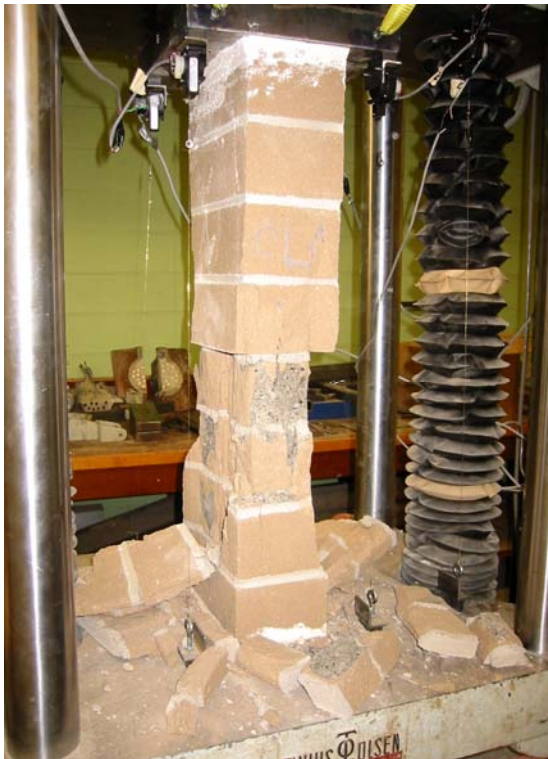
Figure 3 - Clay prism after testing

Loading of a prism specimen to failure typically was completed in less than 3 minutes. During testing, pieces of the masonry were often ejected from the prisms in an explosive manner. Prisms made of concrete blocks generally exhibited a more gradual failure compared to failure in the brick prisms. Before collapsing, a crunching sound was audible for most of the prisms. Prisms without fibers typically developed vertical splitting and face shell spalling during testing. Damaged regions developed over a large portion of the specimen length and typically included damage to the grout cores. Failure in the prisms with fibers tended to extend over a smaller portion of the specimen length. In most cases, the fiber-reinforced grout cores remained intact even after the masonry had spalled away. Figures 3 and 4 show typical failures in the clay and concrete prisms, respectively.

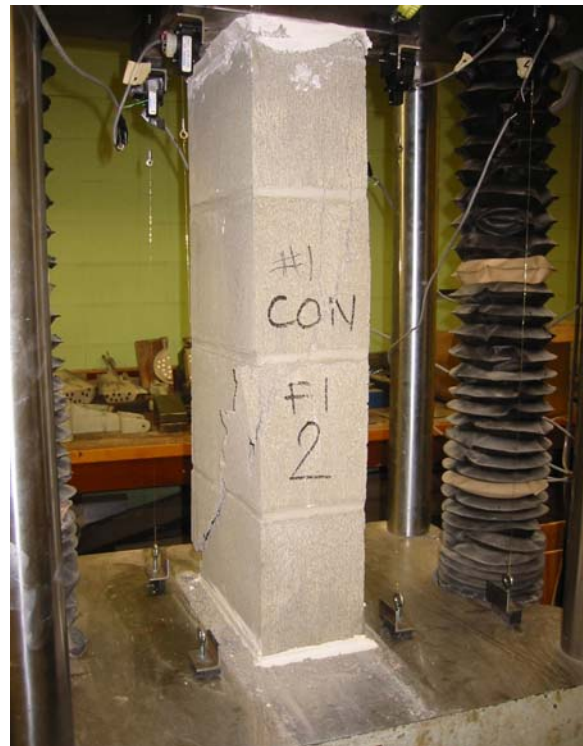
Figure 4 – Concrete prism after testing

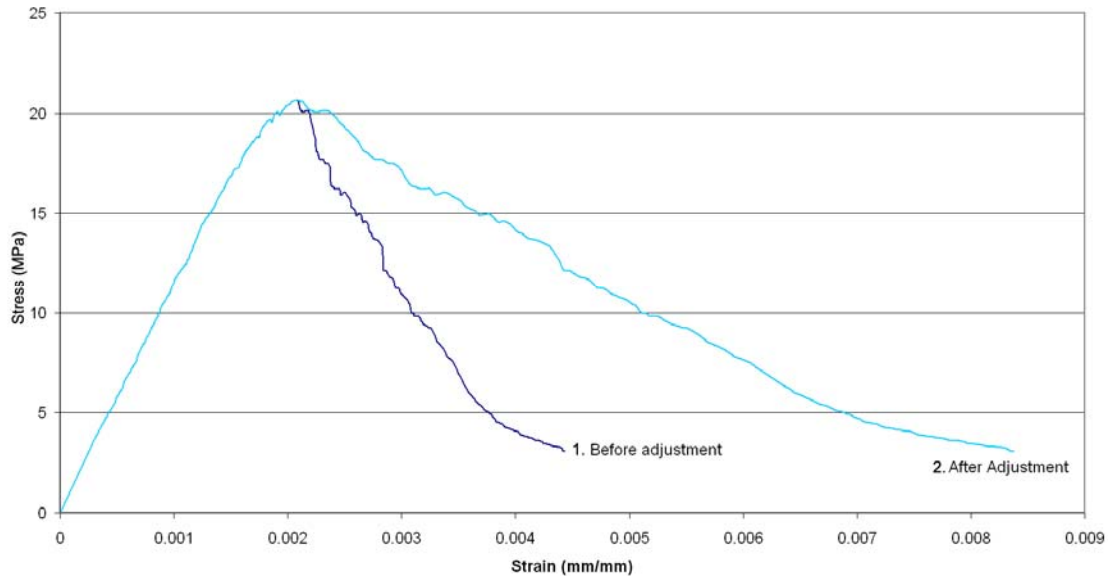
Figure 6 - Stress-strain curve adjusted for undamaged regions (1 MPa = 145 psi)

An additional correction to the prism strain computation was made to account for the confinement provided by the upper and lower platens bearing on the prism ends, similar to the procedures used by Priestley and Elder [2]. Observations made during testing as well as photographs of each prism were used to define the region over which damage occurred. Undamaged prism material was assumed to unload according to the initial prism stiffness and contribute added strain to the damaged prism region. Corrected damaged zone strain values were computed and plotted with the uncorrected average total strains, as shown in Figure 6.
