USE OF FIBRE REINFORCED POLYMER TO ENHANCE THE SLIDING SHEAR RESISTANCE OF UNREINFORCED CONCRETE MASONRY

Frank Campanaro¹ and Robert Drysdale² and Ahmad Hamid³

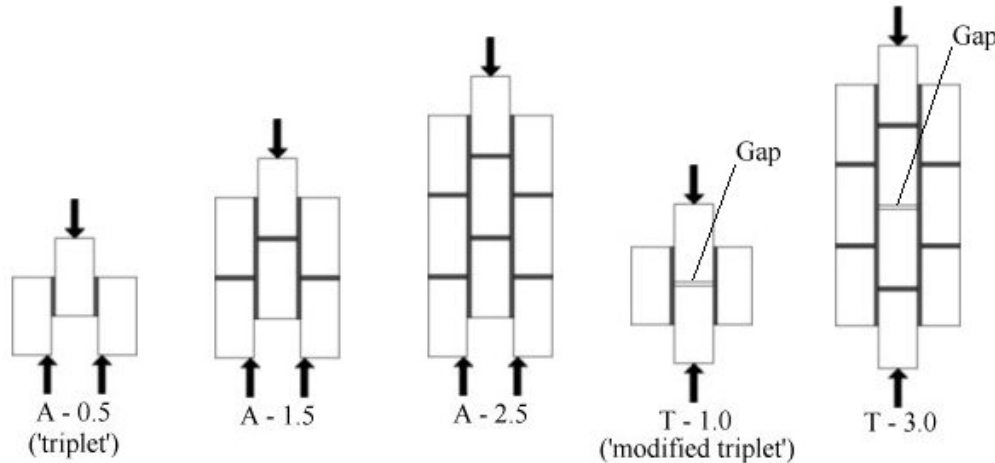
In this preliminary investigation, 40 specimens were constructed using standard 20 cm hollow concrete blocks and Type-S mortar. These specimens, as can be seen in Figure 1, are simply modifications of the “triplet” and “modified triplet” used in past studies [4] to determine the shear-slip resistance along mortared bed joints. The modified triple shape provided symmetry about the midheight above and below the gap provided to permit slip.

Figure 1 - Test Specimens and Loading Conditions

For later reference, note that the designation for each specimen begins with the letter ‘A’ or ‘T’. The letter ‘A’ indicates the specimen is a ‘triplet’ or a variation of it, and the letter ‘T’ indicates the specimen is a ‘modified triplet’ or a variation of it. The next letter in the designation is ‘U’ or ‘R’ which stand for unreinforced or reinforced, respectively. Reinforced specimens had a bi-directional $0^{\circ}/90^{\circ}$, 0.25 mm thick Glass-FRP (GFRP) sheet with 2.55 g/cm^3 density of E-glass fibres bonded to both faces using epoxy. The next number in the designation indicates the length of the mortared bed joint as a multiple of the number of blocks. The last number is simply the specimen number. Five specimen shapes were selected and eight of each were constructed. Out of each eight specimens only three were reinforced with GFRP. The type of GFRP reinforcement was kept constant so that the performance of each shape could be directly compared. Four specimens were damaged and were not tested.

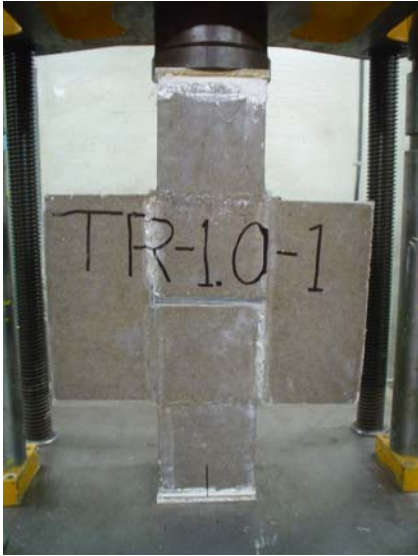
Figure 2 – Test of Smaller Specimens Using Test Machine

The specimens were tested under monotonically increasing compression loading. The smaller specimens (i.e. A-0.5, A-1.5, T-1.0) were tested in a Tinius Olsen testing machine, as seen in Figure 2. For the larger specimens (i.e. A-2.5, T-3.0) it was necessary to construct a customized testing apparatus, as seen in Figure 3. The apparatus consisted essentially of two steel columns, a spreader beam and a 50 mm (2 inch) thick steel top bearing plate. The load was applied using a hydraulic cylinder, with a 1779 kN (400,000 lbs.) maximum capacity. The load was monitored using a commercial load cell.

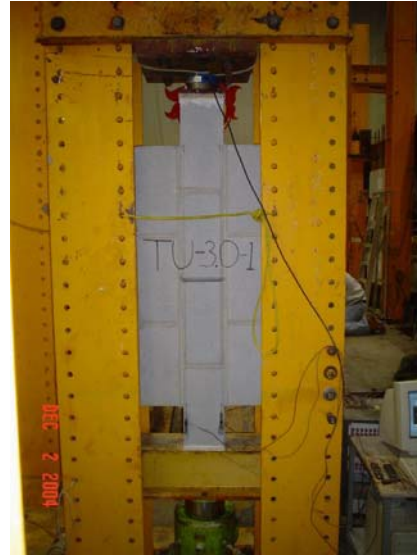
Figure 3 – Test of Larger Specimens Using Customized Testing Apparatus

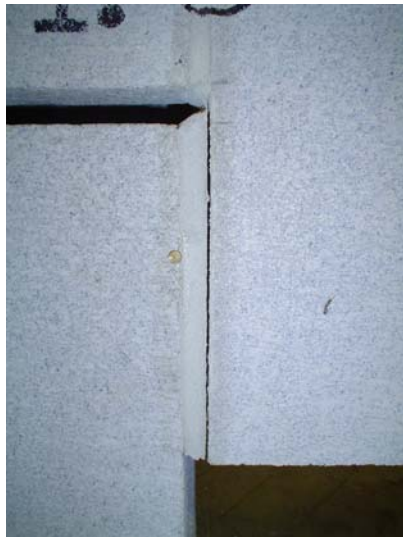
Figure 4 – Unretrofitted

Failure of the unretrofitted specimens was a brittle shear-slip debonding mode that occurred at low levels of both load and displacement. The debonding occurred at the interface between the block and the mortar, as shown in Figure 4. This failure mode is typical considering the weak shear bond strength of the mortar and the absence of compressive stresses normal to the mortar

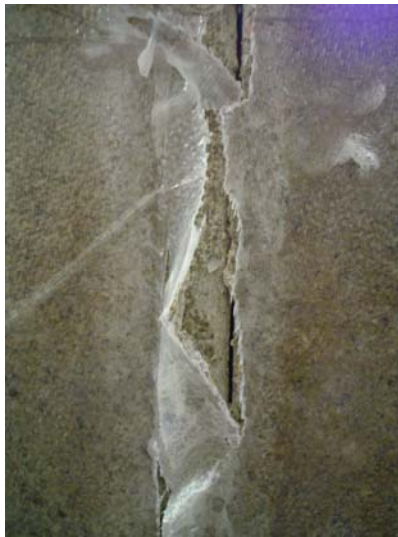
Figure 5 – GFRP Failure

All of the reinforced specimens, with one exception, failed in shear slip along the bed joints but at much higher loads. As shown in Table 2, they reached shear slip strengths ranging from 3.2 to 7.7 times that of their unretrofitted counterparts. Upon examining the failed specimens it was discovered that the mortar joints were damaged and thus the laminates were resisting the entire applied load. For all of the retrofitted specimens, at large slip displacements, the laminate became entirely torn, as shown in Figures 5 and 6, and could not resist further loading. Failure by delamination did not occur with any of the specimens. The exception to the above description was specimen type AR-2.5 which consistently failed by toe crushing. The laminate was undamaged and, therefore, the strength is only a lower bound estimate of shear-slip capacity.

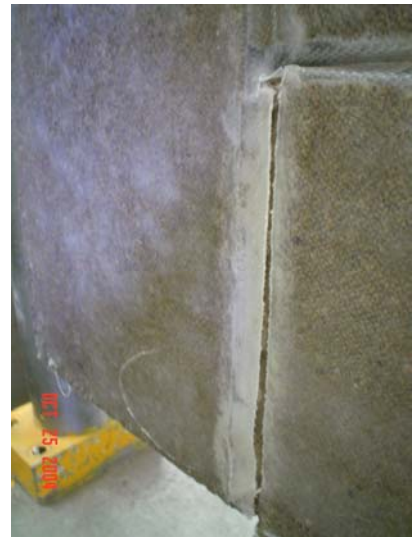
Figure 6 – GFRP Failure

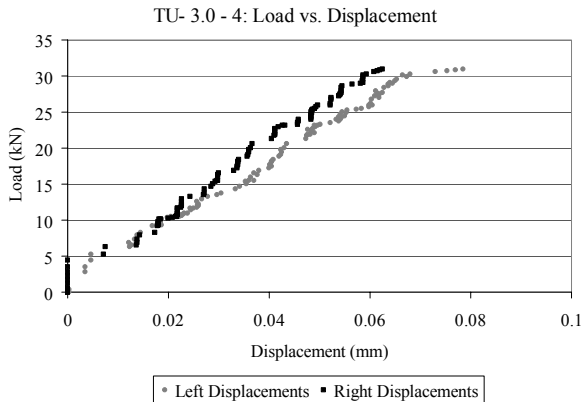
Figure 7 – Load-Displacement Data for Specimen TU-3.0

Typical load versus displacement behaviour of the unreinforced specimens can be seen in Figure 7, for specimen TU-3.0. These specimens exhibited a sudden, brittle loss of capacity for their maximum stress at an average slip of 0.051 mm. In comparison, after retrofitted assemblages reached their respective maximum loads, a gradual decrease in load occurred, as shown in Figure 8, for specimen TR-3.0. This greatly increased deformability and ended with the eventual tearing of the GFRP laminate. The experimental and analytical work conducted by Ehsani et al. [1] revealed that when FRP fibres were oriented at 0°/90° to the applied load, the resulting shear-deformation relationship was nonlinear. This was shown to be the case here.

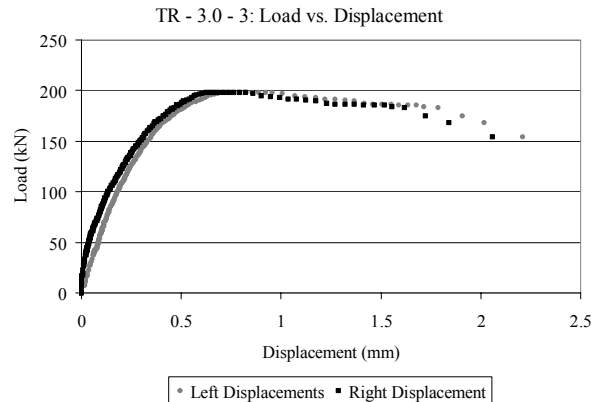
Figure 8 – Load-Displacement Data for Specimen TR-3.0

For the illustrated specimens, the average shear slip displacement at the maximum shear stress was 0.772 which is in excess of 15 times that of its unretrofitted counterpart. The average maximum displacement was 6.6 mm.
