## EXPERIMENTAL STUDY OF PARTIALLY GROUTED CONCRETE MASONRY WALLS WITH OPENINGS

K.C. Voon<sup>1</sup> and J.M. Ingham<sup>2</sup>

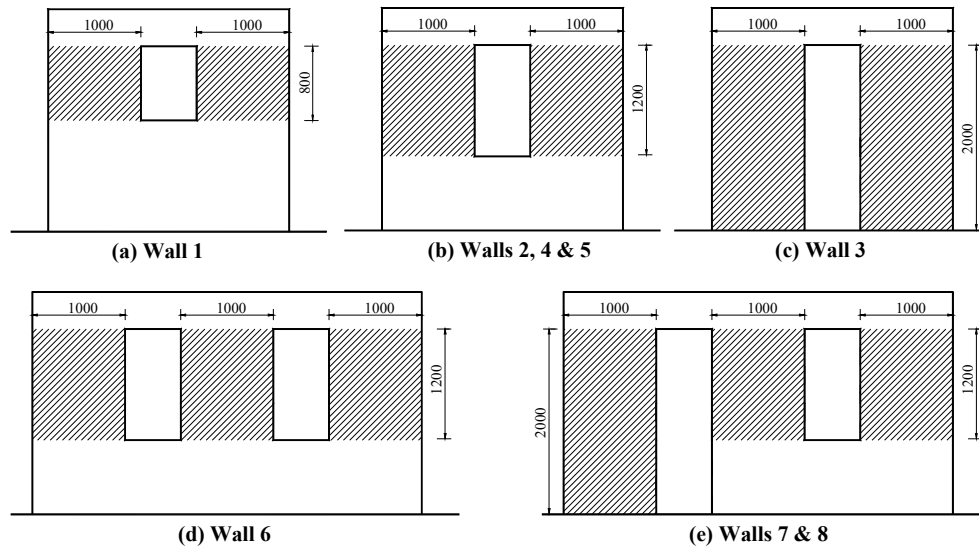
Recalling that NZS 4229:1999 is primarily targeted for use by architects and draftspersons, rather than structural engineers, a simplified procedure was adopted for the assessment of bracing capacity. The strategy employed in NZS 4229:1999 for proportioning bracing capacity is primarily dependent on wall geometry. The assumption was that the bracing capacity of a masonry wall having penetrations could be determined based on the geometry of individual bracing panels, as demonstrated by the shaded areas shown in Figure 2, where the bracing capacity geometry of each bracing panel is based upon the vertical dimension of the smallest adjacent opening. The total bracing capacity is then assumed to be the sum of the capacities provided by the individual bracing panels of the wall. From Table 1, it is evident that the wall bracing capacity increases as the panel length increases, but diminishes as the panel height increases. This prompted some observers to comment on the influence which a small wall opening would have, as this would effectively generate two bracing panels with a small height,

**Figure 2 – Identification of Bracing Panels**

rather than a single panel that is taller and longer, such that it is conceivable that the addition of a small wall opening might result in the evaluated capacity of the wall to increase.

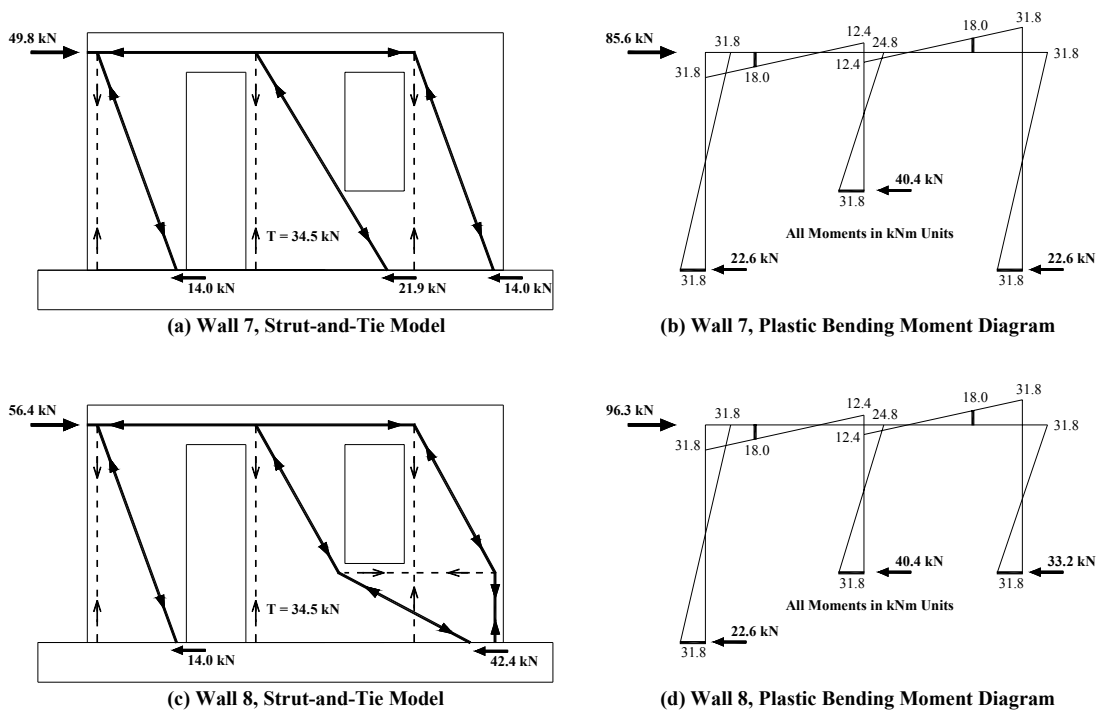
Due to the presence of openings in the test specimens, Equation 1 was deemed to be inappropriate for evaluating the nominal lateral strength of the test specimens. Consequently, a strut-and-tie model and a plastic hinge model were employed to evaluate the wall strengths. A simple illustration of these two models for Walls 7 and 8 are shown diagrammatically in Figure 3. For the strut-and-tie model, it was assumed that all panels were pinned at the bond beam centre. The resultant strut-and-tie analyses are presented in Figures 3a and 3c, where the struts are indicated by a broader element thickness. It is also illustrated in Figure 3c that the introduction of extended lintel reinforcement beneath the window in Wall 8 would result in an increase in wall strength, due to change of slope of the strut component in the right hand side panel. Please note that the model shown in Figure 3c would not be applicable when the force was reversed because the lintel reinforcement below the window was not extended to the door.

As for the plastic hinge model, the wall was treated as a frame comprising of three vertical piers in order to develop the plastic bending moment diagram shown in Figures 3b and 3d. By conducting a push-over or plastic collapse analysis, it was found that the flexural strength at the base of each pier was developed, but that the moments at the top of the frame were largely governed by the lintel strength.

Figure 3 – Strut-and-Tie and Plastic Hinge Model

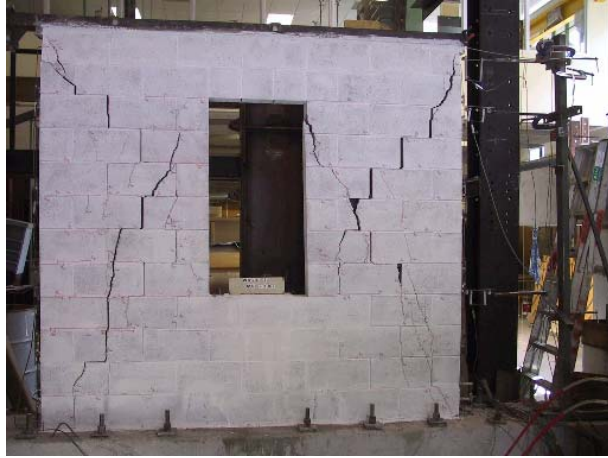
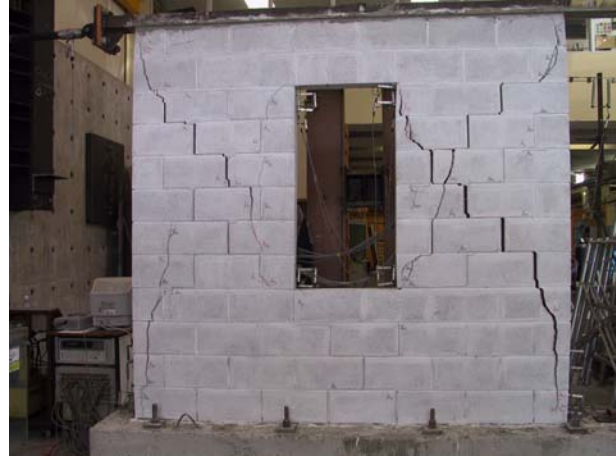
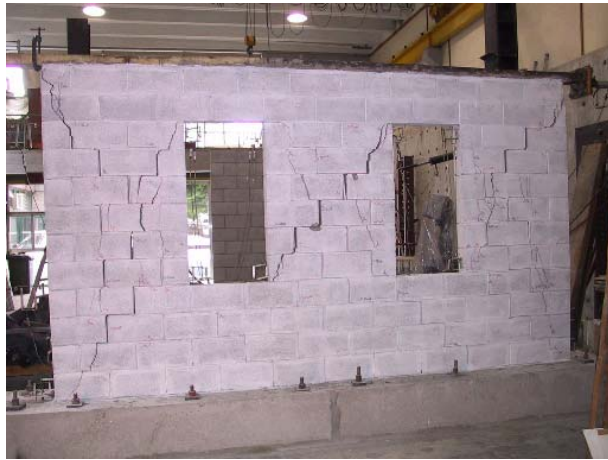
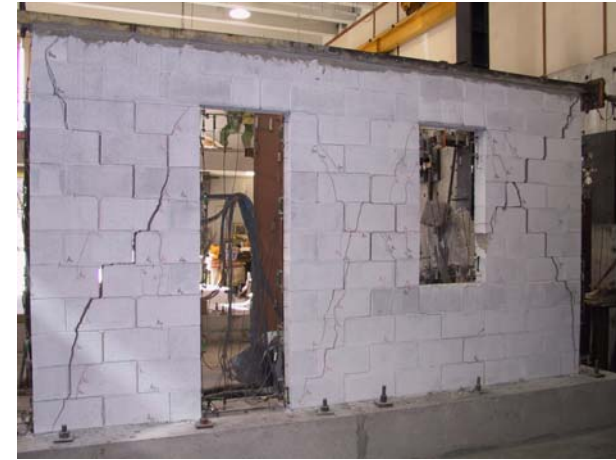
Due to the lack of distributed horizontal shear reinforcement, all walls were observed to fail in a diagonal tension mode. This type of failure was characterised by the development of early flexural cracking, which was later exaggerated by diagonal cracking that extended throughout the wall panels. As shown in Figure 4, the diagonal cracking patterns align well with the load paths by which shear force is transferred to the foundation in the strut mechanism. Furthermore, vertical compressive cracks similar to the vertical strut shown in Figure 3c, were also identified beneath the lintel reinforcement in Walls 4 and 8. These observations further support the use of strut-and-tie analysis as the tool to evaluate the strength of walls with reinforcement details similar to those shown in Figure 1.

As shown in Figure 4, the absence of major damage in the solid grout-filled bond beam supported the notion of frame-type action being developed at later stage of the test. This leads to the considerable inelastic displacement capacity of the partially grout-filled walls where  $\mu_{av}$  was measured to consistently be above 2.0.

**Figure 4 – Cracking Patterns in Test Specimens**

4. The diagonal cracking patterns align well with the load paths by which shear force is assumed to be transferred to the foundation in the strut mechanism. This observation supported use of strut-and-tie analysis as the tool to evaluate the strength of nominally reinforced masonry walls with openings.
5. NZS 4229:1999 was found to over-predict the strength capacity of the wall containing a small opening. The conservatism of NZS 4229 would increase when the depth of opening is increased or the length of lintel reinforcement is extended below an opening.

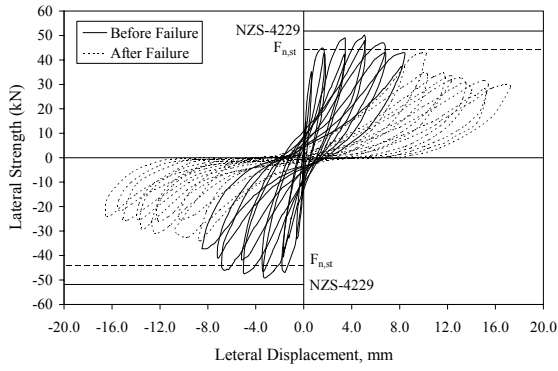
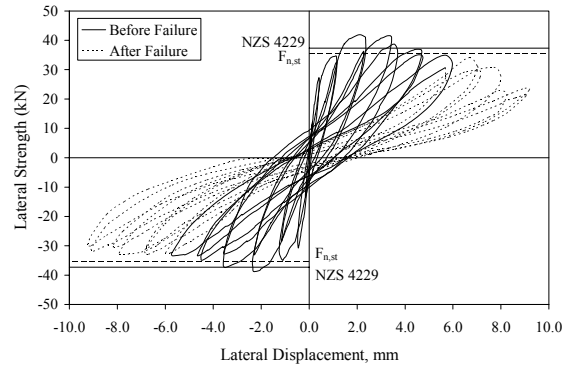
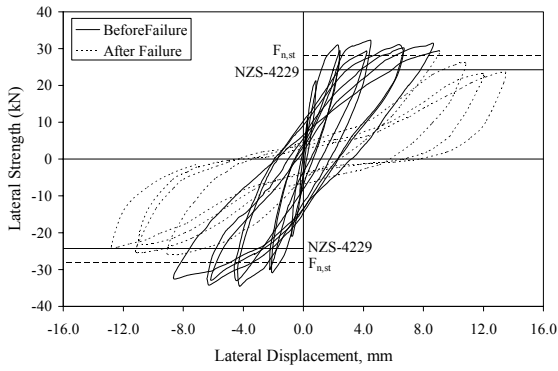
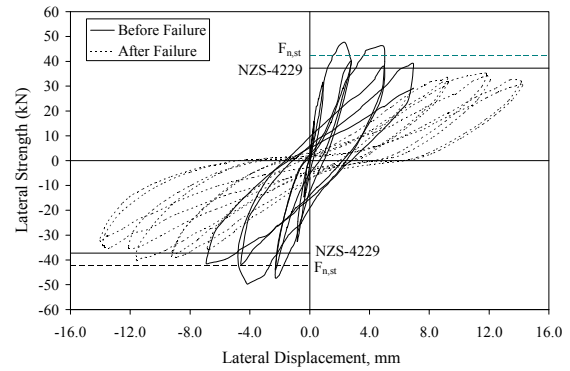
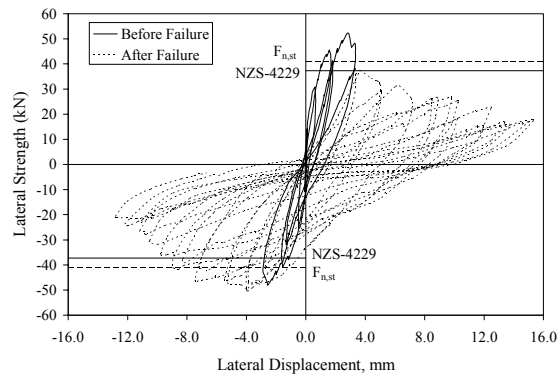
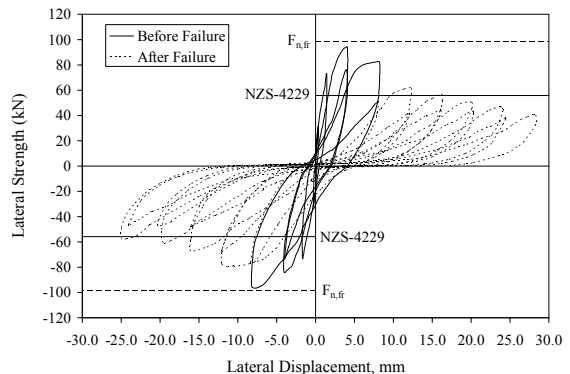
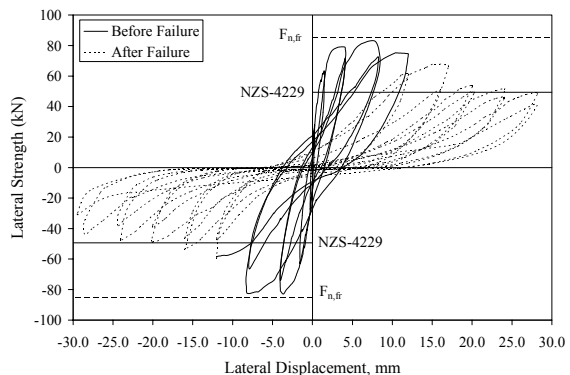
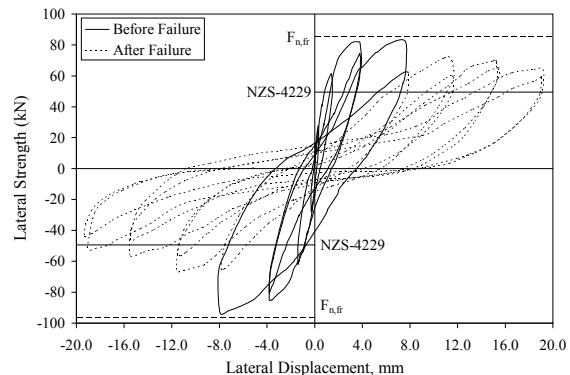
The force-displacement response derived from the eight wall tests are shown in Figure 5. In all cases, the first loading excursion was into the positive quadrant. The nominal strength,  $F_n$ , of each wall (derived using strut-and-tie analysis or plastic collapse analysis) is also included in these plots, along with the strength value (denoted NZS-4229) derived from NZS 4229:1999. Also shown in these plots is the theoretical failure point, corresponding to the cycle in which the peak strength failed to exceed 80% of the maximum previously attained strength.

From the force-displacement responses presented in Figure 5 a number of general characteristics can be identified:

1. The maximum strength was typically developed during the first excursion to  $\mu = 4$ . Following this, cracking became significant in some walls and strength degradation began.
2. The partially grouted concrete masonry walls detailed in Figure 1 exhibited gradual strength degradation and in no case did any wall suffer from sudden failure. This desirable behaviour of the nominally reinforced partially grout-filled masonry walls with openings was created by the solid filled bond beam at the top of the walls, which caused a frame-type action at latter stage of testing.

3. The force-displacement plots consistently illustrated a pinched shape. This was primarily due to the presence of significant shear deformation in this type of masonry construction.
4. Less hysteretic energy was expended during the second cycle to any displacement level, when compared with the first displacement cycle. This is illustrated by the more pinched hysteresis loops of the second cycle.

**Figure 5 – Force-Displacement Response of Masonry Walls**

1. Based on test results of the eight concrete masonry walls with openings presented in Table 2 and Figure 5, it was concluded that considerable inelastic displacement capacity could be developed for partially grout-filled nominally reinforced masonry walls having penetrations.
2. The partially grouted masonry walls exhibited gradual strength degradation after the peak wall strength was developed.
3. When evaluating the strength of partially grouted masonry walls containing openings, it is recommended to neglect the development of frame action occurring due to the presence of the solid filled bond beam. Instead, strut-and-tie models should be employed in the analysis process.
