## STRENGTHENING OF MASONRY COLUMNS WITH SPRAYED GLASS FIBRE REINFORCED POLYMER (SGFRP)

E. Shaheen<sup>1</sup> and N.G. Shrive<sup>2</sup>

### ABSTRACT

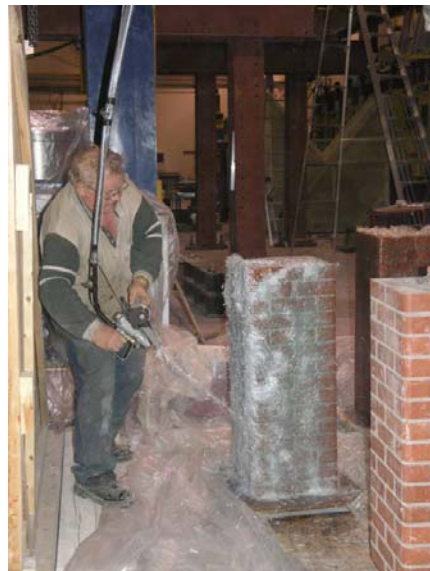
Spraying is shown in Figure 3. After the FRP had cured, the columns were trimmed to remove excess GFRP, and the columns capped using Plaster of Paris.

**Figure 3 – GFRP spray process**

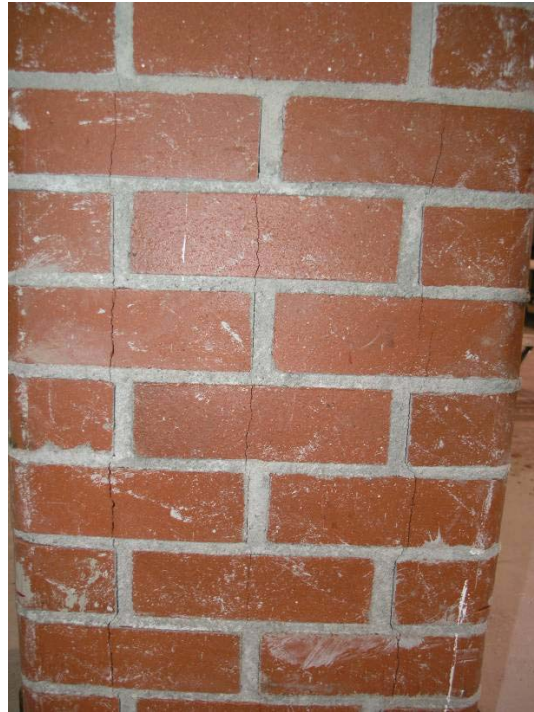
Six un-sprayed specimens were tested and all (plain or reinforced) behaved in a similar manner. Vertical cracks initiated at the four column sides, at mid-height (Figure 4). Cracks then

**Figure 4 – Cracking in a plain column**

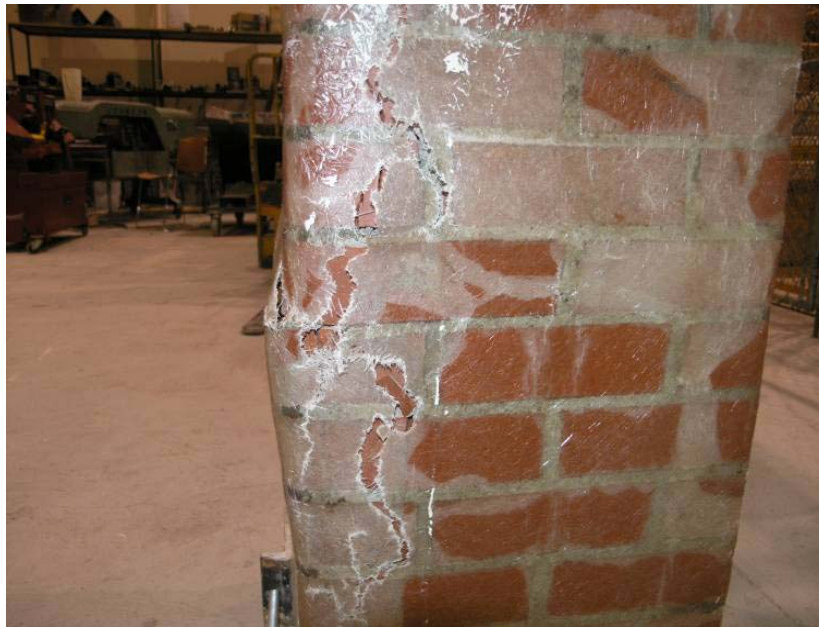
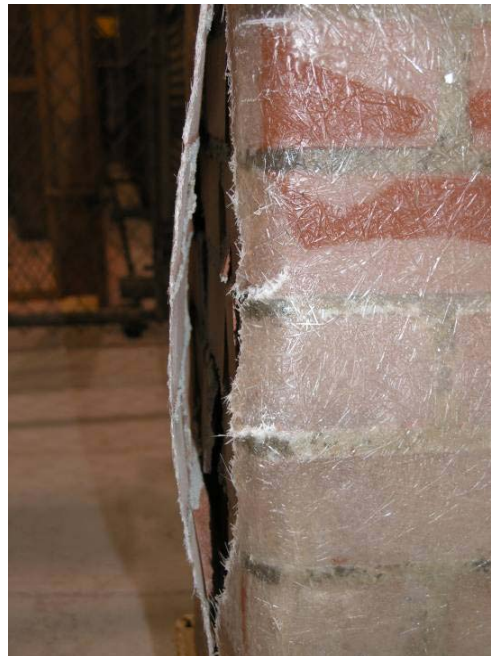
All GFRP sprayed columns failed similarly. The SGFRP started to debond before failure, followed by tearing of the laminate as the masonry tried to punch out. The tearing of the SGFRP was a combination of Mode I and Mode III cracking, as shown in Figure 7. Failure loads, stresses and strains are given in Table 4. Overall there was marginal increase in strength between columns with 2 mm and 4 mm thick SGFRP, the small difference being related to the inconsistency in the spraying process.

**Figure 7 –Failure of SGFRP laminate in AP2 (above) showing a mix of Mode I and Mode III cracking and BP4 (below) showing only Mode III**

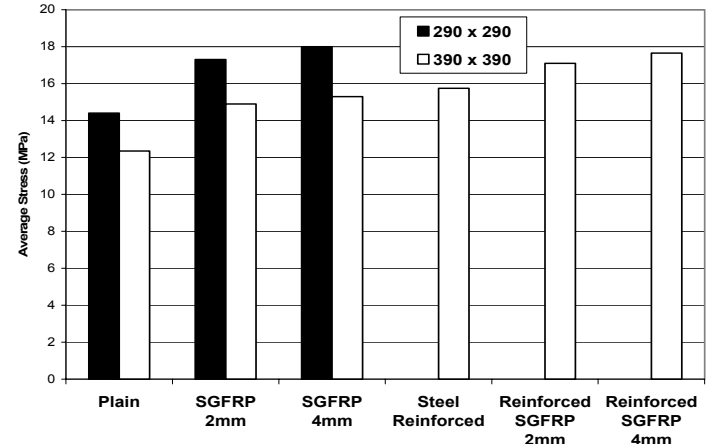
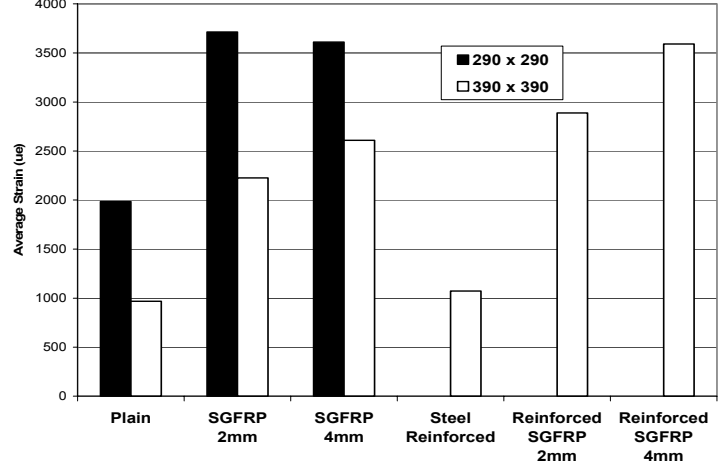
**Figure 9 – Average ultimate load, stress, and strain for all columns.**  
**(a) Ultimate load for plain, reinforced, and SGFRP;**  
**(b) Ultimate stress for plain, reinforced, and SGFRP;**  
**(c) Ultimate strain increase for plain, reinforced, and SGFRP.**

For the small masonry columns, the spraying of GFRP increased load capacity 19-21 % for Plain/SGFRP 2 mm specimens, and 23-28 % for Plain/SGFRP 4 mm. Again a slight increase in load capacity was obtained for the thicker layer of GFRP, and higher capacity was observed for steel-reinforced specimens. As with the larger specimens, strain capacity was increased for all specimens, compared to control ones. The increase was in the range of 82-93 % for Plain/SGFRP 2 mm specimens and 69-97 % for Plain/SGFRP 4 mm. A typical load-deflection curve for a SGFRP specimen is shown in Figure 8. Increases are shown in Figure 9.

The load-displacement curves of all columns showed an initial approximately linear phase followed by strain softening. In general, external spraying of the masonry columns with GFRP resulted in a remarkable increase in ultimate strain, a decrease in stiffness, and slight increase in strength and ductility. Despite the difficulty controlling the degree of cracking in each test, the following trends can be deduced from Figure 9:

- The ultimate loads of columns sprayed with GFRP did not increase substantially except in the case of 390 x 390 mm columns with a nominal 4 mm thick SGFRP.
- Loads increase with increasing SGFRP thickness, and with the use of steel-reinforcement.
- Average stress decreases with increasing column cross-sectional area.
- Large increases in ultimate strain were obtained for all specimens with SGFRP confinement.
- Spraying GFRP is a relatively easy technique of providing significantly increased strain capacity and small strength increases to concentrically loaded masonry columns.
- Further tests need to be performed to determine if the same benefits are observed under eccentric loading.
