## STRENGTHENING AND HAZARD MITIGATION OF URM WALLS USING FRP

An experimental investigation was conducted to study the behaviour of unreinforced masonry (URM) walls retrofitted with composite laminates. Five masonry-infilled steel frames were tested with and without retrofit. The composite laminates increased the stiffness and strength and enhanced the post peak behaviour by stabilizing the masonry walls and preventing their out-of-plane spalling. Tests reported in this paper demonstrate the efficiency of FRP laminates in improving the capacity of URM containing the hazardous URM damage, preventing catastrophic failure and maintaining the wall integrity even after significant structural damage.

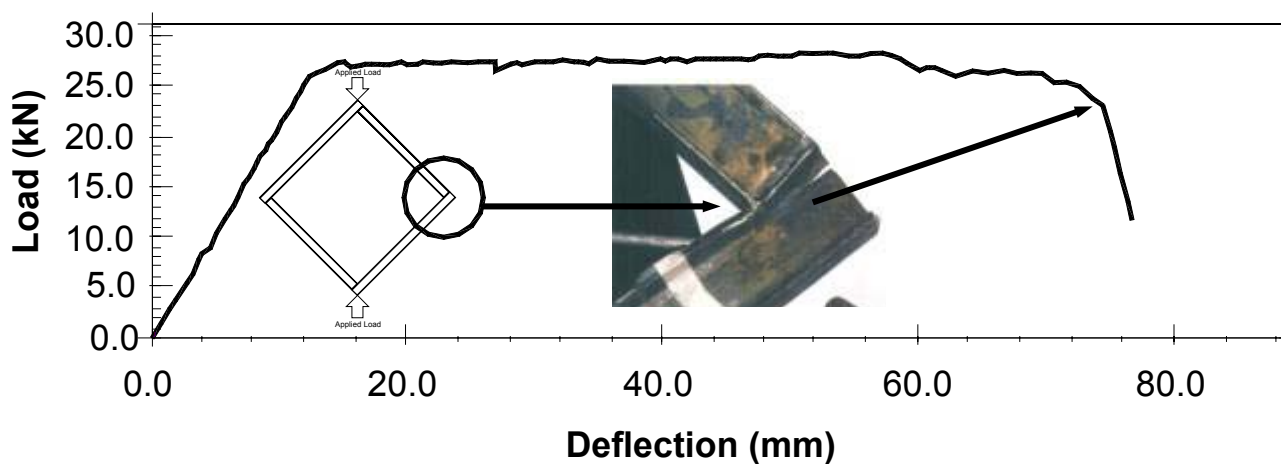
Figure 2 - Load-deflection relationship for frame WB

As expected, the frame joints underwent severe rotation and distortion and behaved in an elastic-perfectly plastic manner. Both joints along the tension diagonal experienced tearing of the webs as shown in Fig. 2, and the frame suffered permanent (i.e., plastic) deformations. The initial stiffness obtained from the load-deflection curve (Figure 2) was 2.2 kN/mm. A linear behaviour was observed up to a load of a 25.8 kN corresponding to an average top displacement of 11.9 mm. Subsequently, a load plateau of 27.0 kN was attained at a top displacement of 14.0 mm. Attributed to the strain hardening effects, a slight increase in load occurred resulting in an ultimate load of 28.3 kN. The actual load-deflection behaviour closely resembles the expected behaviour in which an initial linear response occurs until initiation of yielding followed by a plateau then a slight load increase to attain the ultimate failure load.

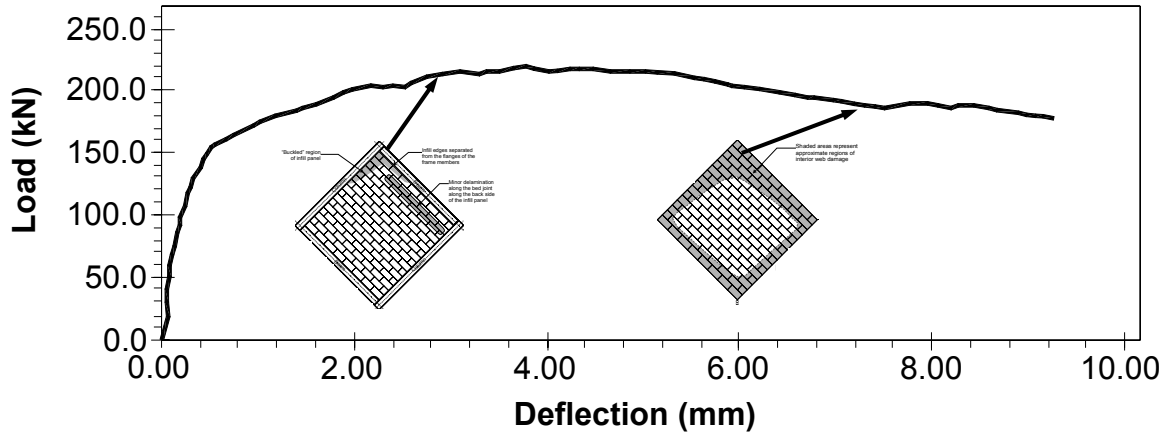
(a)

**Figure 4 - Frame WR: a) Load-deflection relationship; b) out-of-plane wall burst; and c) extent of web splitting**

The load versus deflection curves for the WR frame is shown in Figure 4-a. The maximum load attained by the frame was 218.9 kN which represents increases of 7.7 times and 2.2 times the maximum loads attained by the WB and WU frames respectively. At a load of 182.4 kN corresponding to 83.3% of the maximum load-carrying capacity, some hairline cracks were observed in the blocks near the vicinity of the top loading shoe. These cracks were visible underneath the clear laminate adhered on the exterior of the masonry infill panel. As the load began to decrease, cracking noises and clicks were heard until suddenly at a load of 175.1 kN, corresponding to 80.0% of the ultimate load on the descending branch of the load curve, the interior webs near the top portion of the infill panel were damaged causing the separated retrofitted face shells near the top loading shoe to snap outwards and moved outside the flanges of the frame members (Figure 4-b). Unfortunately, shortly before and after this outward “burst,” the buckled face shell brushed against the main and infill compression LVDTs, thus preventing further recording of displacement.

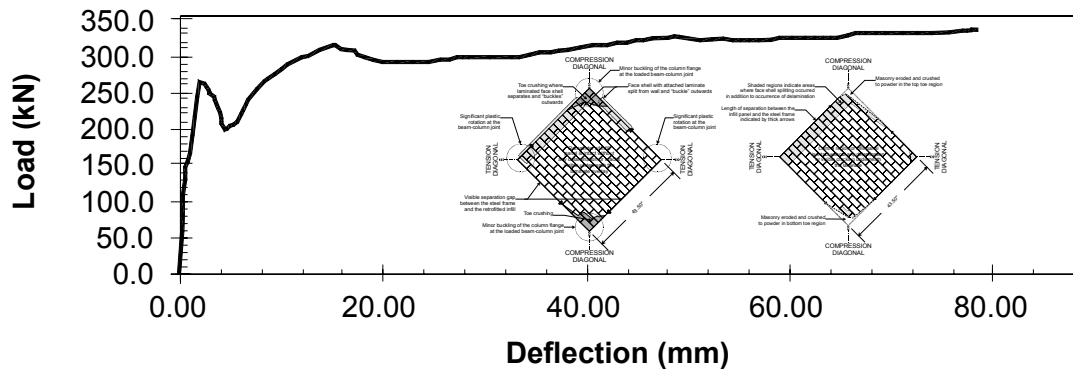
(a)

**Figure 6 - Frame SR: a) Load-deflection relationship; b) Damage progress at top loaded corner; and c) Damage progress at bottom loaded corner d) Final damaged configuration**

Figure 6-a shows the load-deflection relationship of the SR frame. The SR frame's maximum load capacity was 343.0 kN and an initial stiffness of 262.7 kN/mm. At a deflection of 1.98 mm, the load increased until it reached the first peak of 270.1 kN. At this point, a loud bang was heard and crushing at the top loaded toe of the infill panel was observed. As in the retrofitted assemblages, crushing at the top toe of the retrofitted masonry infill panel involved damage of the interior webs leading to the laminated face shells snapping outwards. The damage extended along the infill-frame boundary for a length of approximately six courses (three block-lengths) and only one course wide (one half a block-length). A consequential loss in load capacity
