IMPACT PERFORMANCE OF FULLY GROUTED CONCRETE MASONRY WALLS

ABSTRACT

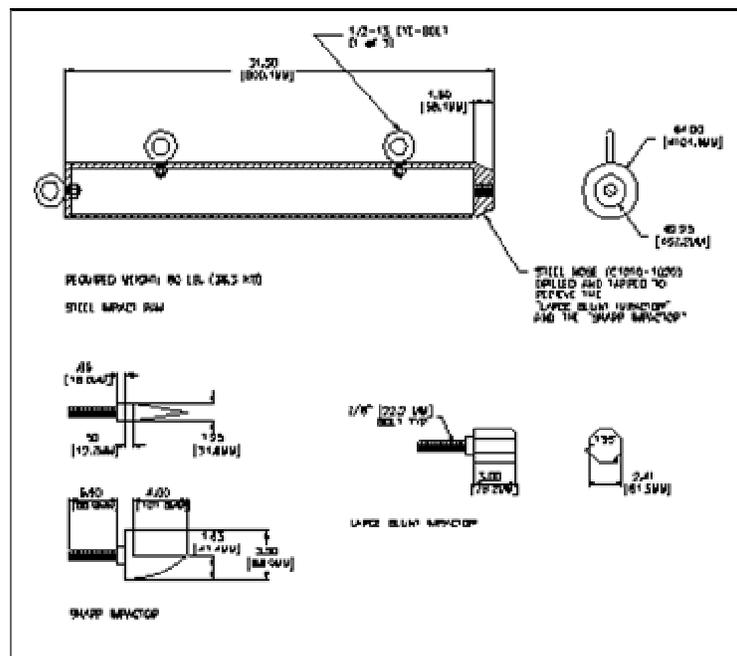
Figure 1 - Pendulum Testing Ram Apparatus

Attack is simulated via a series of impacts from a pendulum testing ram apparatus shown in Figure 1. The testing ram is fitted with two heads: a blunt impactor to simulate a sledgehammer and a sharp impactor simulating a fireman's axe. The testing protocol calls for blows from both the blunt and sharp impactors, applied in sequences of 50 blows each.

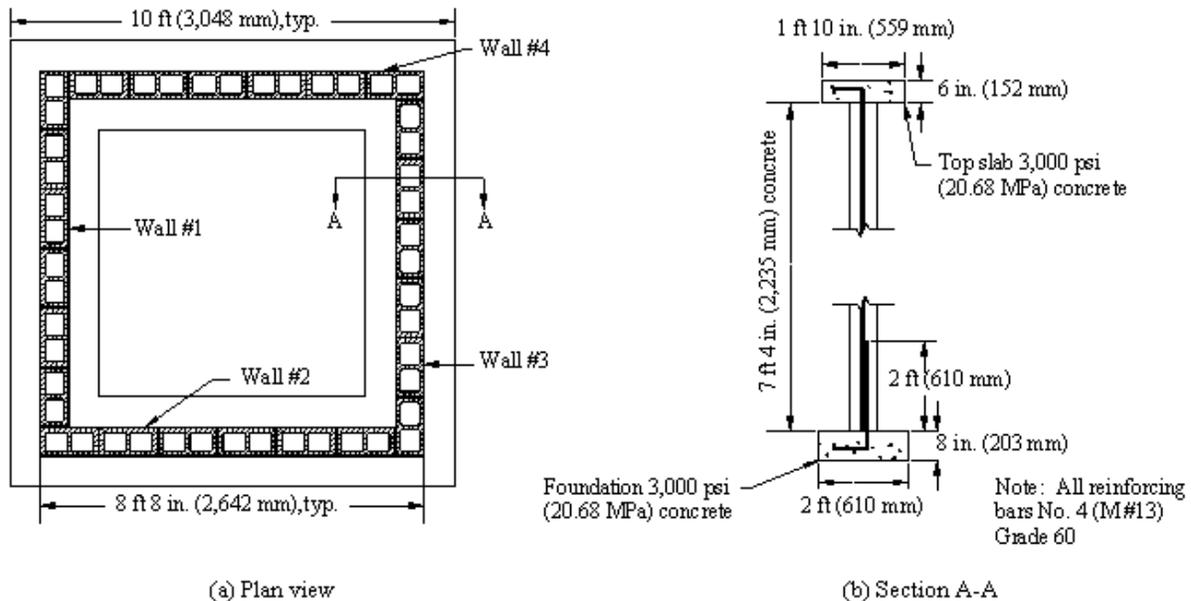
Figure 2 - Details of Prison Wall Test Panels

Typical wall construction provided stiffness at both the top and bottom of the wall through interconnection with the foundation below and the floor slab above. Rather than constructing individual flat wall panels with a foundation below and a slab above, as well as end returns (simulating stiffness provided by wall intersections), a four-sided closed cell was constructed. Each wall was reinforced vertically with a 13 mm (No.4) Grade 60 (400 MPa) reinforcing bar in each grouted cell of the CMU. Details of the foundation, top slab and individual walls are provided in Figure 2.

The foundation was constructed first with 13 mm (No.4) Grade 60 vertical dowels placed at 203 mm (8-inch) spacing and two 13 mm (No.4) Grade 60 horizontal reinforcements around the

entire perimeter of the foundation. Once the foundation concrete was placed and allowed to sufficiently cure, the four individual walls were constructed. Every CMU cell in all four walls was reinforced vertically with a 13 mm (No.4) Grade 60 reinforcing bar. Grout was placed and vibrated using a 19 mm (¾ inch) mechanical vibrator. The entire grouted assembly was cured in ambient conditions for 28 days prior to initiation of impact testing.

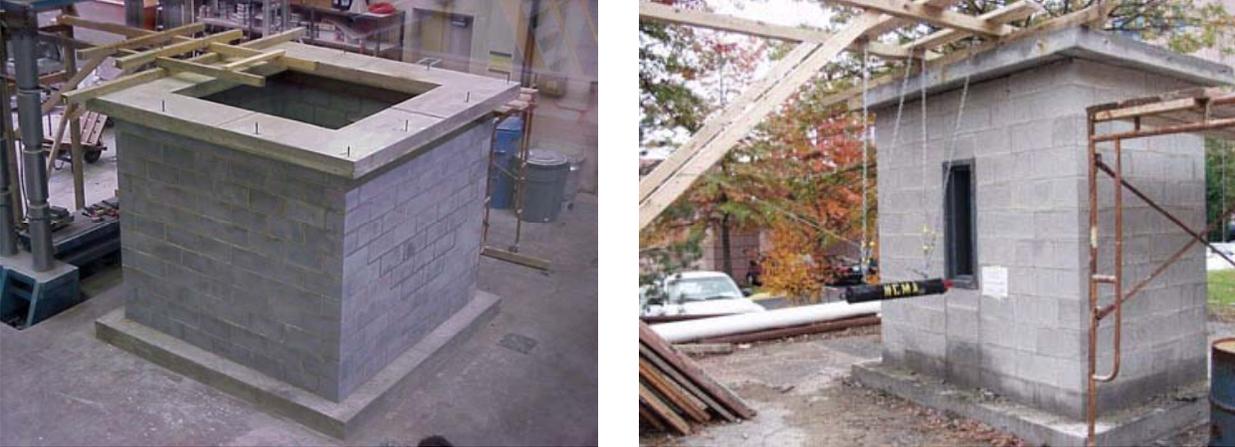
Figure 3 – Prison Impact Test Walls

this impact testing was to check the integrity of the frame-to-masonry connection by striking at a corner of the window frame. Figure 3 shows the prison impact test walls. Figure 4 shows a detail of the window frame.

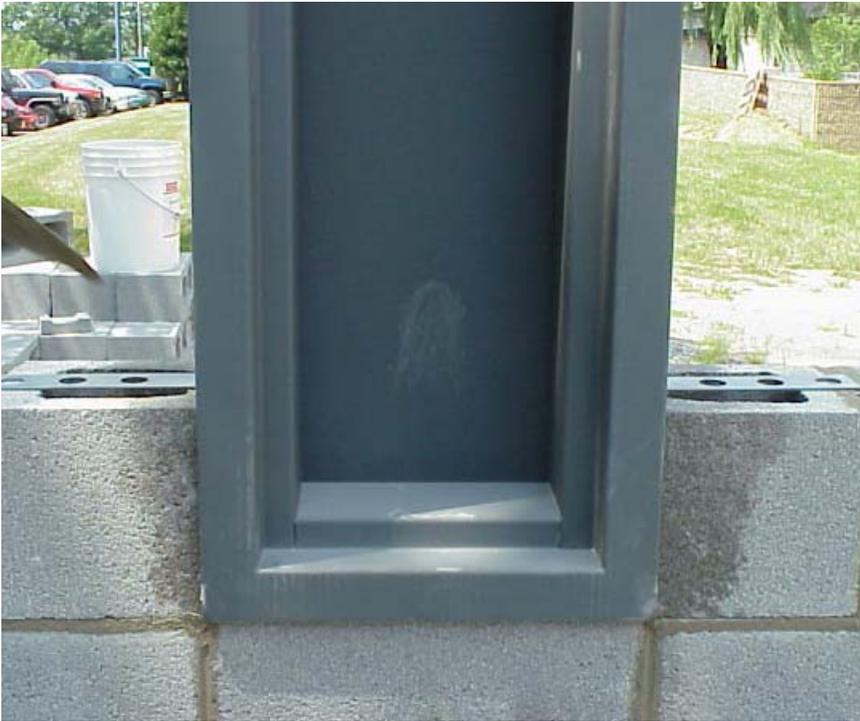
Figure 4 – Detail of Window Frame

For the panel with the typical prison window frame, the window frame was manufactured to meet *Guide Specifications for Detention Security Hollow Metal Doors and Frames*, ANSI/HMMA 863 [4] as required by ASTM 2322. The nominal dimensions of the frame were 356 mm wide, 965 mm high, with a jamb width of 222 mm (14 x 38 x 8 ¾ in). The window frame was constructed of 6.4 mm (¼ in) thick steel. The frame came equipped with masonry anchors that accommodated the vertical reinforcing bars in the masonry and then were attached to the window frame. Once installed, the hollow area at the jamb was grouted solid. The intent of

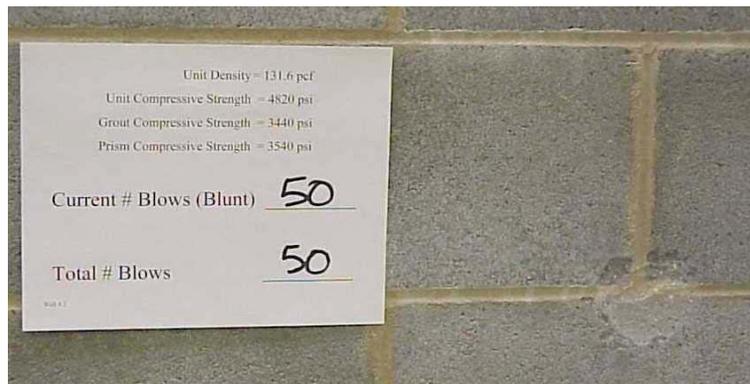
Figure 5 – Test Wall Assembly after 50 Blows

Starting with the blunt impactor, the target area was hit with a series of 50 blows. The sharp impactor was used for the next series of 50 blows and the blunt and sharp impactors were subsequently alternated in 50 blow increments until an opening large enough to achieve forcible egress was produced. Figure 5 shows the target area and the amount of damage after 50 blows. All wall assemblies showed similar damage after 50 blows.

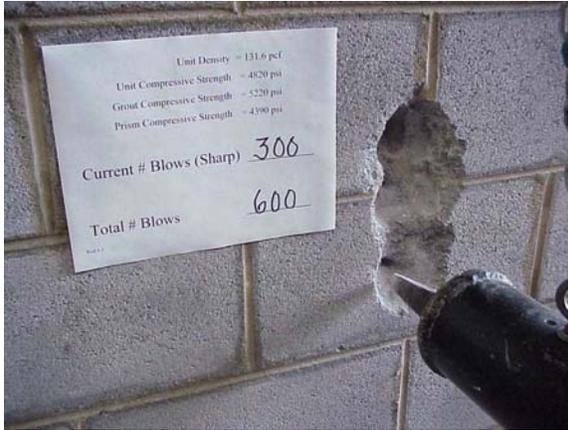
Figure 6 – Typical Wall Condition After 600 Blows – Front Side

As noted previously, ASTM F 2322 contains security grades for fixed barriers. Grade #1, the most secure, calls for the wall assembly to withstand 600 blows from the blunt and sharp impactor applied in sequences of 50 blows each. This blow count is also equated to a representative barrier duration time of 60 minutes. Walls #1 through #4 were able to withstand the 600 blows and therefore would be designated as a Grade 1 wall in accordance with the ASTM F 2322. Additionally, the rear of each assembly was monitored after each sequence of 50 blows and no damage, included minor cracks, was observed during the 600 blows. Figure 6 shows typical damage after 600 blows of the wall assembly, and Figure 7 the undamaged backside of the wall.

Five concrete masonry wall assemblies were tested [1, 2] and are described in Table 3. All five concrete masonry walls were able to withstand 600 blows and therefore achieve the Grade 1 rating in accordance with ASTM F 2322. Additionally, the rear side of each wall assembly was monitored after each sequence of 50 blows and no penetration or damage, including minor cracks, was observed during the 600 blows.

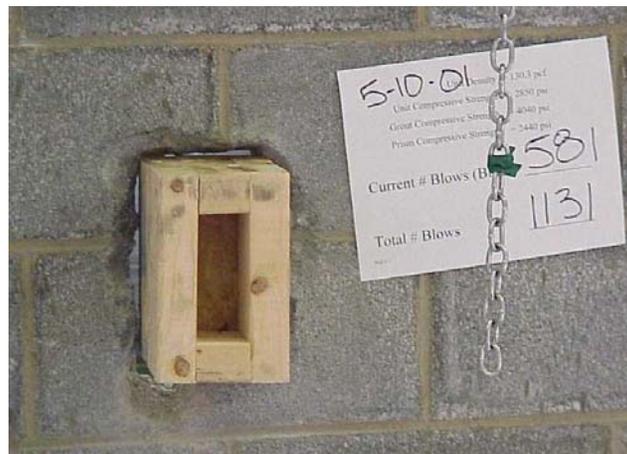
Figure 8 - Typical Breach Failure

Two of the wall assemblies were taken to failure until a forcible breach was observed. A wall constructed of normal weight concrete masonry units was observed to withstand 1,134 blows. Using the criteria in ASTM F 2322, this wall assembly would have a rating of approximately 2 hours (1.89 hours). One wall constructed with lightweight units allowed a breach after 924 blows, which equates to a security rating of approximately 1 ½ hours (1.54 hours). A typical breach is shown in Figure 8.

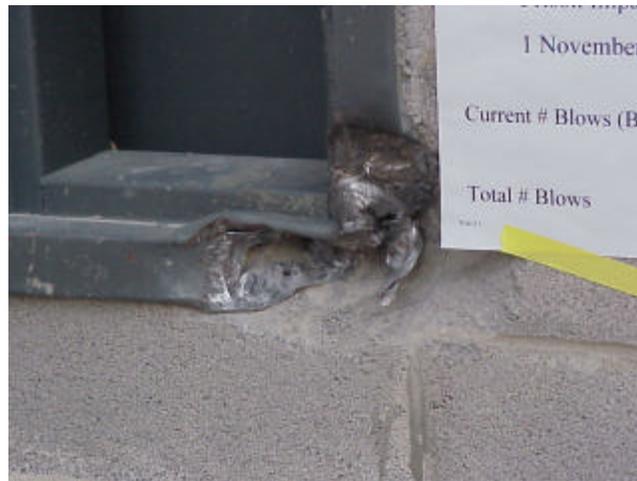
Figure 9- Close-up of Window Frame Damage at 935 Blows

The window frame connection withstood 935 blows from the impactor, exceeding the highest rating of 600 blows found in ASTM F 2322. The testing was stopped after 935 blows because

the ram apparatus chain connection became disconnected. The frame damage at 935 blows is shown in the Figure 9.

The impacts for the 203 mm (8 inch) CMU wall/window frame connection were applied to the lower right hand corner of the window frame. This location was chosen based on guidance from ASTM F 2322. As with the other testing, the blunt and sharp impactors were alternated in 50 blow increments, with each strike landing within ± 51 mm (2 inches) horizontally and vertically from the designated target area.
