11th Canadian Masonry Symposium, Toronto, Ontario, May 31- June 3, 2009

MEASUREMENT OF DAMAGE IN MASONRY

J.M. Nichols¹, C Kavars² and A. B. Nichols³

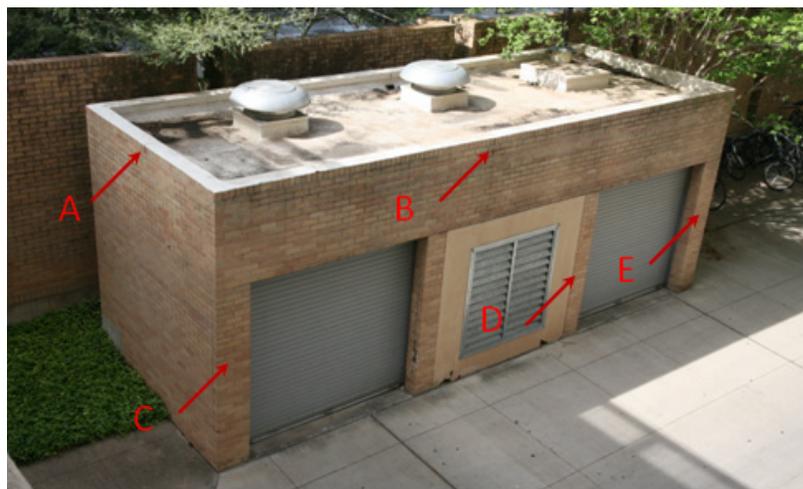
The test building is a single storey generator building at Texas A & M University (Figure 3). The building has damage of the masonry columns caused by steel corrosion. This damage does not interfere with the results, as the research interest is time and damage parameter independent.

Figure 3: Test Building – Langford Architectural Complex (9.1 x 2.2 x 3.1 m)

Permanent mounting points have been provided at five locations on the building, labelled A to E on Figure 3. Accelerometer GP 2 was mounted at Point C with the Y-axis vertical, the X-axis in plane and the Z-axis out of plane. Data was recorded using the Standard SENSR program that records, time, integer time steps, accelerations in the local instruments X, Y and Z directions, the resolved vector maximum for the acceleration and the temperature using a Pentium 4 Dell Portable. The signal analysis was completed using SIGVIEW 1.98. The building has two roller doors on the southern side, with solid masonry walls (203 mm) and a reinforced concrete roof (100 mm thick). Figure 4 shows the south-western column adjacent to the left-hand roller door, with GP2 in place on the wall at mounting point C.

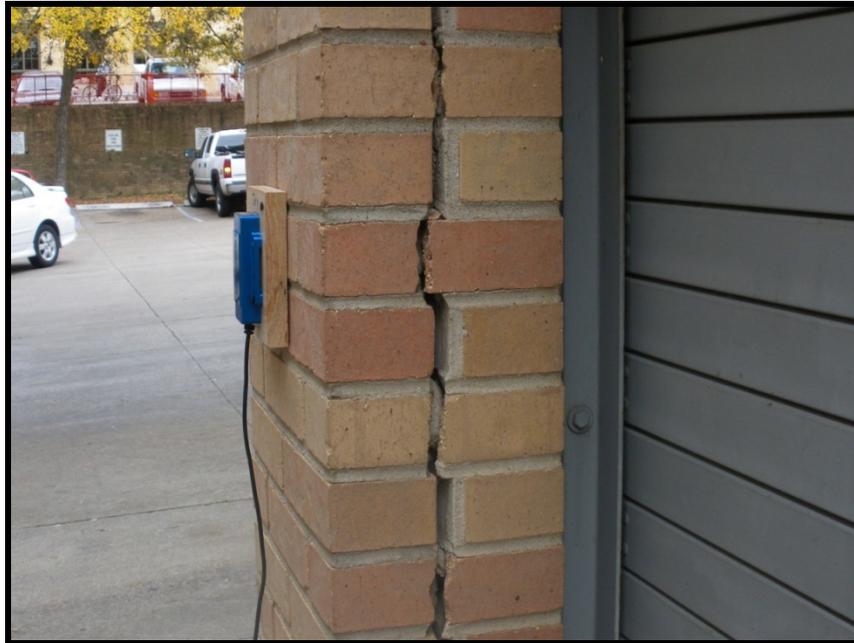
Figure 4: Building One – Mounting point C – GP2 Installed on White Oak Block

The column damage predates the experiments resulting from steel corrosion not related to the experiments. The corrosion does not affect the conclusions reached from the study. The mounting points are 1.475 m above the adjacent RC pathway. White oak mounting blocks 140 x 114 x 19 mm attach the accelerometers to the permanent mounting positions. The assumption is the white oak blocks do not affect the results. This assumption will require further study, but it is considered reasonable for this early work.

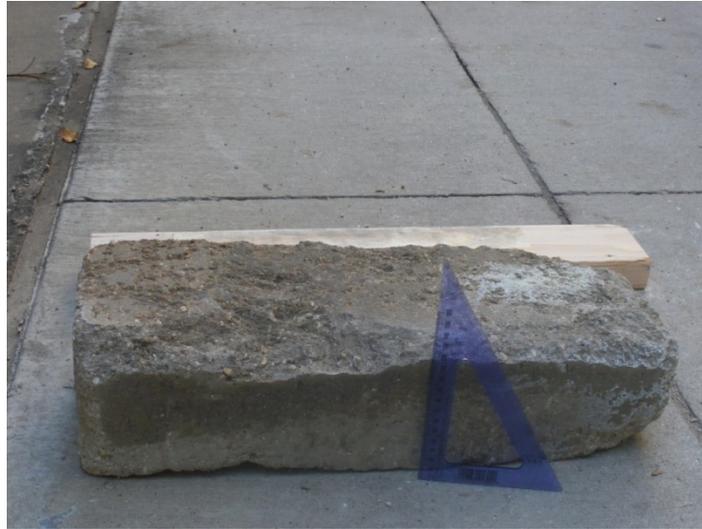
The loading pattern developed for the study evolved from the early experiments. The first earlier experiments had the purpose of determining the sensitivity of the accelerometers and establishing the best methods to log and analyse the results. The conclusion from these results was a lower resolution limit of approximately 0.015 – 0.02g based on a quiescent period of study on a four storey Reinforced Concrete building. The loading function for the current experiments uses a step kerb of approximately 130 – 150 mm to generate a pulse load in the reinforced concrete pathway. The point load comes from a Ford F150, with a mass of 2120 kg passing over the kerb at a slow speed. Figure 5 shows the kerb setup adjacent to Mounting Point C. The kerb is centred approximately one metre from the wall to allow for truck clearance issues.

Figure 5: Test Building – Measurement at Mounting Point C – 150 mm Kerb Point
