11th Canadian Masonry Symposium, Toronto, Ontario, May 31- June 3, 2009

MONOTONIC AND SHAKE TABLE TESTING OF GRAVITY LOAD DESIGNED REINFORCED CONCRETE FRAMES WITH UNREINFORCED MASONRY INFILL WALLS

J. Centeno¹ C.E. Ventura² S. Foo³ and S. Brzev⁴

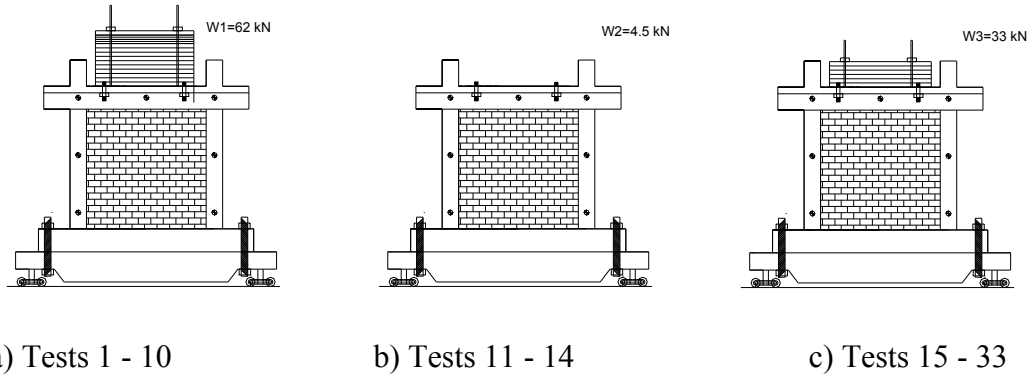
Figure 3: Surchage loads used during shake table tests

The UBC Earthquake Engineering Research Facility (EERF) uni-axial shake table allows simulation of ground motions in one direction. The dimensions of the shake table are 3 m by 4 m. The shake table test program was organized into 5 series of tests. The surcharge load was changed at different stages of the testing program, as shown in figure 3, with Specimen #2 subjected to all 33 shake table tests.

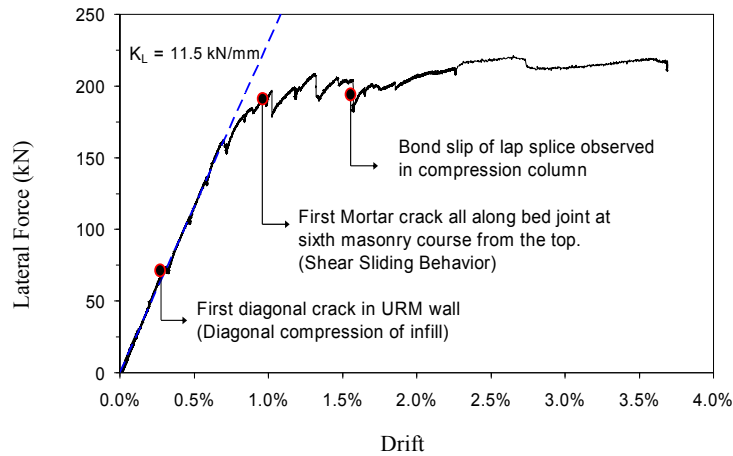
Figure 5: Monotonic loading vs. drift curve

The monotonic loading test showed in good detail a variation in the interaction of the infilled frame structure, presented in Figure 5 is the resulting monotonic loading vs. drift curve and in Figure 6 is the specimen at different stages of loading. The initial load resisting behavior was through diagonal compression behaviour of the masonry wall, with a high axial tension stress on the tension column, see Figure 6a. The linear elastic stiffness was constant through this behaviour with a value of 11.5 kN/mm.

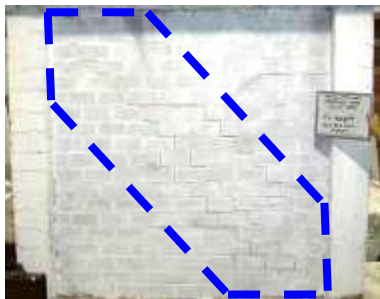
a) Diagonal Crack Patterns at Drift 0.77%

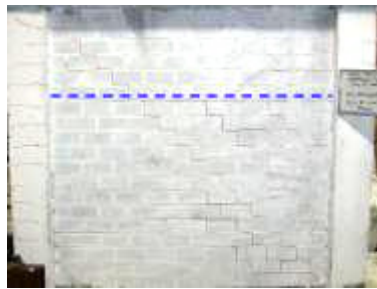
b) Shear Sliding at Drift 1.00%

At 1.00% drift, the structure behaviour changed to a shear sliding behaviour, confirmed by one horizontal crack that extended along the full length of the wall which was formed at the sixth course from the top of the URM wall, see Figure 6b. Yielding was observed at 1.25% drift, reaching a lateral load of 205 kN. The sliding mechanism, observed as additional horizontal cracks formed along the full length of the wall, was not observed beyond the 1.65% drift level.

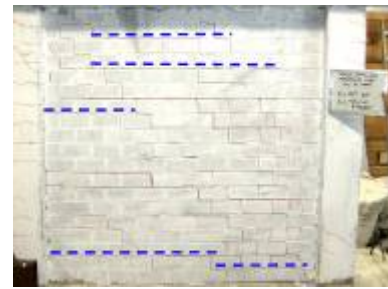
c) Bond Slip Initiates Drift 1.65%

At 1.65% drift, vertical cracks were observed at the base of the tension column, coinciding with the location of the lap splice of the longitudinal rebar. At 3.55% drift, these vertical cracks extended in length until the end of the lap splice of the longitudinal rebar. Both columns, along the length of their lap splices, showed no clear development of flexural cracks. There was no physical indication of the formation of plastic hinges at the base despite having reached a perfectly plastic behavior and a drift of 3.55%. This suggests that the free rotation and splitting of concrete are evidence of problems due to cold construction joints and inadequate lap splices, thus preventing rebar yielding stress, as confirmed in the literature [1]. No strength degradation occurred before the maximum displacement was reached.

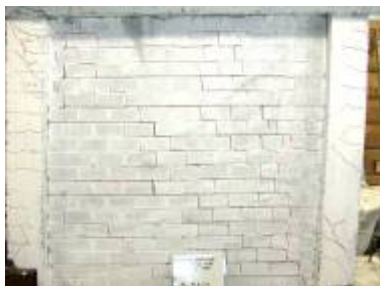
d) Maximum deformation reached at Drift 3.55%

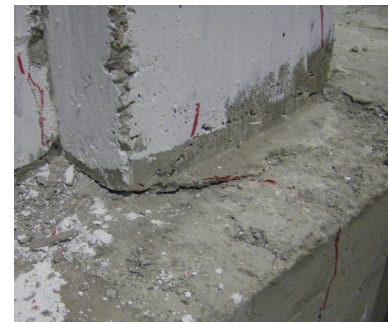
f) Compression column Drift 3.55%

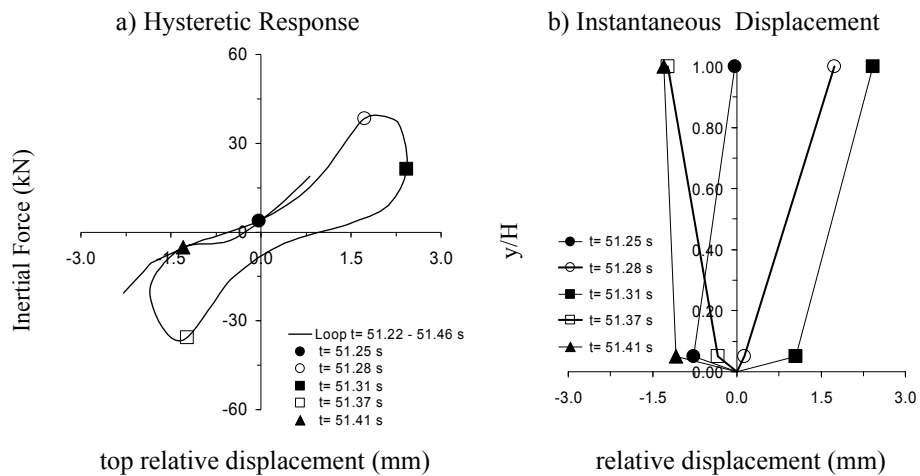
Figure 8: Inertial force and displacement response for Specimen #2, test #01

At the base of the columns of the three tested GLDRC frames there were observed and measured rotations and concentrated shear sliding. Significant shear sliding displacements were found at the base of the infilled frames, as shown in Figure 8b. This sliding of the columns is a result of the infill wall's diagonal compression transferring of the inertial load to the base of the adjacent column and to the foundation. This shear sliding of the columns was seen starting from the first shake table test and resulted in a pinched hysteretic plot, see Figure 8a.

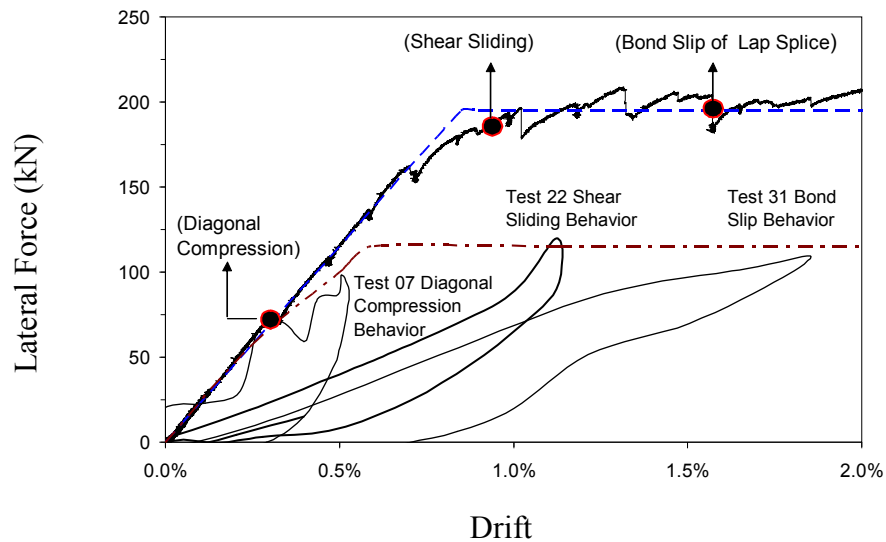
Figure 9: Variation in damage for different stages of shake table testing

A comparison plot of the monotonic loading vs. drift curve and the enveloping curve of three of the hysteretic loops in the shake table test program performed on the GLDRC frames with URM infill wall specimens is presented in Figure 9. It can be observed that the strength was significantly reduced from its monotonic capacity due responding to many severe earthquake ground motions. From this plot in can be seen that the governing mode of response was controlled by the maximum deformation response.
