11th Canadian Masonry Symposium, Toronto, Ontario, May 31- June 3, 2009

EVALUATION OF YOUNG'S MODULUS FOR STONE MASONRY WALLS UNDER COMPRESSION

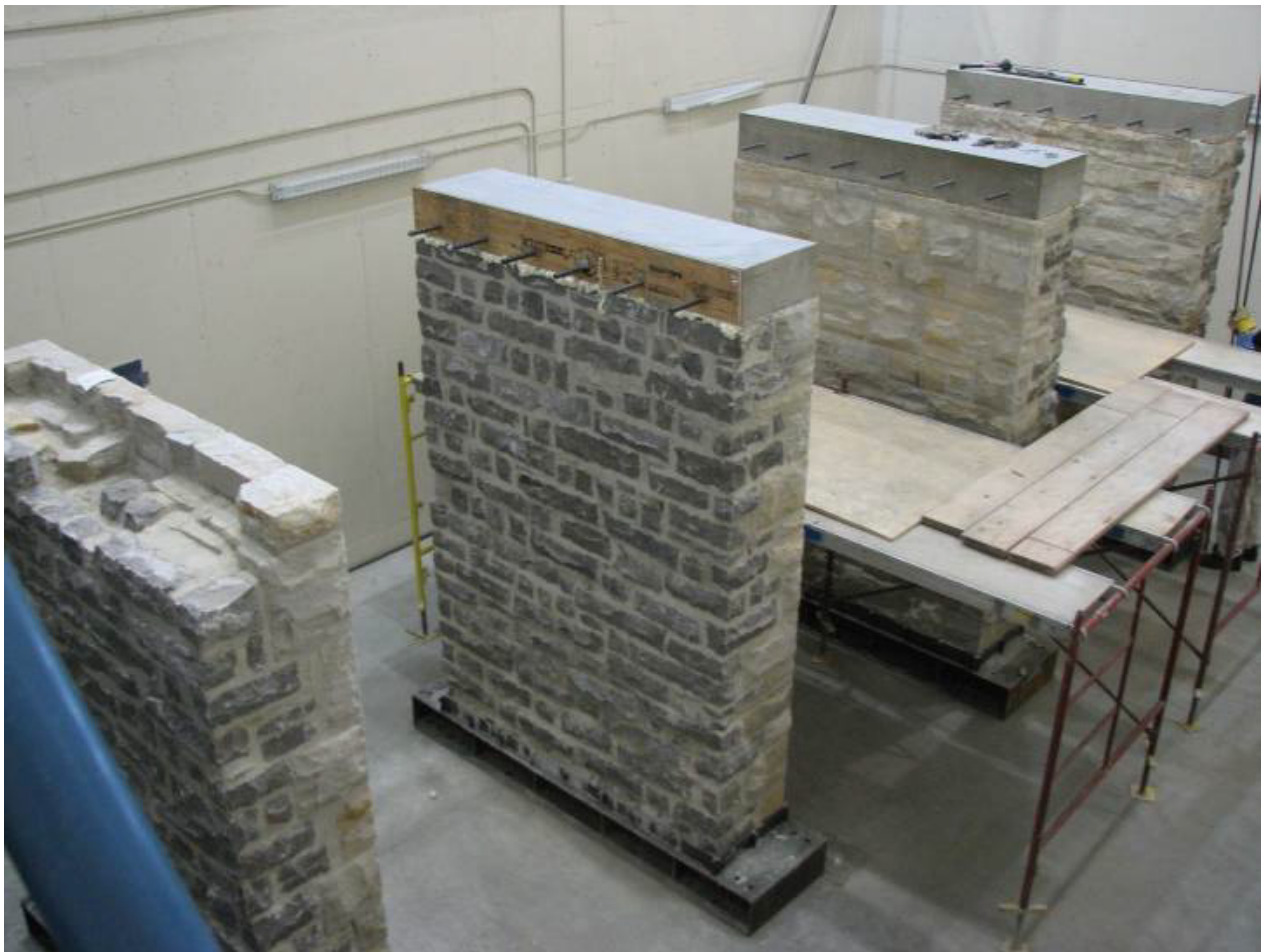
Figure 1: The walls were constructed with one side from sandstone in a sneck pattern (as seen in the two walls on the right), and the other side from limestone in a running bond pattern (as seen in the two walls to the left)

Eight double-wythe stone masonry walls were built to represent the buildings on Parliament Hill. All the walls had one side constructed from sandstone in a sneck bond pattern while the other wythe was built from limestone in a running bond pattern, Figure 1. The gap between the two wythes was filled with rubble - shards from dressing the stones, smaller stones and mortar. The walls were built with hydraulic lime mortar as were the original walls on Parliament Hill. The mortar had lime: sand ratio of 1:3. No Portland cement was used. The specimens were built in two batches by skilled heritage masons who work for Public Works and Government Services Canada (PWGSC). The masons were instructed to build walls that would represent the low end of the spectrum of construction that could be expected on Parliament Hill, recognizing that many masons worked during the original construction, and that the quality of that construction would therefore be variable. The walls were about 2.75 m high, 2 m wide and 0.54 m thick. After the walls were built, a concrete cap was cast on their top to make the total height of the wall and the cap equal to 3 m. The concrete cap was poured to allow for different fixtures required for the different tests that were to be performed. The caps were also to help distribute the loads evenly

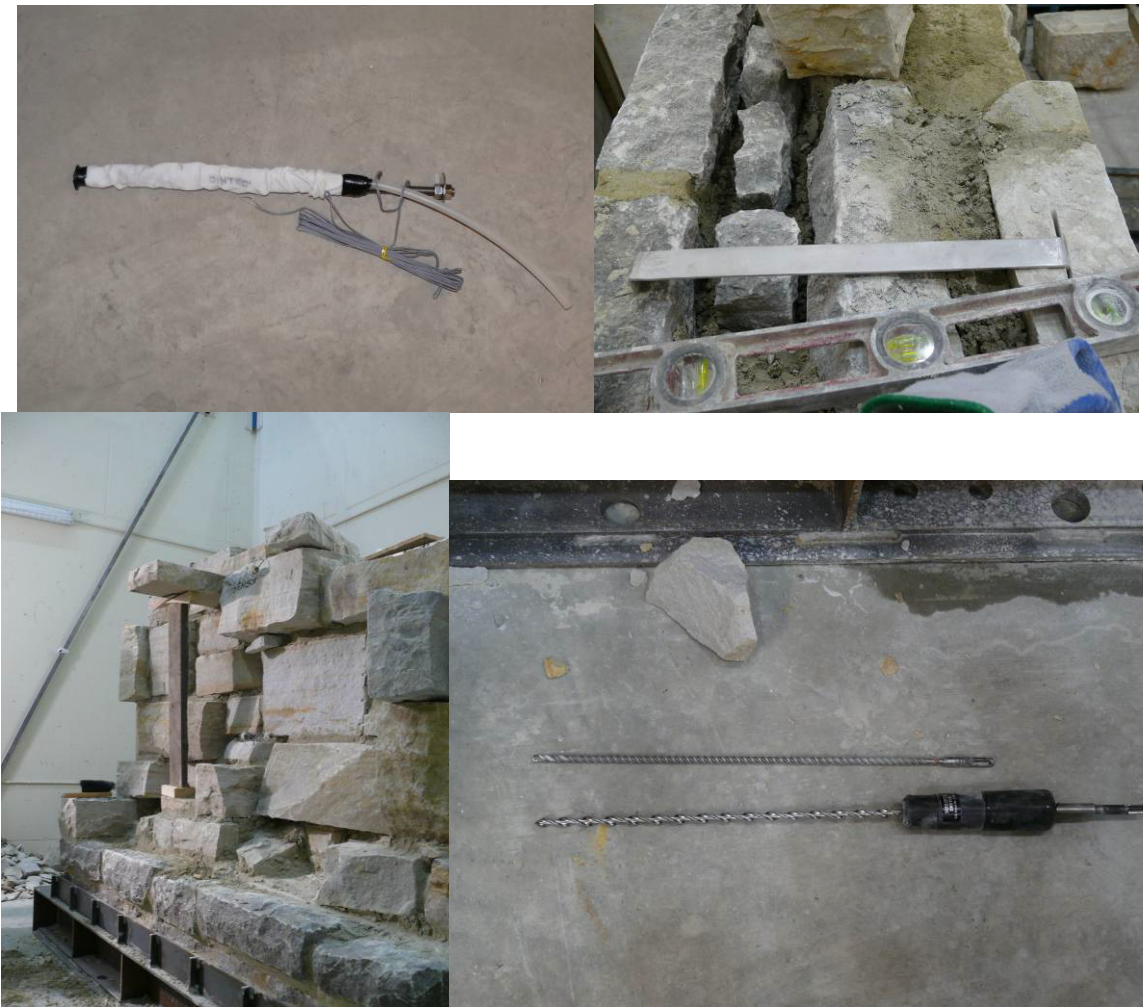
Figure 2: Examples of the different anchoring types: top left Cintec anchor, top right Stainless Steel Cramps, bottom left overlapping stones, and bottom right Helifix anchors

Five potential strengthening techniques were used in the walls. The objective of all techniques was to anchor the sandstone and limestone wythes together across the width of the walls. Of the eight walls, two were left plain, two had Cintec anchors which were installed during building the walls, one had Cintec anchors installed after the wall was built, one had Helifix anchors installed after the wall was built, one had stainless steel cramps installed during construction, and one had traditional anchoring by overlapping stones from the two wythes. The different anchoring types are shown in Figure 2, while the specific walls are listed in Table 1.

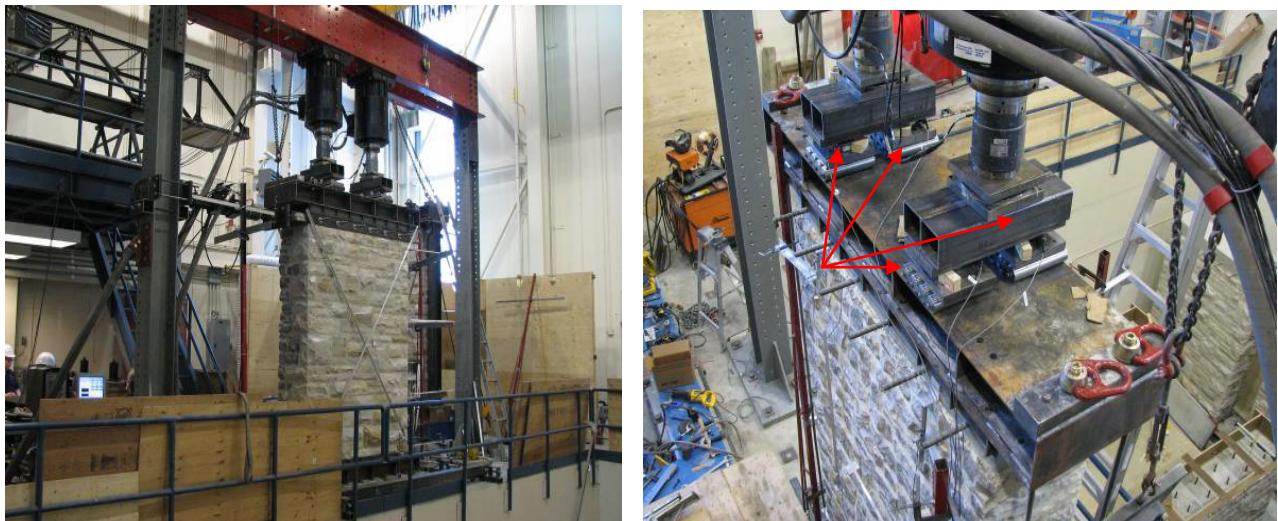
Figure 3: The testing rig (left) and the four loading points shown with arrows (right).

The compression load was applied on the walls using two 1.5 MN actuators. The load was applied at four points on a steel beam mounted on top of the concrete capping. The steel beam was needed for moving the walls, and was also used with the four loading points to distribute the load evenly over the walls. The testing rig and loading points are shown in Figure 3. The load from each 1.5 MN vertically oriented actuator is distributed to two loading points by double-box-beams, and thence through rollers to the main steel beam. The rollers were needed to allow the wall to move laterally when the in-plane shear load was applied, without applying side load on the vertical actuators.

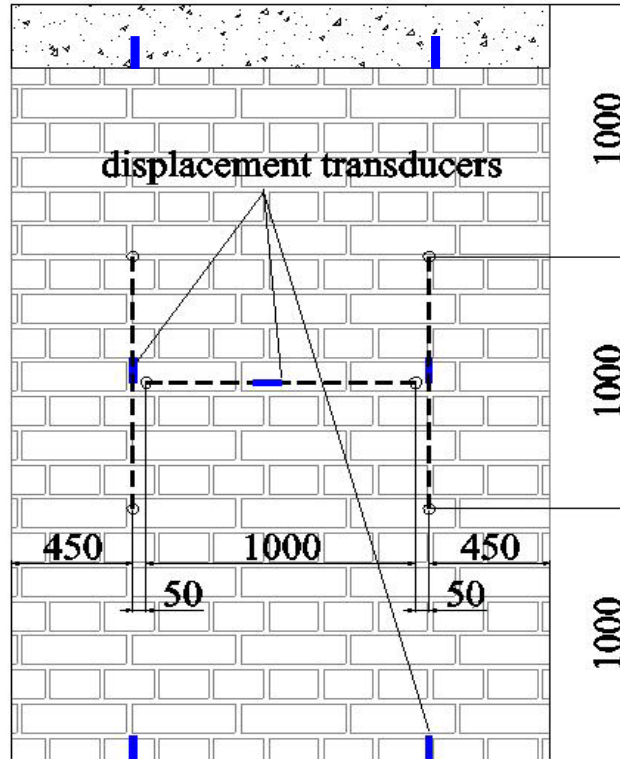
Figure 4: Schematic of the instrumentation for a compression test. All distances are in mm.

During the tests the loads and displacements were recorded simultaneously, as appropriate for the test performed. In the compression tests, the vertical displacements of the walls were measured over the full height of the wall as well as over the middle third of the wall. The load from each actuator was recorded, in addition to the load at each of the four loading points from load cells above the roller set at each point. The transverse displacement on both sides of the wall was also measured at mid height. The instrumentation for an axial test is shown schematically in Figure 4.

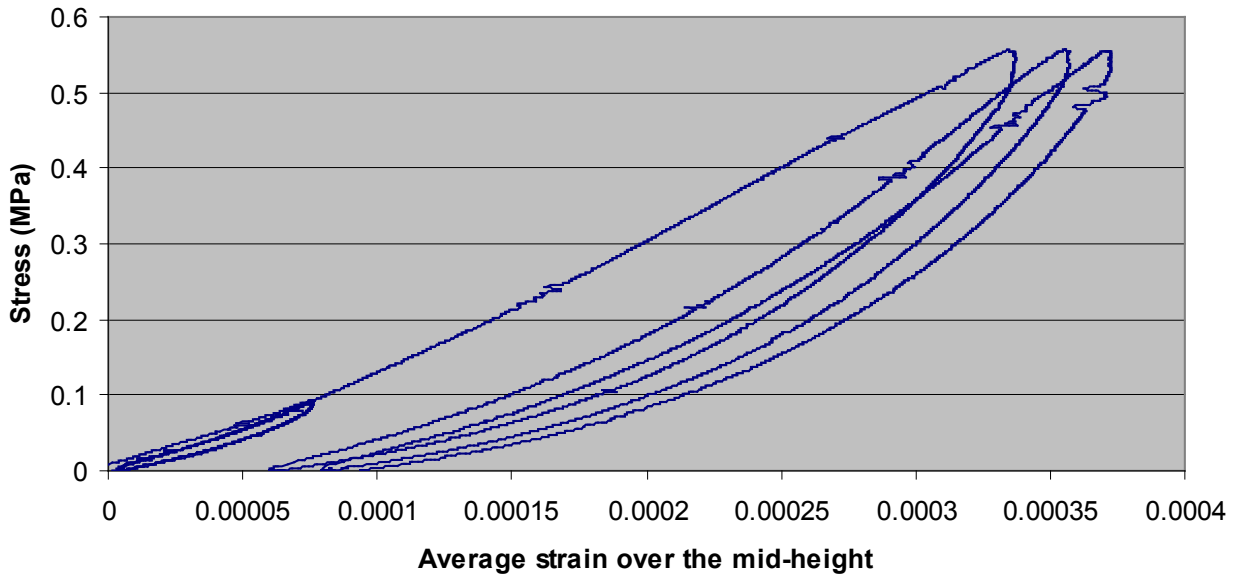
Figure 5: A typical Stress-Strain curve. The one above is the final one for Wall #5, after it had been subject to in-plane racking and the out-of-plane shake table testing. Wall #5 had Cintec anchors installed after it had been built. The strain shown is that measured over the middle third of the wall.

A typical stress-strain curve for a wall is shown in Figure 5. Three initial seating loading cycles were performed up to a stress level of 0.1 MPa. These three cycles were followed by three cycles of loading to 0.55 MPa. The Young's modulus was determined as a secant modulus to the maximum stress reached from these curves. Values for Young's modulus for the different walls at different stages of the testing are presented in Table 1.

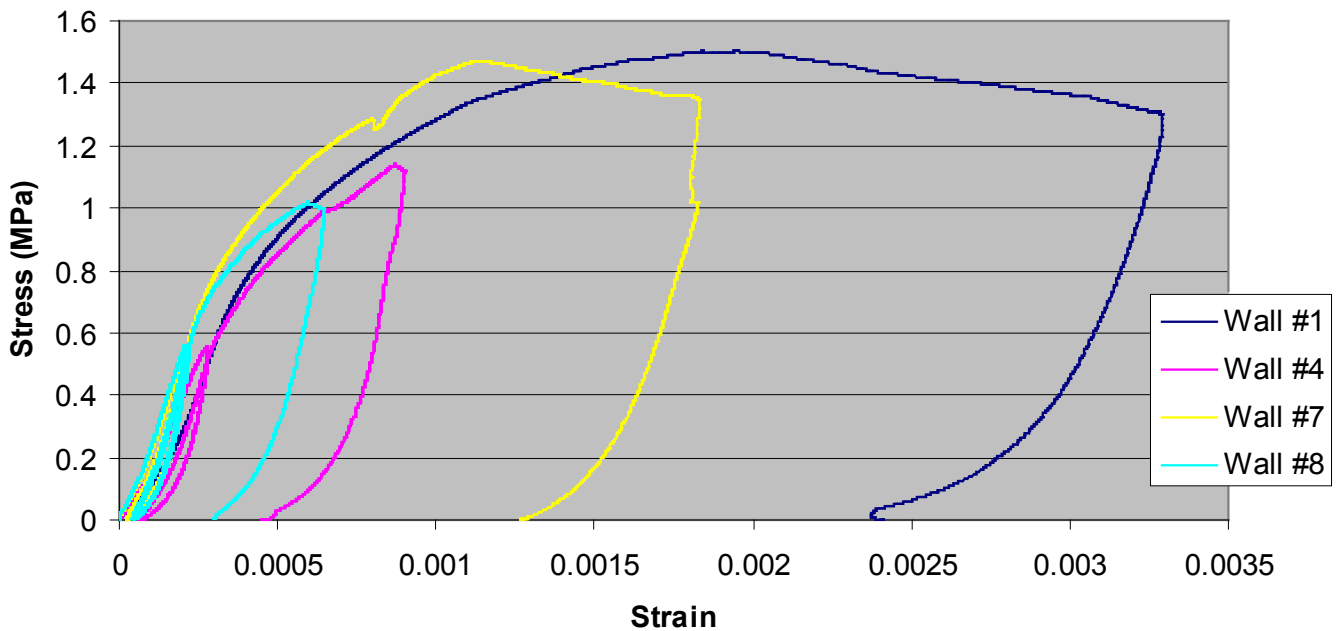
Figure 6: Stress-strain curves for walls #1, #4, #7 and #8 when taken beyond peak axial capacity after having been damaged in all the previous in-plane and out-of-plane tests.

After all the testing had been performed on walls #1 (a plain wall), #4 (a wall with Cintec anchors placed during construction), #7 (the wall with stainless steel cramps) and #8 (the wall with the overlapping stones from the sandstone and limestone wythes), these damaged walls were loaded in axial compression up to their peak capacity. The stress-strain curves obtained from these tests are shown in Figure 6. As these walls approached their maximum capacity, mortar spalled from the surface of the walls, particularly the limestone side, and in some cases a few stones on the limestone side cracked. Such a cracked stone is shown in Figure 7. Although some stones cracked, and some had become loose from this or previous tests, such that they could be wiggled by hand, no stones fell out of the walls, nor was it possible to pull any stones out of the walls.

The walls tested up to peak capacity reached stresses ranging between 1 and 1.5 MPa, which is two to three times the estimated stress level at the base of the walls in the buildings on Parliament Hill. The loading was terminated on walls #4 and 8 immediately after reaching the peak strength, while the loading was carried on further for walls # 1 and 7, as some confidence had been gained in the robustness of the construction. Wall #1, a plain wall, reached the code [1] ultimate strain of 0.003.

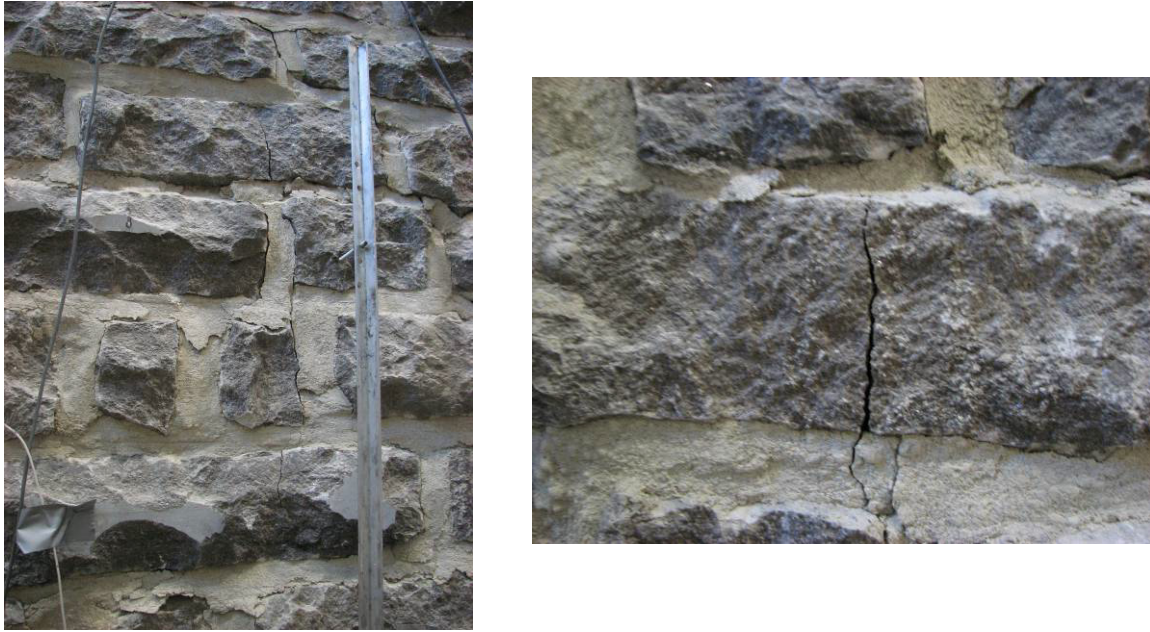
Figure 7: The cracking on the lime stone face (left), and a close up of a cracked limestone
