FIRE RESISTANCE OF A MASONRY WALL CONSTRUCTED FROM NOVEL UNITS COMPOSED ENTIRELY OF WASTE MATERIALS AND BOUND WITH WASTE VEGETABLE OIL

J.P.Forth¹ and T.Heaton²

¹ Senior Lecturer, Civil Engineering, University of Leeds, LS2 9JT, j.p.forth@leeds.ac.uk

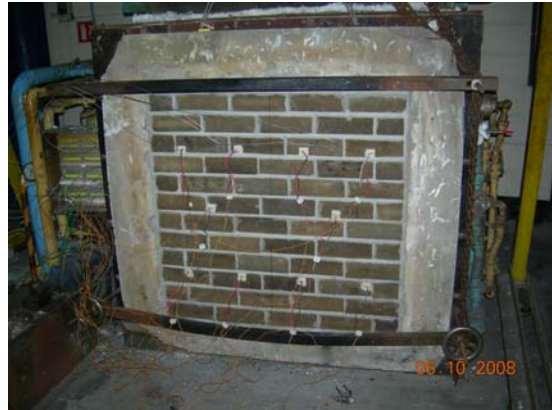
Figure 2b): The unexposed face of the test wall with thermocouples as it appeared attached to the furnace.

Both halves of the wall had five thermocouples attached to the unexposed face using a high temperature adhesive. The maximum allowable rise in temperature for the test process was to be 140°C above the ambient temperature. In addition, three internal gradient thermocouples were inserted into pre-drilled holes 25mm, 50mm and 75mm deep from the unexposed surface and closed off with a fire resistant cement. The gradient thermocouples were inserted high on the assembly where the heat would be most intense. The construction formed the front face of a one metre cubed gas fired furnace chamber. The setup is viewable in Figure 2b.

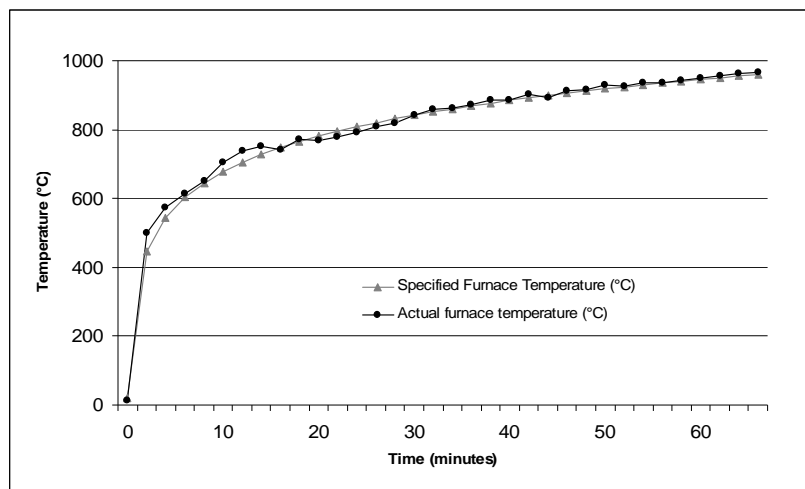
Figure 3: Plot of the temperature curve specified in the British Standards fire resistance test guidelines versus the monitored furnace temperature during the test.

The temperature of the furnace was raised in line with the conditions specified in the British Standard [6]. The thermocouples took readings at two minute intervals which were recorded by a computer. The curve showing the relationship between the specified temperatures and the actual, monitored furnace temperatures over time is shown in Figure 3.

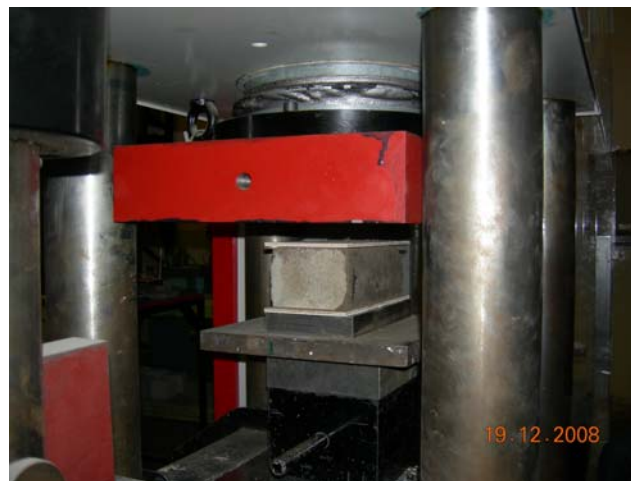
Figure 5: Configuration of the compressive strength tests.

Compressive strength tests of bricks retrieved from the wall were performed according to the British Standard specification [7]. The testing apparatus was a Tonipact 3000 cube crusher that uses the Servocon Digital Control computer programme. The load was applied at a rate of 6.75 kN/sec. Pieces of 6mm plywood were placed both on top of and underneath the specimens, in order to ensure a uniform application of load by the testing apparatus. The peak load values given by the failure detection mechanism of the machine were recorded. Figure 5 shows the equipment set up to crush a specimen.

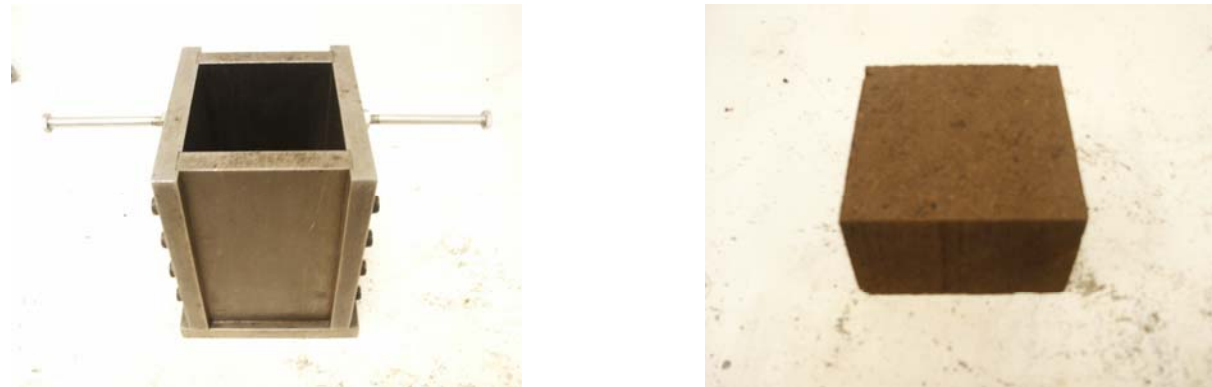
Figure 6: 100mm mould and block.

Preparation of the block specimens was performed similarly to the brick specimens. The moulds however, were of a smaller size, and the blocks were cured at 120°C rather than 160°C in the convection oven. This was to observe any possible effect of additional curing when the bricks were exposed to relatively lower temperatures in the furnace. An image of the mould and a typical block sample is shown in Figure 6.
