IN-SITU OUT-OF-PLANE TESTING OF UNREINFORCED MASONRY PARTITION WALLS

D. Dizhur¹, H. Derakhshan², J.M. Ingham³ and M.C Griffith⁴

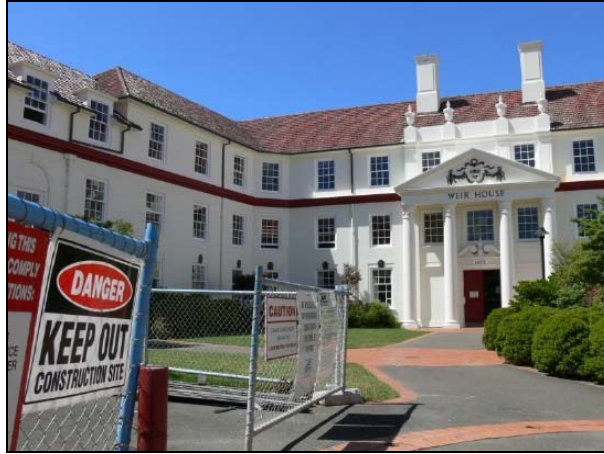
Weir House is comprised of three main buildings. The William Weir (WW) Wing was built in 1932 and is the original structure of the complex (see Figure 1). The William Weir wing is registered as a heritage building and as such, any strengthening and securing works had to be sensitive to the existing building fabric and be designed in consultation with Wellington City Council.

**Figure 1: Weir House, case study building
(Facing south-east)**

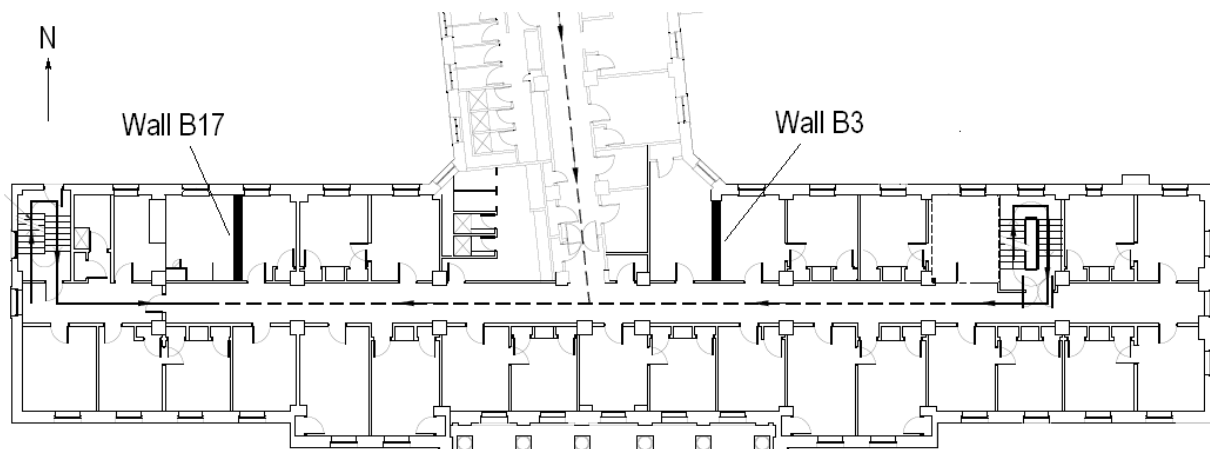
The original Weir House building comprises a main rectangular block that has footprint dimensions of 56 m x 11 m. This block is primarily a 3 storey building with the front section on the eastern side containing a part basement level. A 3 storey western wing structure approximately 21 m x 11 m extends to the west, forming the 'T' shaped building (see Figure 2).

Only out-of-plane testing of the URM partition walls was conducted at the Weir House. The partitions are non-load bearing 1-leaf clay brick terracotta masonry walls that are lined with 12-15 mm thick cement plaster finish on both sides. Two walls B3 and B17 (see Figure 2) were selected for testing. The walls had identical dimensions of 4.1 m long by 3.6 m high.

Figure 2: Floor plan and test locations

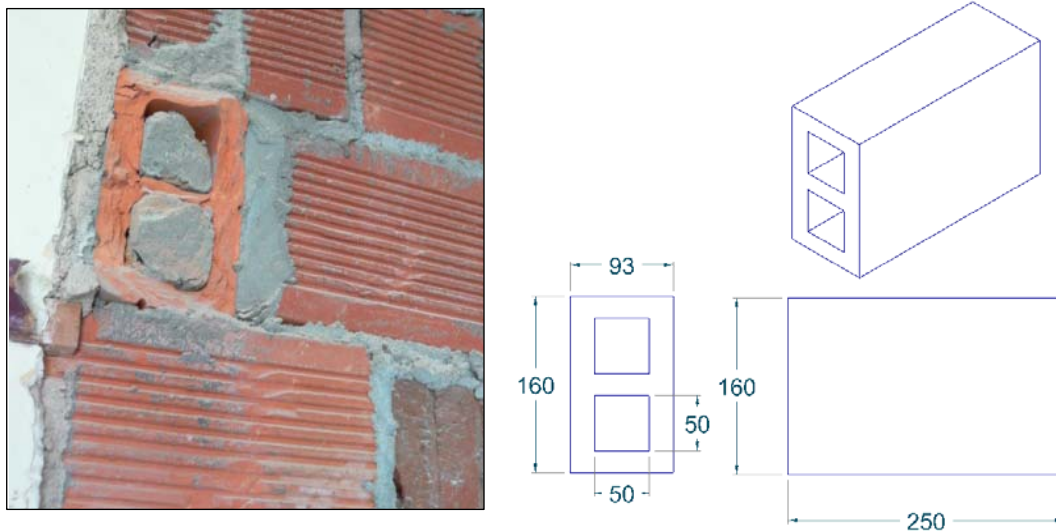
Figure 3 illustrates the masonry type present in the Weir House. Because of the heritage characteristics of the building, destructive testing was not permitted and no masonry samples were obtained to determine accurate material properties. The New Zealand Society for Earthquake Engineering (2006) provides guidelines for estimating strength parameters of masonry based on visual characteristics and hand tests, as summarised in Table 1.

Figure 3: a) Exposed masonry construction b) Terracotta brick dimensions

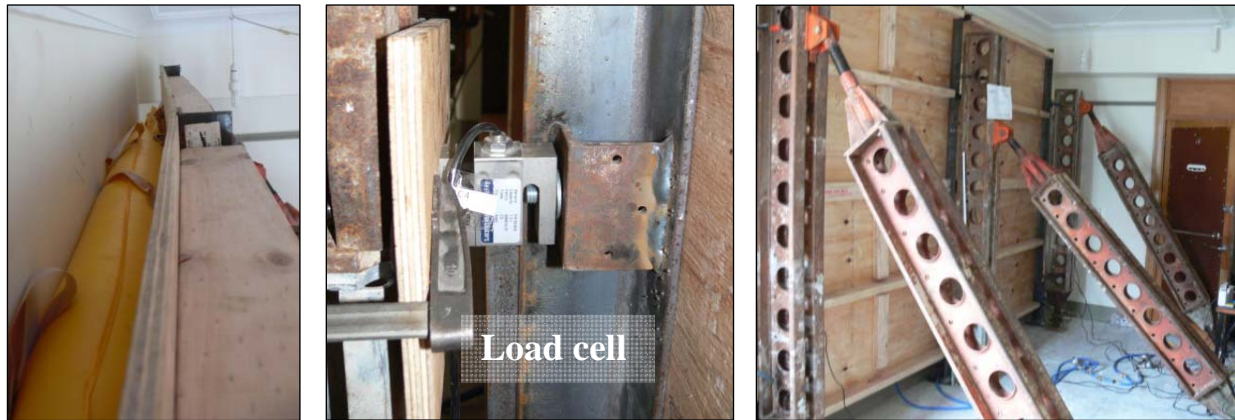
Loading was applied by gradually inflating the Bigfoot vinyl airbags. When fully deflated, each airbag had dimensions of 2.1 m x 1.2 m. To accommodate the airbags, a gap of 50-75 mm was left between the wall and the plywood backing. As a result the contact area, used for calculating the face pressure between the airbag and the wall face, was approximately 80 % of the airbag's

deflated area. The load was generated and gradually increased between the wall surface and the plywood backing, as illustrated in Figure 4a. To ensure that the three airbags were inflated to an equal pressure level, a slow rate of inflation was adopted.

The plywood backing, measuring 3.4 m x 2.4 m, consisted of an assemblage of plywood sheets and steel angles. The plywood backing was supported by a reaction frame which consisted of large vertical and diagonal steel members bolted to the concrete floor. The applied load was transferred from the airbags to the plywood backing and to the reaction frame using six S-type 1000 N load cells, as shown in Figure 4b. The load cells were attached between the plywood backing and reaction frame and provided horizontal stability to the plywood backing. To ensure that the entire load was transferred through the load cells, frictionless plates were used underneath the plywood backing. The experimental set-up is shown in Figure 4c. The set-up closely resembled the set-up used to conduct laboratory out-of-plane testing on URM walls at the University of Adelaide (Griffith et al. 2007) and the University of Auckland (Derakhshan and Ingham 2008).

Figure 4: a) Airbag's position b) S-type load cell c) Experimental set-up

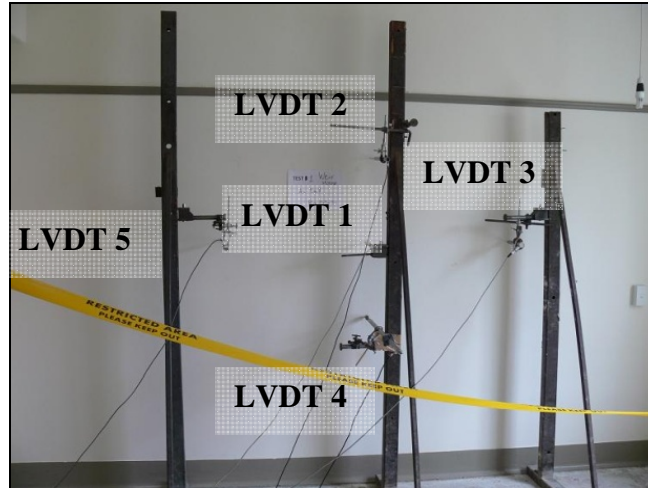
Out-of-plane displacement was measured using 5 Linear Variable Differential Transducers (LVDT) mounted on the opposite side of the wall. One LVDT was placed mid-height and at the wall centreline, two were placed 750 mm above and below the wall centreline and two were located 450 mm left and right of the centre. Figure 5 shows LVDT locations.

Figure 5: LVDT locations

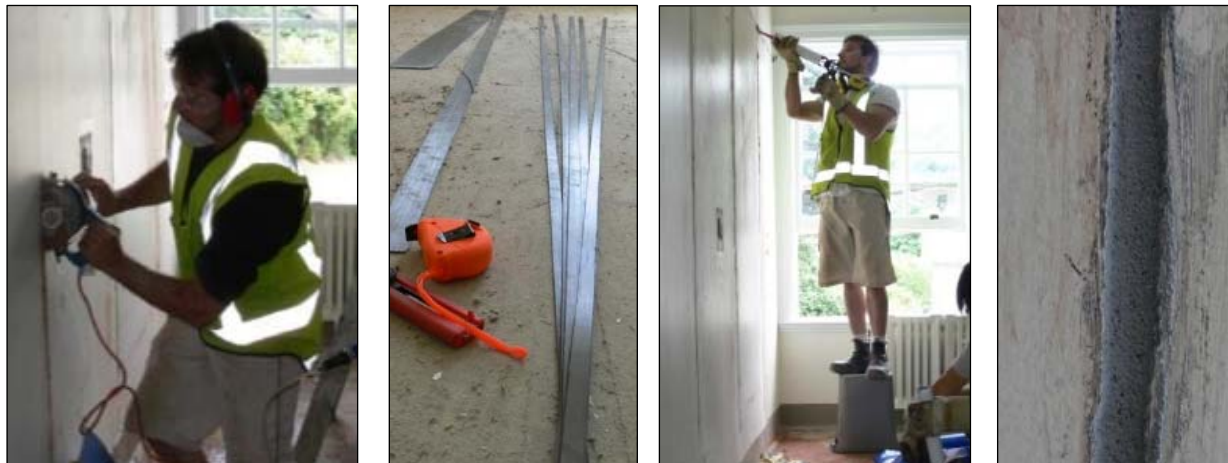
Figure 6: a) Groove cutting b) 15 mm CFRP strips c) Epoxy application d) Groove pointing

Wall B17 was reinforced using CFRP strips (Young's modulus equal to 165 GPa) 15 mm wide and 1.4 mm thick, as shown in Figure 6. Grooves were cut into the masonry with a circular saw (5 mm thick blade) to a depth of approximately 30 mm at 800 mm spacings (Figure 6a), with the depth selected to ensure direct bonding of CFRP strips to the brick surface and not the plaster layer. Two part epoxy adhesive was used to bond the CFRP strips into the grooves in the brick. The grooves were entirely filled with epoxy prior to CFRP strip insertion to ensure maximum bond area. Figures 6c and 6d show the installation procedure.

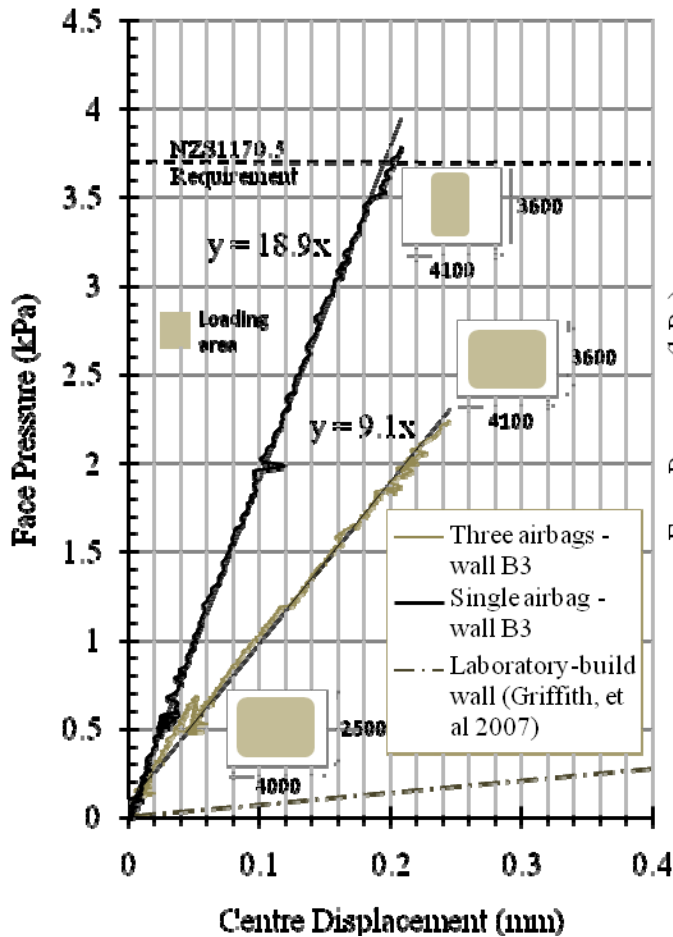
The first test was conducted on the as-built partition (Wall B3). The pressure in the airbag was slowly and uniformly increased and the total force exerted by the airbags onto the wall was calculated by summing the readings from the 6 measuring load cells. For comparison purposes the pressure acting on the wall was determined using the total force and the respective loading area. Comparison between single and three airbag arrangements is shown in the force-displacement plot in Figure 7. From the graphs it is evident that the flexural stiffness for the single airbag loading was 2.1 times that of the three airbag loading (and consequently the deflections are reduced by a factor of 2.1). The deflection ratio obtained from numerically modelling the two loading arrangements was shown to equal the experimental value.

Figure 7: Force-displacement response for wall B3-comparing three and single airbag loading and laboratory-built wall

Using the New Zealand Standard, NZS 1170.5:2004 - Earthquake Actions (SNZ 2004), assuming a shallow soil site, an annual probability of exceedance of 1/500 and a near-fault factor of 1.0, the partition wall would encounter a face pressure loading of 3.7 kPa during a design level earthquake. From Figure 7 and 8 it is clear that during testing the face pressure value specified by NZS 1170:5 was exceeded.

Loading and unloading of the wall was repeated up to 6 times, with the resulting force-displacement plots closely follow a straight line, indicating that the flexural stiffness remains constant throughout these semi-cycles. For clarity, the complete loading history has been omitted from Figure 7 and 8.

The in-situ test result and the results obtained from similar tests on a laboratory-built wall specimen (Griffith et al. 2007) do not compare well. As shown in Figure 7 the flexural stiffness of the in-situ specimens was much larger than that obtained from the laboratory-built specimen. Even though the in-situ and laboratory testing methods and wall dimensions were very similar, the in-situ walls exhibited much greater strength compared to the laboratory-built walls. This was attributed to the elevated strength of the aged cement mortar used in the building, compared to a weak mix 1:2:9 (cement:lime:sand) used in the laboratory specimen. Plaster layers have also been shown to contribute 25% to the strength of the URM walls (Tumialan et al. 2003).

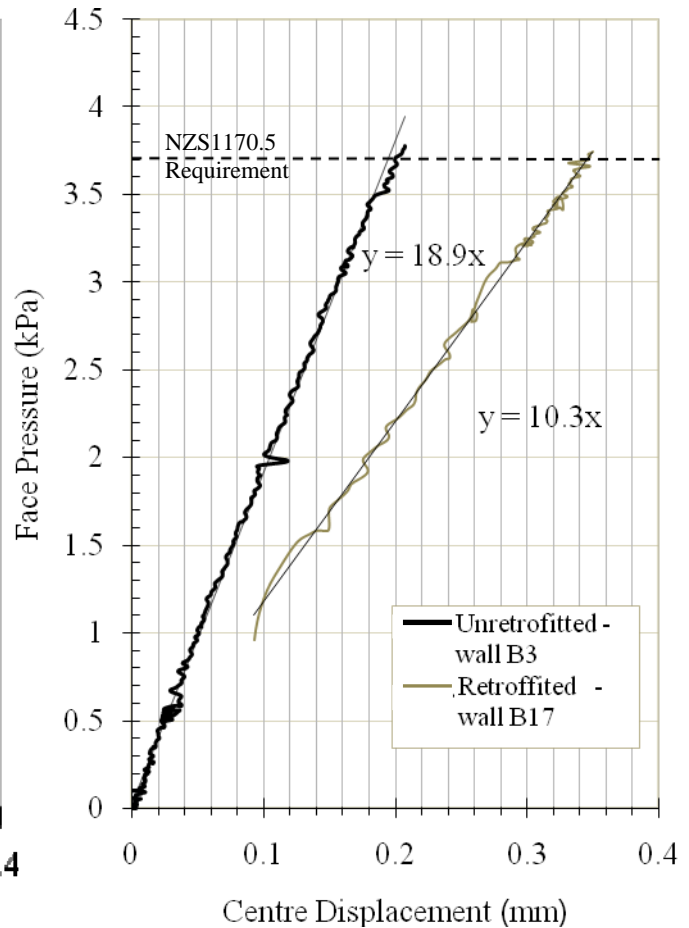
Figure 8 shows a comparison between the force-displacement plots of wall B17 (retrofitted) and wall B3 (as-built). Surprisingly, the flexural stiffness of the retrofitted wall was less than that of the as-built wall. Because of identical dimensions for wall B3 and B17, the difference in flexural stiffness of the walls was attributed to the possible variation in material properties and difference in quality of construction between the walls. Due to time constraints the testing of the as-built partition wall and then the retrofit of the same wall was prevented. Therefore, direct comparison of the results is not possible.

Figure 8: Force-displacement response for wall B3 & B17-comparing retrofitted with as-built (single airbag loading)
