EXPERIMENTAL SMALL-SCALE ANALYSIS OF THE CONNECTIONS BETWEEN STRUCTURAL CLAY BLOCK WORK MASONRY WALLS SUBMITTED TO VERTICAL LOADS

M.R.S. Corrêa¹, E.M.S. Moreira² and M.A. Ramalho³

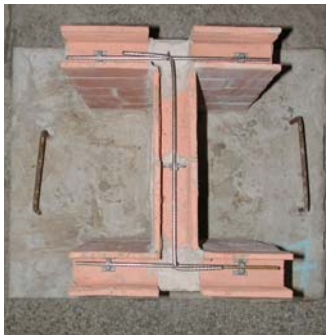
Figure 1: a) Steel bars in the bond beam; b) Steel truss; c) Steel staple

One steel bar of 4.2mm diameter and a 600 N/mm² yield limit was inserted into each bond beam (Figure 1a).

The steel trusses placed at each course as connectors were square 4mm meshes made of 0.70mm diameter galvanized wires (Figure 1b).

The staples inserted into each course with the same aim were made of steel bars of 2.74mm diameter and a 458 N/mm² yield limit (Figure 1c).

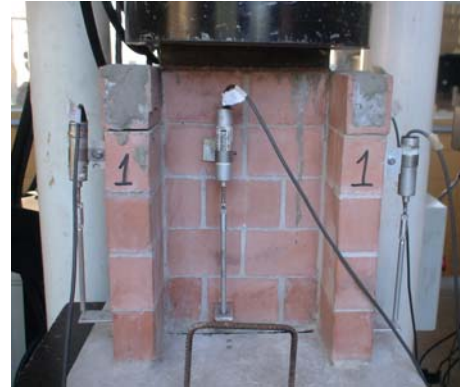
Figure 2: a) Specimens' dimensions; b) Test apparatus

the same age. Vertical loads were applied to the web top and only the flange bases were supported. The average shear strength was assessed by the ratio of the failure load to the vertical interfaces area (2 x unit thickness x specimen height). The web top was capped with dental plaster and plywood plates, before placing the steel plate to provide a uniform load distribution. A few initial cycles of small vertical loads were applied in order to bed the specimens and check the instrumentation. All the tests were carried out in a servo controlled hydraulic jack INSTRON with an initial speed of 0.01mm/s, reduced to 0.002mm/s near the failure load. Figure 2b shows the test apparatus.

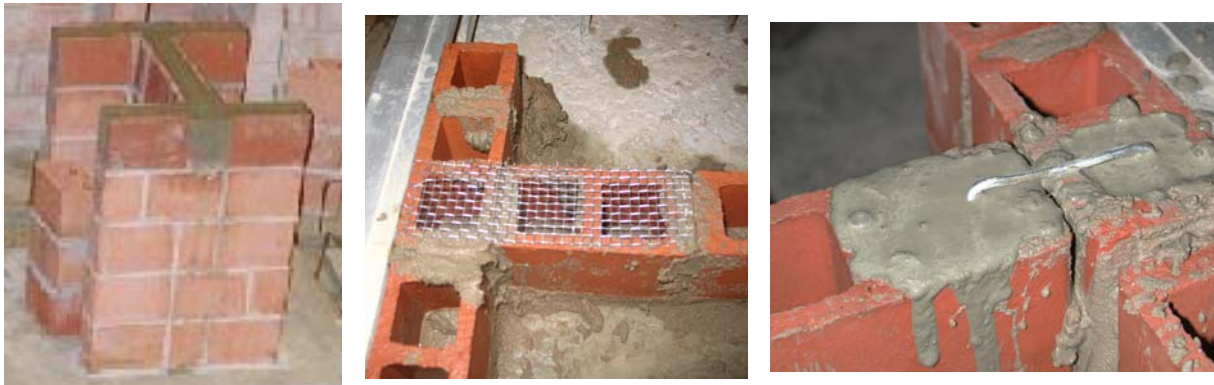
Three distinct situations were investigated: running bond interconnected walls (Figure 3a); web and central walls connected by steel trusses at each course (Figure 3b) and web and central walls connected by steel U-staples inserted into each course anchored in adjacent vertical holes (Figure 3c).

Figure 3: Vertical interfaces: a) Running bond (RB); b) Stack bond connected by steel trusses (SBT); c) Stack bond connected by steel U-staples (SBS)

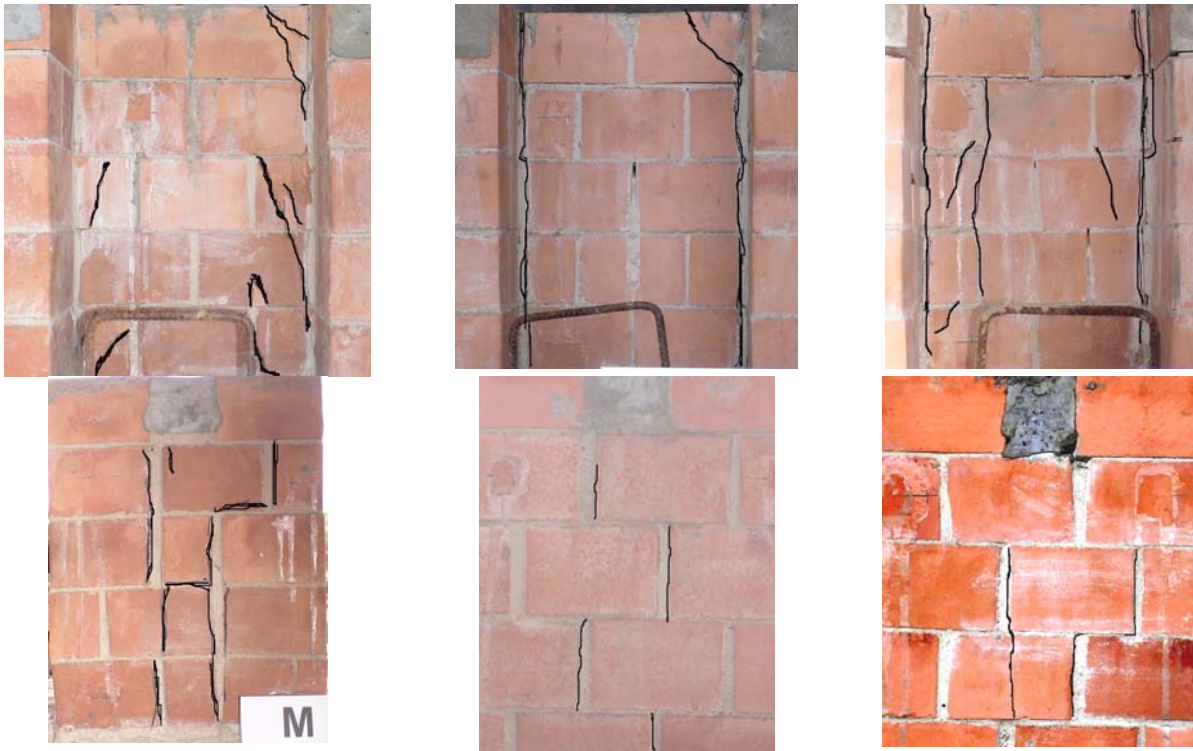
Figure 4: Comparison of typical failure patterns: a) Running bond (RB); b) Stack bond connected by steel trusses (SBT); c) Stack bond connected by steel U-staples (SBS)

The typical failure patterns shown in Figure 4 show the central web walls at the top and the flange walls at the bottom for the three types of connections. The cracking schemes point out a typical shear failure, with cracks concentrated near the vertical interfaces. For the RB case, the cracks on the central walls are predominantly short and inclined, while the SB cases present long

and almost vertical cracks near the interface, especially the connection with steel trusses (SBT). The cracks on the flange walls of the stack bond specimens (SBT and SBS) are less severe and thick than the RB case, where there is larger force transference from the central web wall to the flange walls, due to the interpenetration of the blocks.

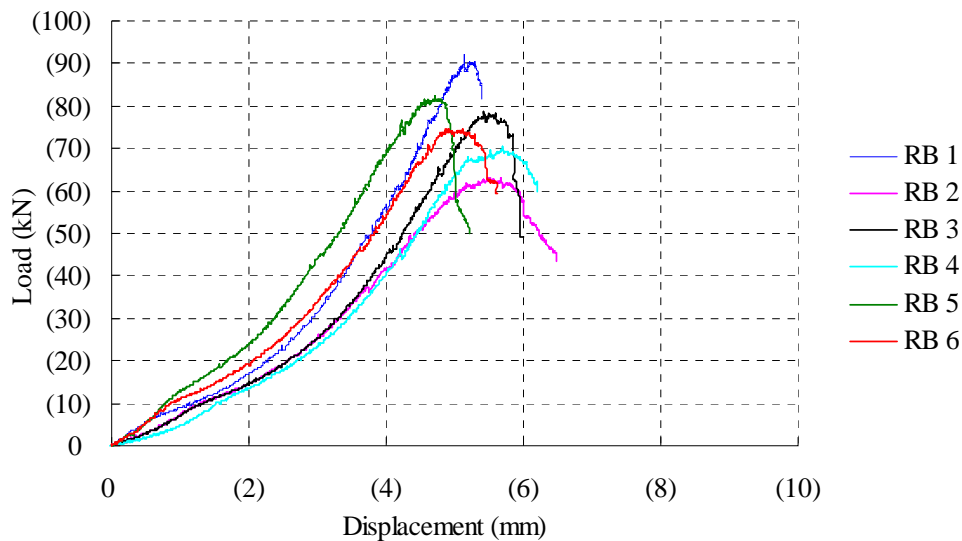
The RB specimens present a brittle failure, while the SB specimens show a tendency for ductile failure, provided by the steel connectors. This can be observed in Figures 5, 6 and 7 that shows the load-displacement diagrams for the three different types of specimens: RB, SBT and SBS, respectively. The plotted displacement corresponds to the vertical movement of the upper plate of the testing machine. The focus of the analysis is the after peak displacement, that is shorter for the RB specimens, with quick drops. Note that some curves for the SBS specimens present a yield threshold.

Figure 5: Diagram load-vertical displacement - RB specimens

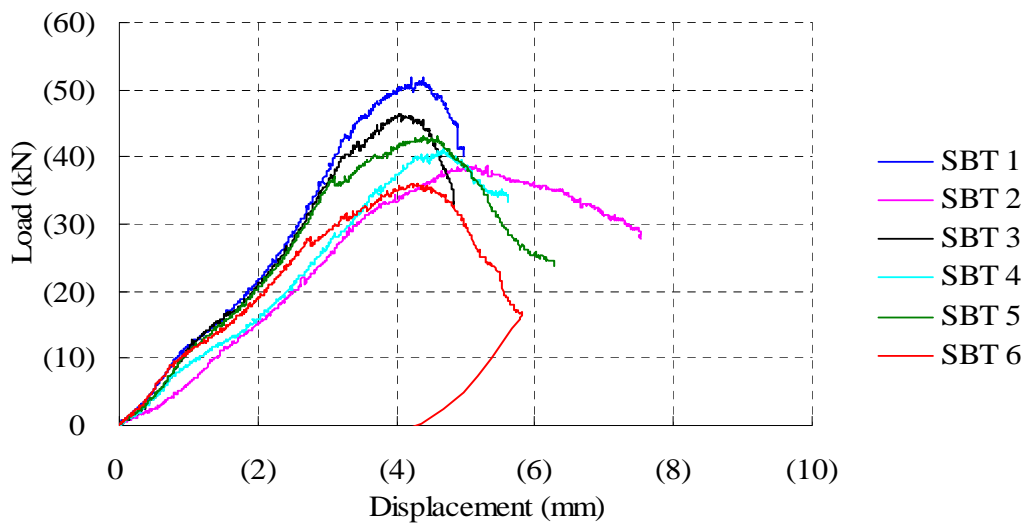
Figure 6: Diagram load-vertical displacement - SBT specimens
