## CASE STUDY AND DEVELOPMENT OF SEISMIC RETROFIT SOLUTION FOR A HERITAGE URM BUILDING

### ABSTRACT

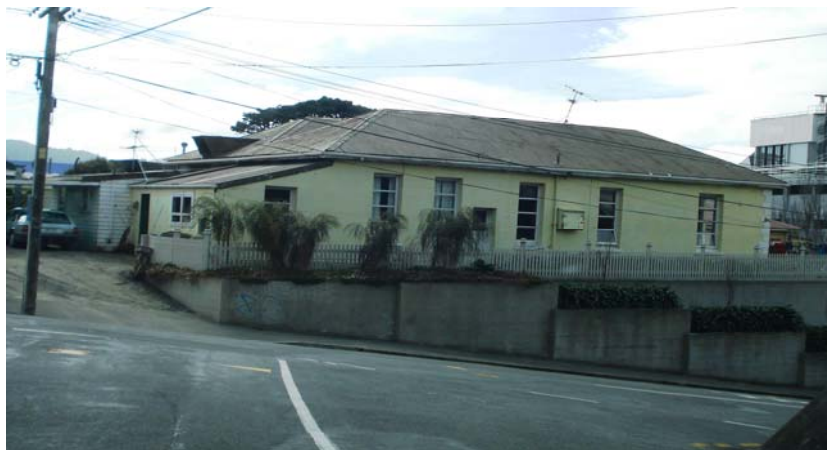
**Figure 1: Avon House street view**

Demolition and reconstruction of the case study building named "Avon House" were uneconomical and undesired tasks, due to its historical and cultural importance. Figure 1 shows the pictorial view of the building. This building was constructed by early British migrants in 1880's and is a single storey four bedroom house with British architecture and construction techniques. The subject building is situated on the northern side of Hargreaves Street and western side of Wallace Street in Wellington. A reinforced concrete retaining wall facing Hargreaves Street was constructed after the failure of the old stone masonry gravity retaining wall. The geological formation under the subject building is a moderately to slightly weathered Greywacke rock [4] and the house is a double-gabled building with a covered porch and a footprint area of 142.85 m<sup>2</sup>. The main gable runs along Hargreaves Street with the sloping gable end facing Wallace Street. The closest neighbouring building is 5 m to the east.

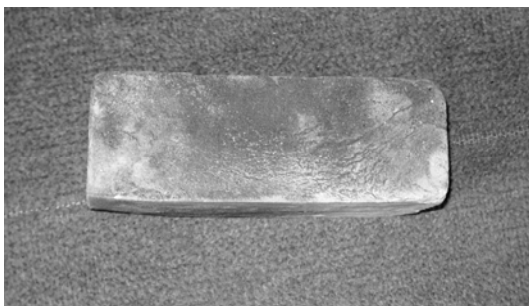
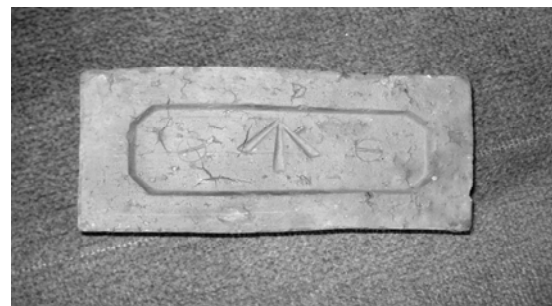
**Figure 3: Bricks used in construction: a) handmade bricks; b) mould-made convict brick**

Two types of bricks were used in the construction. Figure 3 shows features of the extracted brick samples from this building, suggesting that they were handmade. One of the more obvious signs is the rough surface of the bricks themselves. In the process of making bricks by hand, sand was often placed into the mould to prevent the clay from sticking to the sides. This resulted in the imprint of the sand remaining on the brick surface, giving it a rough face. The second type of bricks is the mould-made bricks manufactured by convicts, which is evident from the Arrow stamp and impressions of tightened bolts that are visible on the bricks. The soft nature of the bricks indicates that they were burnt at a low firing temperature. This is an indicator of early brick production.
