FAILURE INVESTIGATION OF A HISTORIC TWO-SPAN UNREINFORCED MASONRY ARCH BRIDGE USING FINITE-ELEMENT ANALYSES

Bryan P. Strohman¹ and Gunjeet Juneja²

ABSTRACT

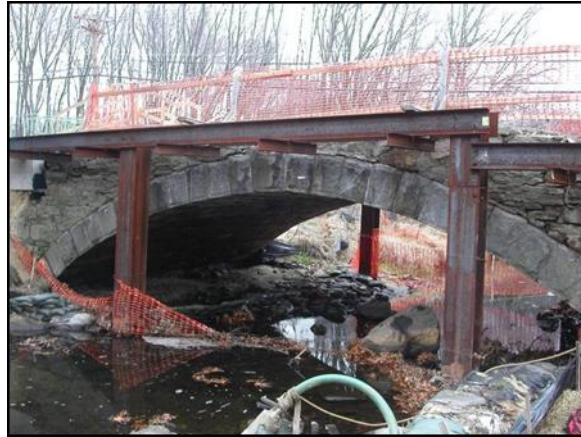
The spandrel walls above the arch were composed of irregularly-shaped uncoursed common rubble masonry stone set in mortar. Figure 1 shows an elevation of the north masonry arch post failure.

Figure 1: North Masonry Arch with Rehabilitation Auxiliary Framing

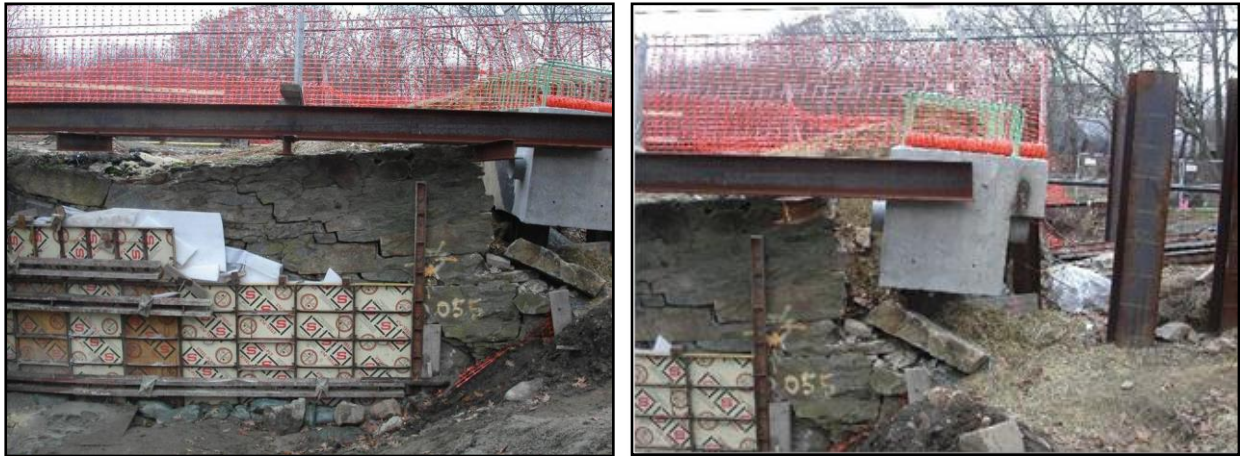
foundation, the south masonry arch effectively failed and underwent large horizontal and vertical movements. Although the arch did not collapse, the arch-ring stones and spandrel walls were severely displaced from their original positions. The movements also caused significant lateral displacement of the top of the new south integral-abutment foundation. The north arch experienced deformation with large longitudinal cracks on the underside and minor displacement of its integral-abutment foundation. The failure also resulted in cracking of the spandrel walls at several locations. Figures 2 and 3 show the damage to the bridge's arches, spandrel walls, and rotation of the new foundations. The purpose of this paper is to present the use of finite-element modeling in assisting the failure investigation of the unreinforced masonry arch bridge.

Figure 2: a) Failure of South Arch and Cracked Spandrel Wall; b) Rotation of New South Abutment

The damage observed during a post failure inspection indicated that the south masonry arch span experienced large movements in the range of about 1 ft (including movement of its foundations, arch-ring stones, and spandrel walls) horizontally and vertically. The observed condition of the south arch is similar to that of a three-hinged arch. As shown in Figure 9, the NASTRAN finite-element model results depict less vertical settlement but localized hinging at about the same locations observed during the post failure inspection.

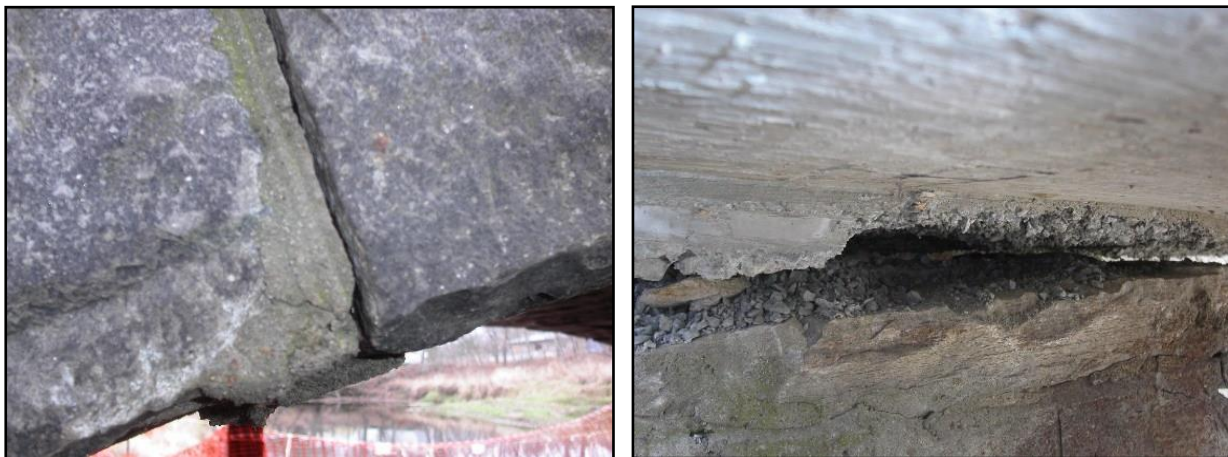
Figure 3: a) Opening in Mortar Joints between Exterior Ring Stones; b) Gap between Bottom of Northeast Spandrel Wall and Top of North Abutment
