EXPERIMENTAL STUDY ON ADOBE WALLS WITH LONG TERM WATER EXPOSURE DUE TO FLOODS

A. San Bartolomé¹, D. Quiun², D. Cabrera³, W. Huaynate⁴, I. Romero⁵ and J. Pereyra⁶

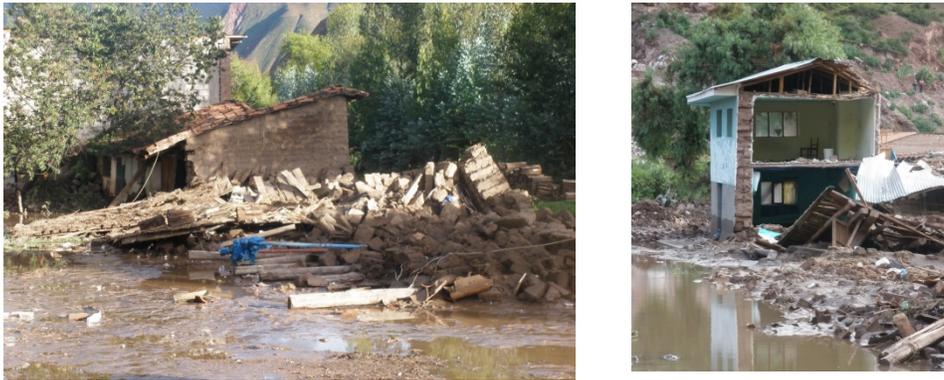
Figure1: Collapse of adobe houses under floods, Cusco Perú - 2010.

As result of our climatic diversity, Peru rural areas are periodically affected by intense rains that generate floods and river overflows. On the other hand, traditional adobe has a high vulnerability under prolonged contact with water product of these floods, which can cause the collapse of the structures (Figure 1). In this paper, two sets of experiments are reported, in which the water action of flooding was simulated on four adobe walls in each set. Eight walls were tested, two were traditional and the other six had some treatment or protection against water action. The solutions to protect the base of the adobe walls were all simple and economic. It is necessary to indicate that these solutions do not protect the adobes structures against the action of avalanches that drag large stones or rocks.

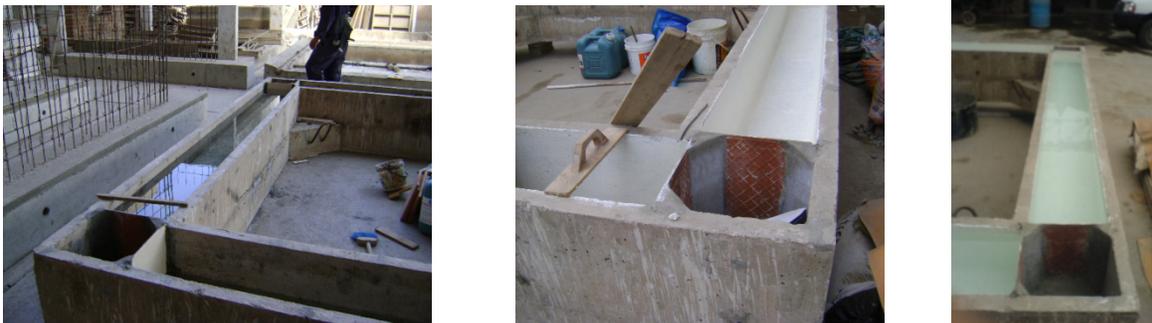
Figure 2: Channel used in the test of flooding. Test of water tightness.

A reinforced concrete channel with “U” section was used for the floods simulations, with an internal width of 280 mm. The channel fulfilled the requirements of impermeability and water tightness. It was divided into four sections of equal dimensions with independent channels as shown in Figure 2. In this way, the analyses of the variables of absorption, capillarity and performance along time of each wall were independent.

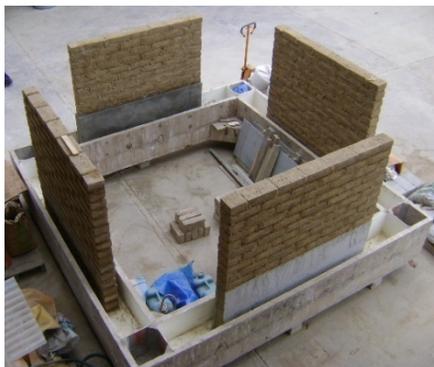
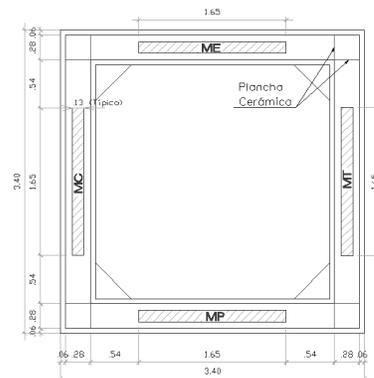
Figure 3: View of the four walls of the first set

The first set of four walls had a Traditional Wall (TW1) and three improved walls with different treatments against water action. The first treatment, Concrete Plinth Wall (CPW), used a plinth of plain concrete, instead of the traditional foundation of adobe walls made of stones. The second treatment, Stabilized Wall (SW), consisted in the use of stabilized adobe units with 5% cement in the bottom six layers exposed to flooding. In the third treatment, Plastered Wall (PW1), the units under water action were protected with a cement-sand (1:5 volume proportion) mortar cover applied over a henhouse mesh made of galvanized wires, connected to the wall. The main characteristics of the walls inside the channel are shown in Figure 3. With exception of the wall PW1 whose thickness increased due to the mortar plaster, all the walls had the same dimensions: 1.50m height, 1.65m length and 0.13m thickness. All the walls were constructed by the same masons. The vertical and horizontal joints of the walls had 15 mm thickness and the mortar was prepared with the same material used in the adobes.

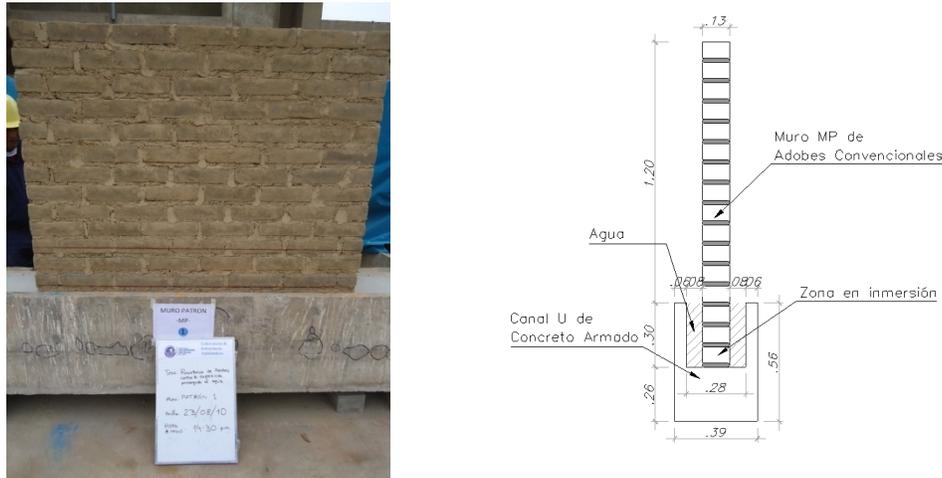
Figure 4: Traditional Wall set 1– TW1

The traditional wall (TW1) in Figure 4 does not have any improvement and the mortar was of the same material of which the adobe units were made. For the construction of the Concrete Plinth Wall CW1 shown in Figure 5, the plinth of plain concrete had $f_c = 21$ MPa. This foundation had 300 mm height over the water level and had the same thickness as the wall. The same traditional units and mortar were used (similar to TW1).

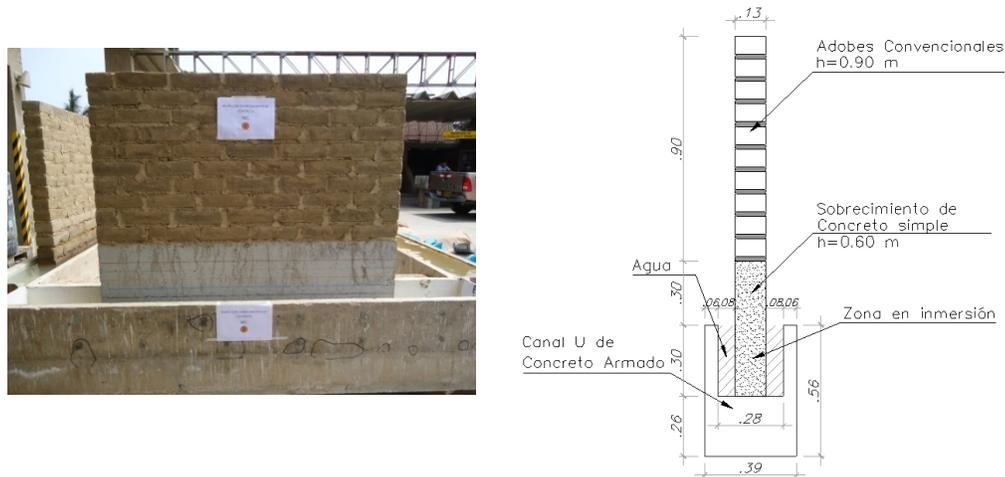
Figure 5: Concrete Plinth Wall – CW1

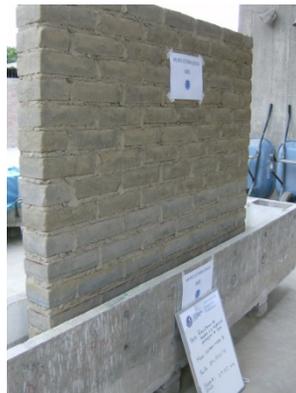
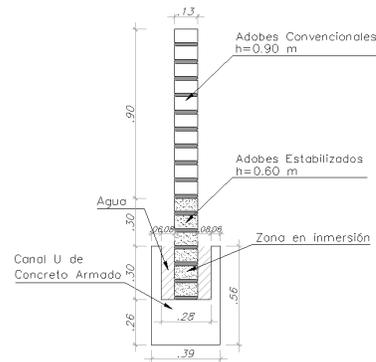
Figure 6: Stabilized Wall - SW

In the stabilized wall SW (Figure 6), from the base of the channel up to a height of 300 mm over the water level, six layers of stabilized adobes with 5% of cement (in weight), were used. The mud mortar was stabilized with the same proportion of cement, whereas the following layers had traditional adobe units and traditional mortar, similar to TW1. The plastered wall PW1 (Figure 7) was constructed totally with traditional adobes and mortar mud (similar to TW1). Later, it was plastered with a cement-sand mortar mix of 15 mm thickness, from the base up to a height of 300mm above the water level, over a henhouse wire mesh.

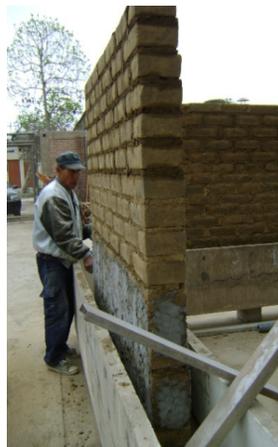
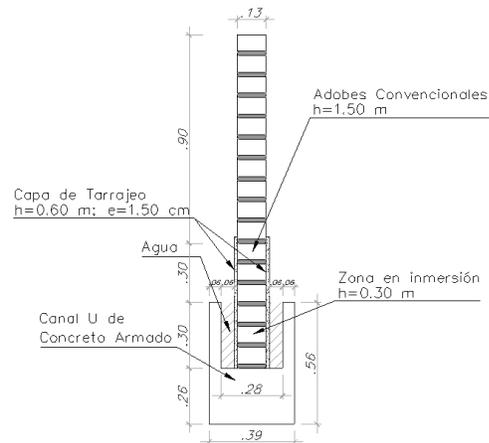
Figure 7: Plastered Wall set1 – PW1

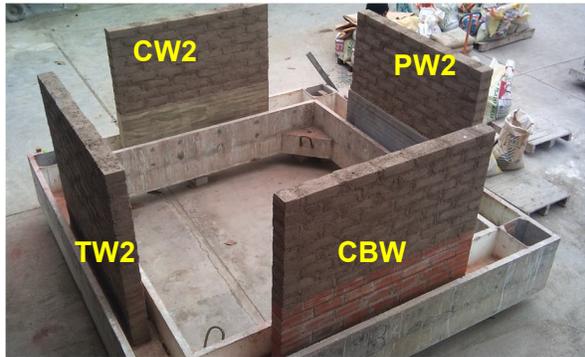
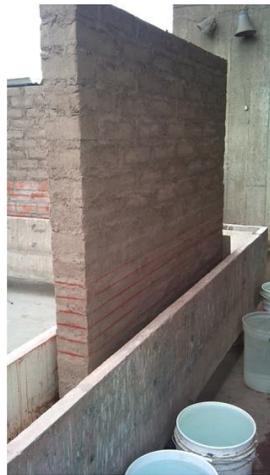
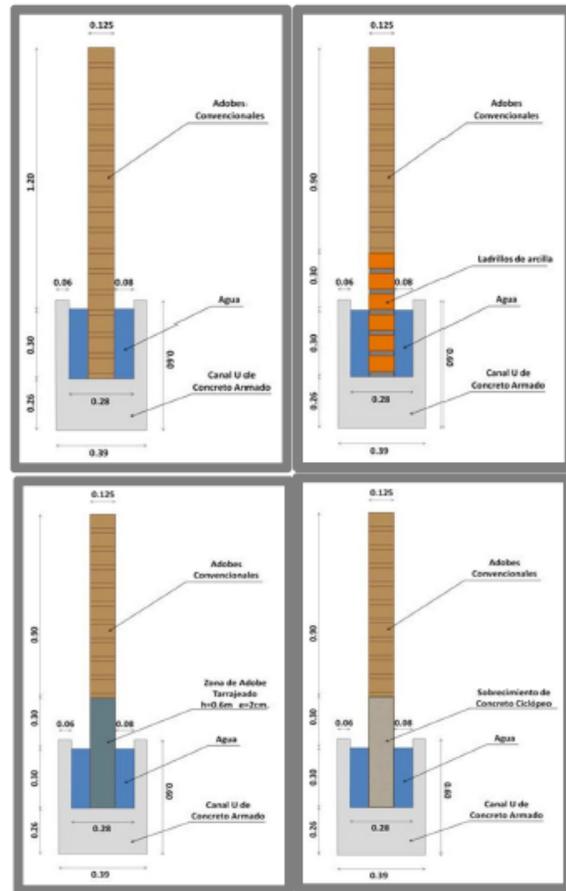
Figure 8: Walls of set2 – in the drawings
TW2 (upper left), CBW (upper right), CW2 (lower left), and PW2 (lower right).

The second set of four walls had a Traditional Wall (TW2) and three other improvements in the wall treatment against water action. The CBW wall had the bottom six layers of clay brick units, as a brick plinth of 600 mm height, which is twice the area in contact with water. The mortar mix was cement-sand 1:4 volume proportion. The following 10 layers were of traditional adobe units, similar to TW2. The CW2 wall had a plinth of low resistance plain concrete; it had 600 mm height in which concrete was poured in layers, with 75 mm (3") previously washed stones placed in each layer. The last wall PW2 was built similar to the TW2, but a mortar cement plaster was applied afterwards over a welded wire mesh, to a height of 600mm and 20 mm thickness over the perimeter. The wire mesh was placed on both sides of the wall and it was connected to the wall with smaller wires in the vertical joints every 250mm. Finally, the plaster surface was polished by using cement powder with water.

Figure 8 displays the characteristics of the four walls of this second set. Also their position inside the concrete channel is shown.

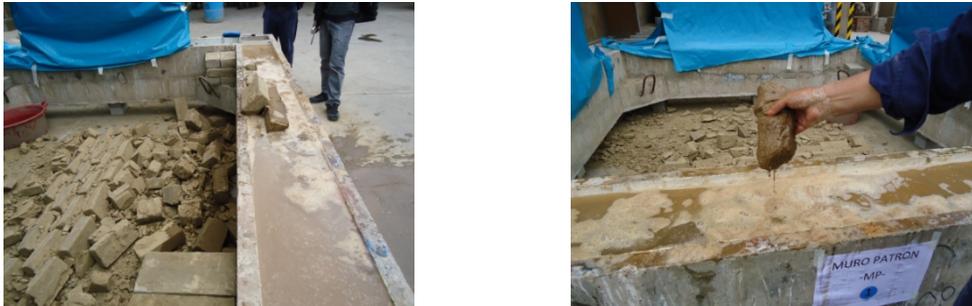
Figure 9: Overturned wall TW1 and condition of the adobes in the base.

The traditional adobe walls collapsed after 20 and 73 minutes, while the other six remained stable without danger of collapse. For the first set of walls, TW1 resisted less than the short period of flooding. The adobe units at the base disintegrated and immediately the wall overturned as can be seen in Figure 9. The other three walls of set 1, CW1, SW and PW1 resisted 16 days of flooding and they are shown in Figure 10.

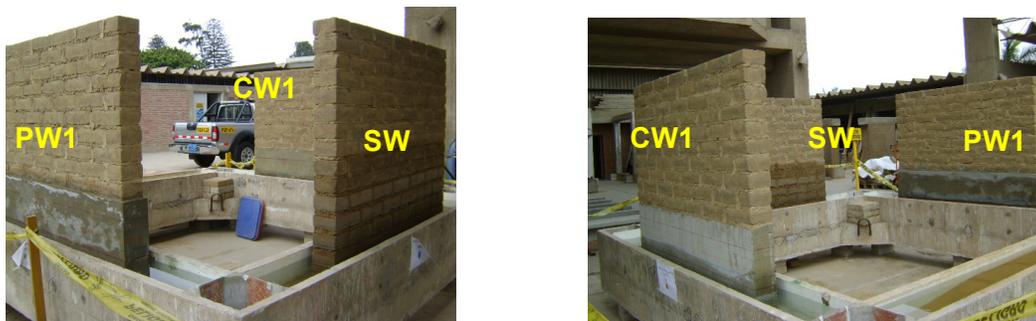
Figure 10: Three walls of set 1 that resisted the flooding simulation test

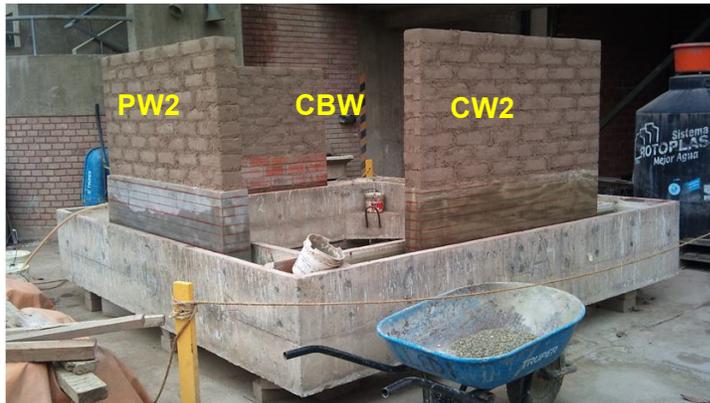
Figure 11: Three walls of set 2 that resisted the flooding simulation test

For the second set of walls, TW2 resisted 73 minutes of flood, also less than the short period of flooding. The other three walls of set 2, CW2, CBW and PW2 resisted all the 24 days of flooding before being demolished, as shown in Figure 11. Figure 12 shows the condition of adobe units of walls PW1 and SW of set 1, and the brick units of CBW of set 2.

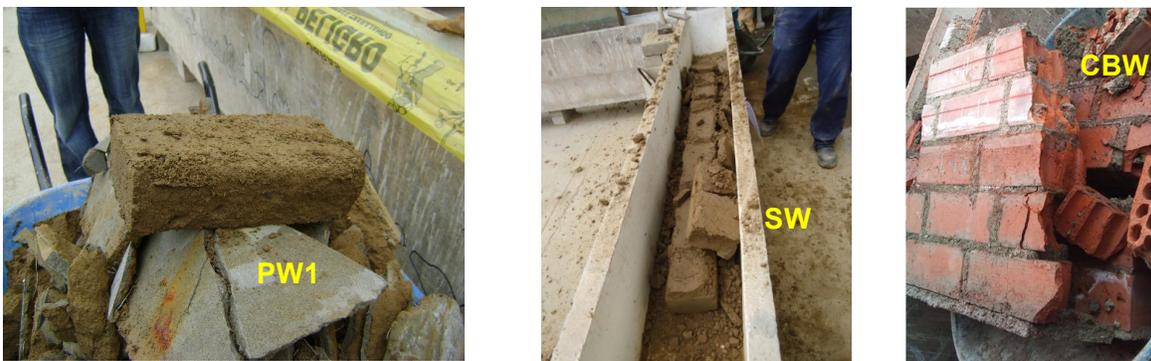
Figure 12: Inspection of masonry units in the base after demolition of the walls.

After finishing the tests, the walls had all their 15 layers carefully dismantled. For set 1 of walls, the first 8 layers of SW and the first 6 layers of PW1 were humid, whereas all the units of CW1 were dry. Therefore, the humidity ratio can be set as 4:3:0 for walls SW, PW1 and CW1, respectively. For set 2 of walls, the first 3 layers of CBW and the first 4 layers of PW2 were saturated, while the first 350mm, equivalent to 3 and a half layers, of CW2 were saturated. Therefore, the humidity ratio is 3:4:3.5 for the walls CBW, PW2 and CW2, respectively.

The consistency of the units was defined as the touch feeling. In this way, the adobe units at the base for walls SW and PW1 had partial instability, whereas CW1's adobes were dry. Therefore the proportion can be set as 1:1:0 for the set 1 walls SW, PW1 and CW1, respectively. Similarly, for set 2 walls, the units of CBW and PW2 were unstable and the units of CW2 were dry. Therefore the proportion can be set as 0:1:0 for the walls CBW, PW2 and CW2, respectively.

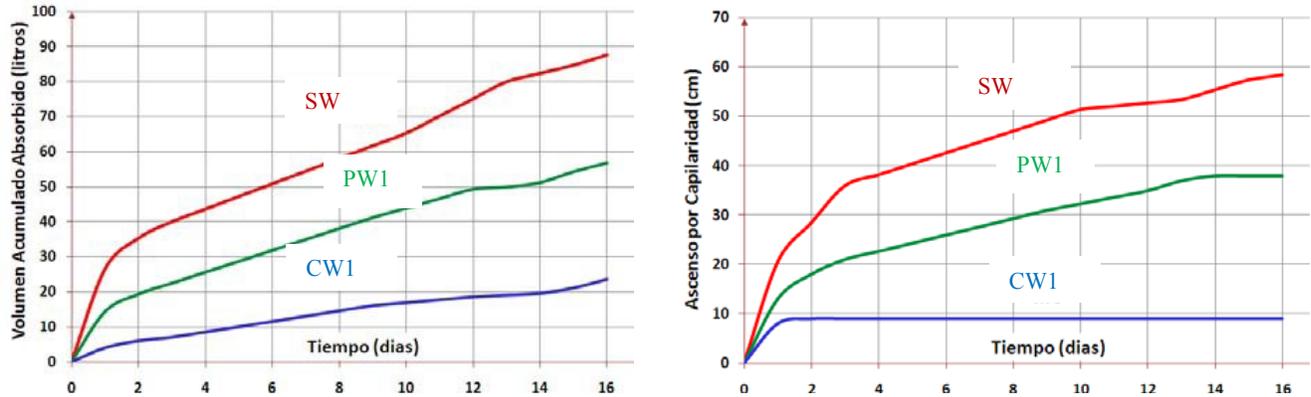
Figure 13: Results for set 1 of walls, absorption (left) and capillarity (right)

In Fig.13 the water absorption (in liters) of the walls and the capillary rise (in cm) during the 16 days of test of set 1 are shown. A rapid absorption of water during the short period of flood is clear, whereas during the long period of flood the slopes of the graphs for walls SW, PW1 and CW1, are in a proportion 3:2:1 respectively. Regarding the capillarity, the rise for CW1 was of only 9cm without reaching the adobe layers and became stable after 48 hours. At the end of the test, the capillary rise proportion was 1.65: 1: 0 for walls SW, PW1 and CW1, respectively. In Fig. 14, the water absorption and the capillarity rise during the 24 days of test of set 2 are shown.

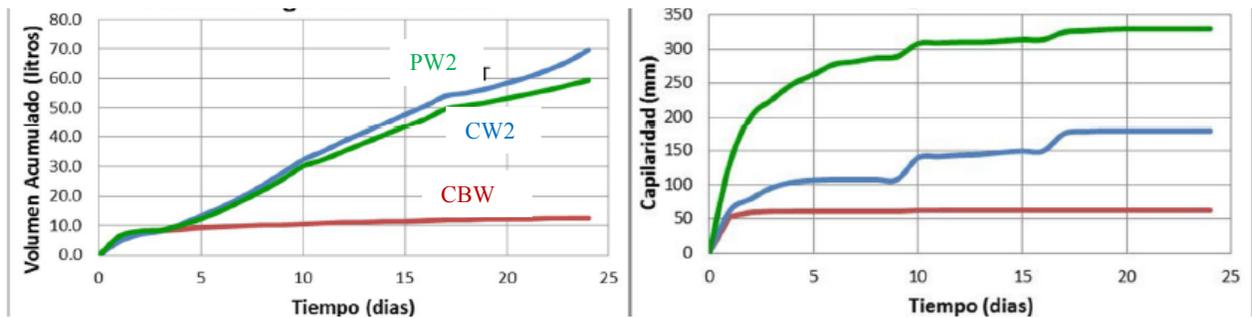
Figure 14: Results for set 2 of walls, absorption (left) and capillarity (right)

Also a rapid absorption of water during the short period of flood is clearly similar for the three walls. Regarding the capillarity, the maximum rise was only 55mm for CBW and for CW2 it was nearly 330mm by day 20. At the end of the test, the capillary rise proportion was 2: 3: 7 for walls CBW, PW2 and CW2, respectively.
