IMPLICATIONS OF THE CANTERBURY EARTHQUAKE SEQUENCE FOR ADELAIDE, SOUTH AUSTRALIA

ABSTRACT

KEYWORDS: Adelaide, Canterbury, earthquake, seismic risk, unreinforced masonry

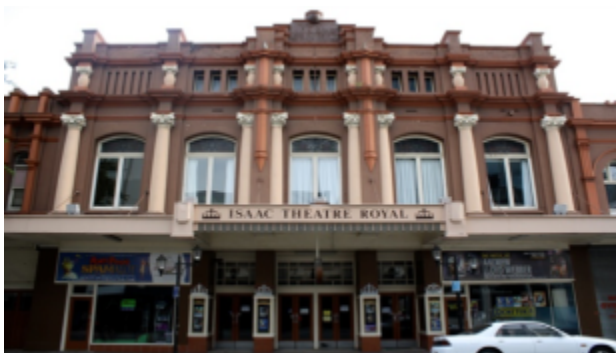
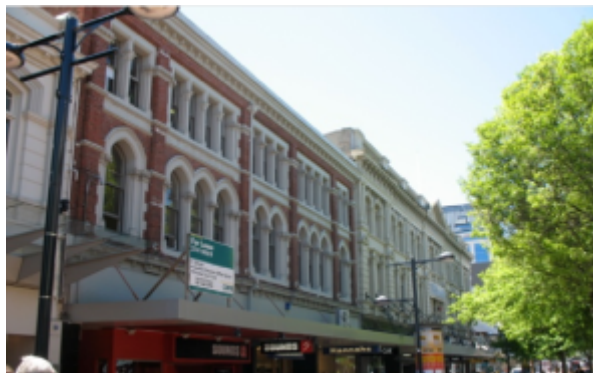
Figure 2: Representative examples URM buildings in Christchurch and Adelaide: a) Corner shops in Christchurch; b) Corner shops in Adelaide; c) Christchurch Theatre; d) Adelaide Arcade; e) Christchurch Mall; f) Adelaide Mall; g) Christchurch Cathedral; h) Bonython Hall, University of Adelaide

Figure 2 shows several examples of the similarities between the existing construction form in Adelaide City and that of Christchurch city before the 2010 Canterbury earthquake.
