EXPERIMENTAL ANALYSIS OF THE SHEAR CAPACITY OF INTERCONNECTED BLOCKWORK WALLS

Luciane Marcela Filizola de Oliveira¹ and Márcio Roberto Silva Corrêa²

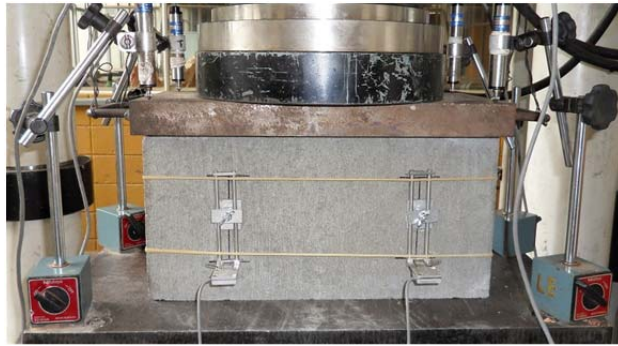
a) Concrete units in compressive strength test

Figure 1 – Test setup of the compressive strength tests of units.

Figure 1 and Figure 2 show the compressive strength tests and splitting tensile strength tests of concrete and clay blocks. Figure 3 shows the compressive strength tests of prisms and wallettes.

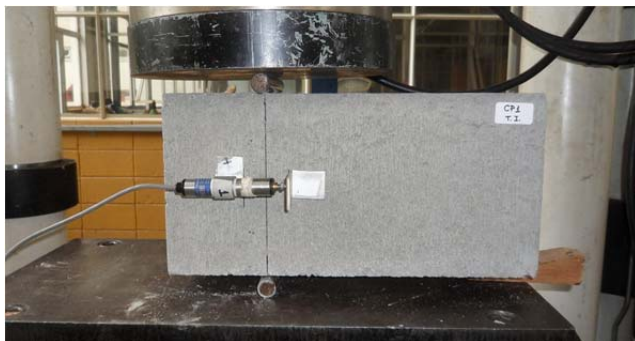
a) Concrete units in splitting tensile strength test.

Figure 2 – Splitting tensile strength tests of concrete and clay units.

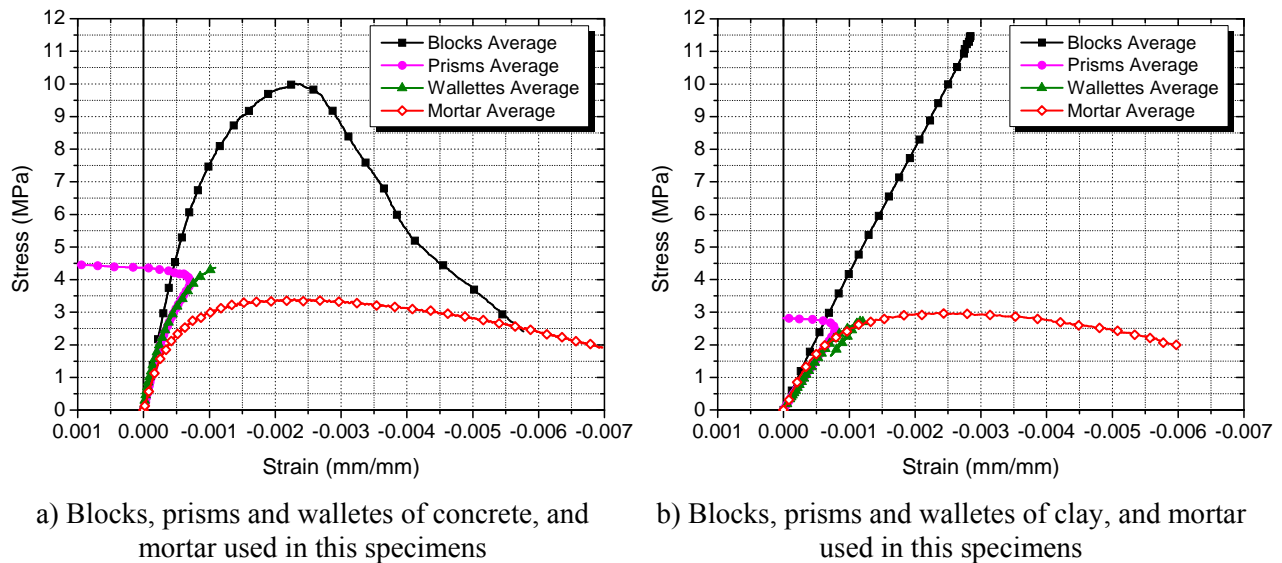
Figure 4 shows the stress-strain diagram results of all compressive tests. In all cases, a brittle failure of the specimens was observed, as expected.

Figure 4 – Stress-strain diagrams of the specimens in compressive strength tests.

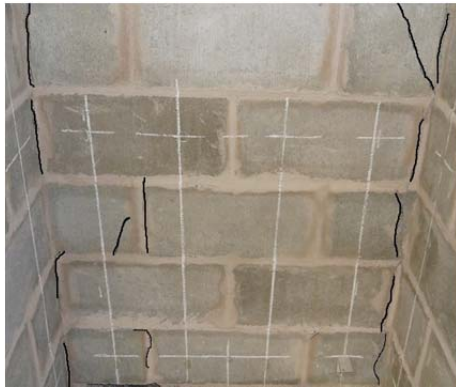
For all series, failure occurred as a shear crack at the flange-web interface. Running bond connection clearly increased the shear strength of the interface. The failure occurred in the blocks due to the accumulated stress on interlocking blocks. Failure did not occur simultaneously on both sides and load capacity increased after initial cracking. In the first two series, the web showed a wide deformation and many cracks occurred before failure. See Figure 8.

a) Cracking patterns of concrete specimens

Figure 8- Failure mode of running bond specimens.

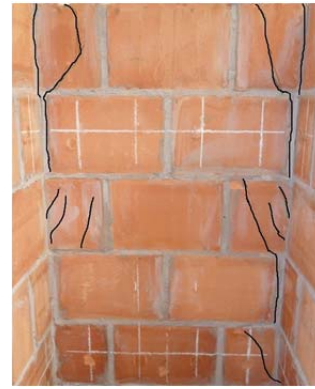
b) Cracking patterns of clay specimens

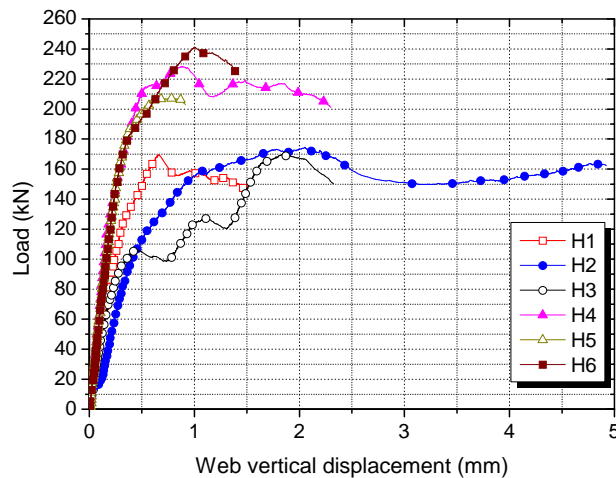
The average load-displacement data for each of the running bond specimens are shown in Figure 9. The initial branch of the load-displacement graph appeared to be linear, up to 75% of the ultimate load in almost all specimens. The cracks on the web started at approximately 50% of the ultimate load.

a) Displacement of web (concrete specimens)

Figure 9 – Running bond specimen load-displacement relationships.
