THE EFFECT OF ASPECT RATIO ON THE SHEAR STRENGTH OF PARTIALLY GROUTED CONCRETE MASONRY WITH WIDE-SPACED REINFORCEMENT

A. Hamedzadeh¹ and N. G. Shrive²

KEYWORDS: in-plane shear, partially grouted masonry, wide-spaced reinforcement, aspect ratio

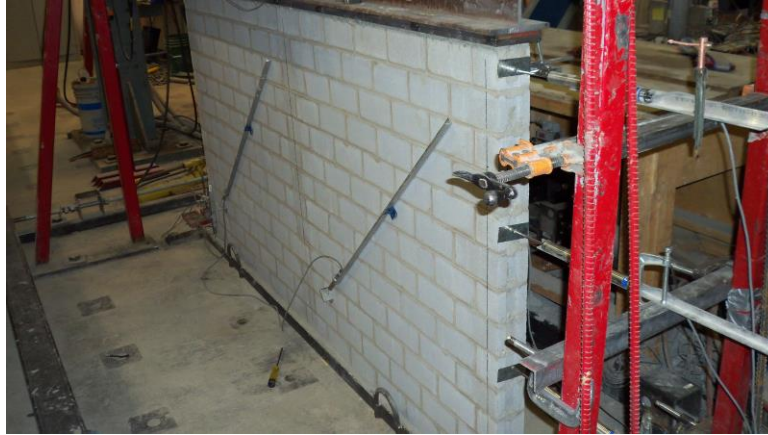
The walls were instrumented with displacement transducers. A diagonal transducer was mounted on each panel to monitor the diagonal cracking of the panel (see Figure 1). Four displacement transducers were placed at one end of the wall to measure the horizontal deflection at different heights. The up-lift of the base and the heel of the wall were monitored as well. Two transducers were placed at the other side to measure the vertical displacement of specimen (Figure 2). Since the top left and right blocks can crack throughout the test and disturb the measurements, the transducers were not mounted directly on the specimen but rather two angles were mounted tightly to the respective blocks and the transducers read the displacements of these mounted angles. The readings from the diagonal transducers are not reliable after the first diagonal crack initiates in the panel: however, the readings can be useful in determining when the major cracks occurred in the specimens. The instrumentation on a squat wall is shown in Figure 1.

Figure 1: Instrumentation of squat walls

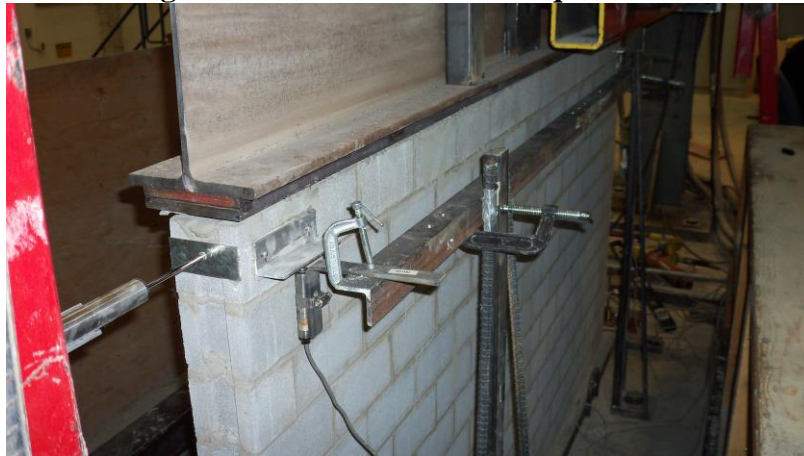
Figure 2. The arrangement of transducers to measure the vertical displacement

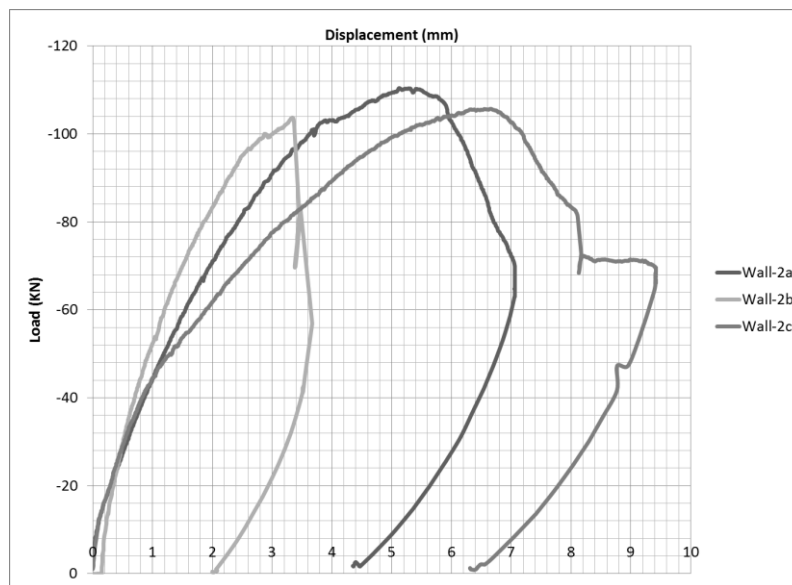
Figure 5: Load-displacement curves for Walls 2a, 2b and 2c

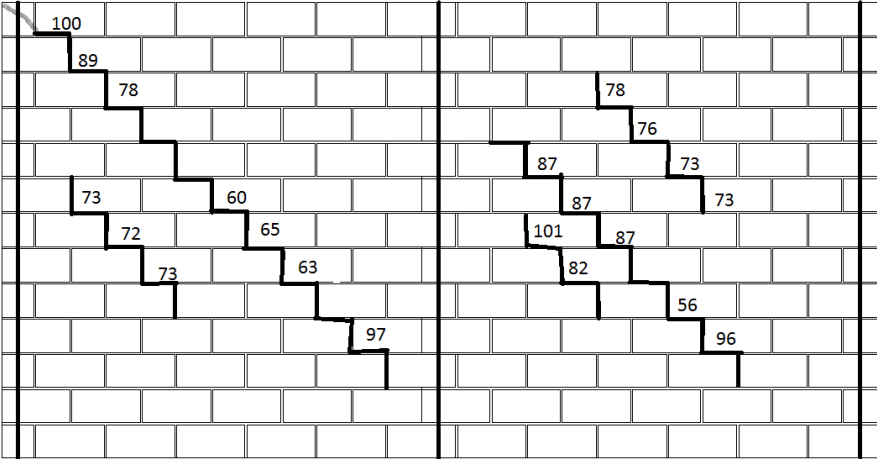
Figure 7: Crack pattern for Wall-2b

In Wall-2b, two major diagonal cracks were observed in both panels. The load dropped rapidly after the specimen reached its ultimate strength. The displacement at ultimate load was significantly lower than for the other specimens in this group. As can be seen in Figure 7, the two panels acted like two separate panels: no crack passed through the middle core.
