13TH CANADIAN MASONRY SYMPOSIUM
HALIFAX, CANADA
JUNE 4TH – JUNE 7TH 2017

PERFORMANCE OF REINFORCED MASONRY WALLS STRENGTHENED WITH FRP COMPOSITE EXPOSED TO COMBINED ENVIRONMENTAL CONDITIONS

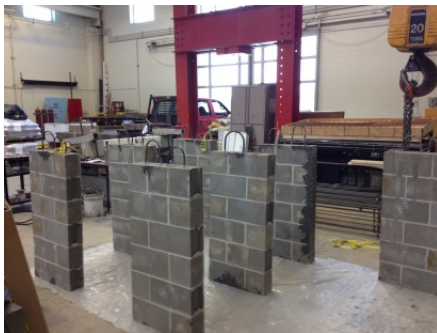
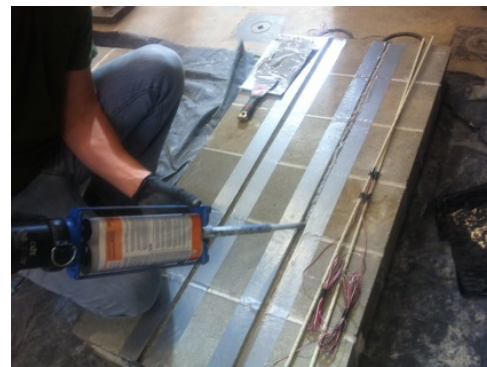
For the NSM there is no surface preparation needed. The NSM FRP installation process involves inserting FRP bar into a groove cut at the tension surface of the wall. A special concrete saw was used to cut the grooves with a dimension double the diameter of the bar to avoid splitting failure of the epoxy cover[11]. The FRP bars are deformed by a helical wrap with a sand coating to improve the bond between the bars and epoxy. The epoxy was pressure injected into the grooves to cover 2/3 of the groove height. The FRP bar was placed in the grooves and lightly pressed to force the bonding agent to flow around the bar and ensure completely bond between the bar and the sides. The groove is then filled with more epoxy and the surface leveled. Construction of masonry walls and installation of FRP in groove are shown in Figure 2.

Figure 2: Experimental Program: (a) Construct Walls and (b) Installation of FRP in Grooves

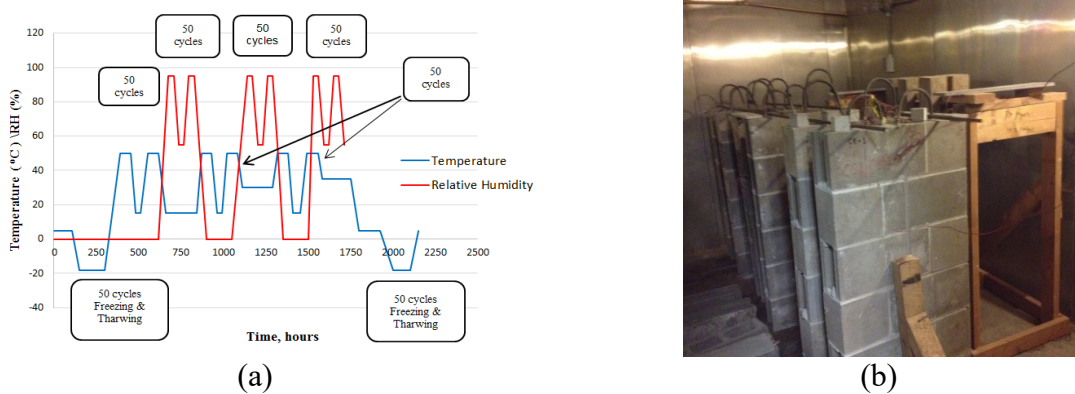
50 minutes and thawing at 4.4°C (40°F) for 50 minutes. The transition period between freezing and thawing was 30 minutes. To simulate the summer season effects, 150 alternating cycles of extreme temperature from 27 to 50°C (80 to 120°F) is used. Extreme temperature cycle consisted of temperature variation between 27°C (80°F) for 25 minutes and 50°C (120°F) for 25 minutes. The transition period between high and low temperature was 20 minutes. Relative humidity cycles were carried out between 60% and 100% and maintained for 20 minutes each, transition period between 100% and 60% humidities was 30 minutes. Relative humidity cycles were carried out at constant temperatures of 15.5°C (60°F) and 26.7°C (80°F). The order of cycling was 50 freeze-thaw cycles, 20 RH cycles at constant temperature of 15.5°C (60°F), first set of 40 extreme temperature cycles, 20 RH cycles at constant temperature of 26.7°C (80°F), second set of 40 extreme temperature cycles, 20 RH cycles at constant temperature of 15.5°C (60°F) and third set of 40 extreme temperature cycles. The exposure regime and specimens in environmental chamber are shown in figure 3.

Figure 3: Environmental cycles: (a) Exposure Regime (b) Specimens in Environmental Chamber

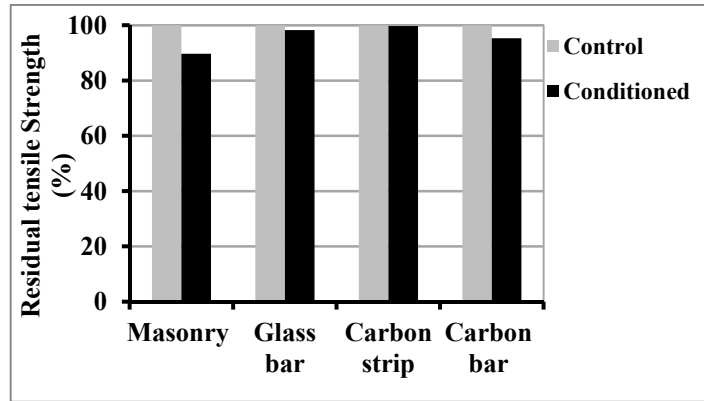
Tensile tests, according to provisions of ACI 440[12] were conducted by [13] to study the change in longitudinal mechanical properties of FRP. The tensile strength of GFRP bars and CFRP strip subjected to the environmental cycles did not reduced showed a good durability resistance comparing with control bar. Carbon bars showed a degradation in tensile strength by approximately 5%[13]. The results of the effect of environmental cycles on individual components are illustrated in Figure 7.

Figure 7: Residual tensile strength (FRP result[13])
