**13<sup>TH</sup> CANADIAN MASONRY SYMPOSIUM**  
**HALIFAX, CANADA**  
**JUNE 4<sup>TH</sup> – JUNE 7<sup>TH</sup> 2017**

**COMPRESSIVE STRENGTH AND FAILURE MODE OF AXIALLY LOADED HOLLOW  
CONCRETE BLOCK MASONRY**

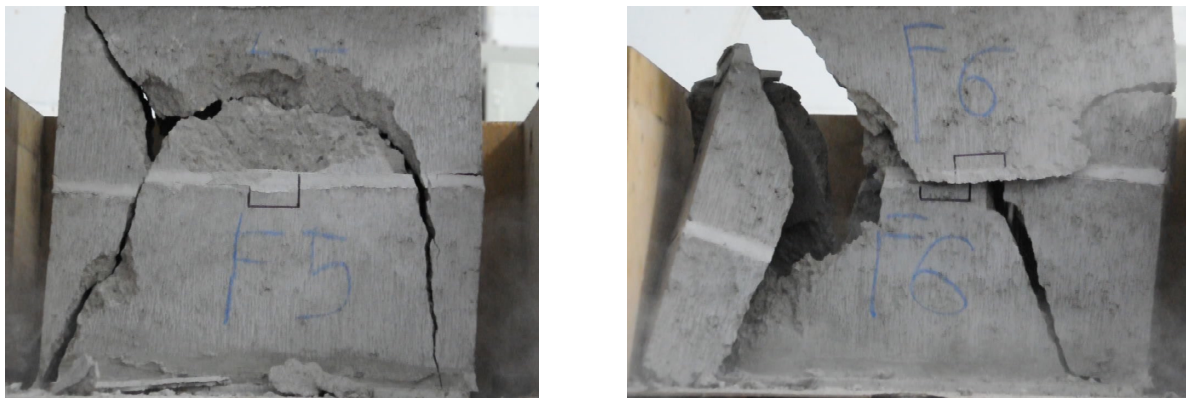
Figure 2 shows prisms S5 and S6 after failure. These prisms are representatives of the behavior of the prism group constructed with the stronger mortar. The failures of the prisms constructed with the strong mortar were brittle, sudden, and explosive.

**Figure 2: Cracking pattern of prisms S5 and S6.**

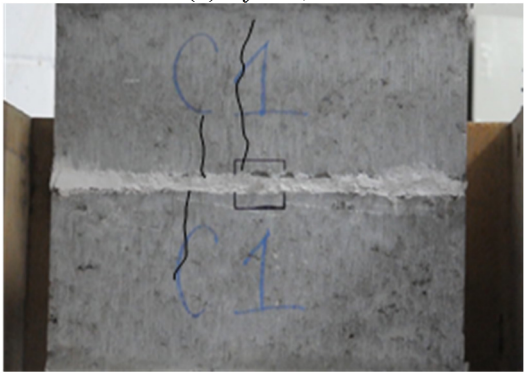
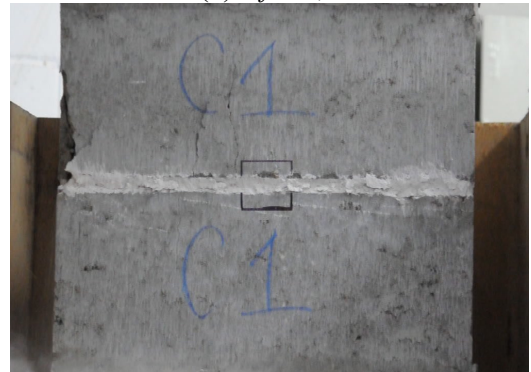
The prisms constructed with the weaker mortar had the behavior represented by prisms W1 and W6, as shown in Figures 3 and 4, respectively. There were regions, highlighted and shown with arrows in Figures 3 and 4, where detachment between the mortar and the block, indicating mortar crushing, were observed. Soon after mortar crushing was observed, vertical cracks appeared on the blocks. A possible explanation for the formation of the cracks is as follows: the mortar detachment and crushing caused the detached region of the block to be unsupported. As load continued to be applied, the gap between the top surface of the bottom block and the bottom surface of the top block at the detached region tended to close generating tensile stresses on the surfaces of the block. The tensile stresses caused the block to eventually crack vertically (as shown in Figure 3).

**Figure 3: Failure sequence of the prism W1.**

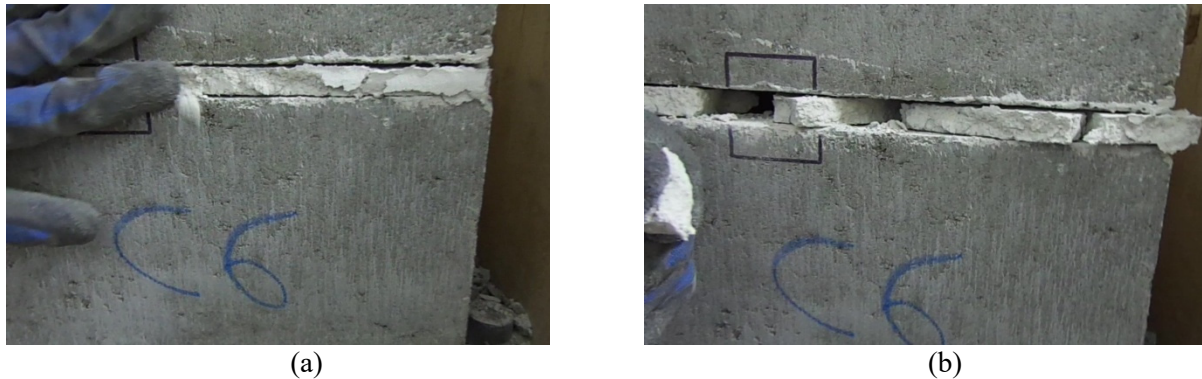
The post-failure autopsy of the prisms with weaker mortar shows that the block-mortar bond was completely broken and the mortar porous structure completely destroyed; the mortar as essentially like a compacted powder. Figure 5 shows the complete detachment between the mortar and the blocks and the compacted powder appearance of the mortar after the failure of prism W6.

**Figure 5: Aspect of the mortar joint of prism W6 after the failure**

The bond between the blocks and the mortar was influenced by the mortar low compressive strength, the presence of water retainers in the manufactured mortar, and the low water absorption capacity of the concrete blocks, which was approximately 6%. Thus, the connection between mortar and blocks was weak, and as the mortar crushing started at a stress level between approximately 2.7 and 4.5 MPa, there was the break of the bond between the components. A similar behavior was observed by Steil et al. [25].
