13TH CANADIAN MASONRY SYMPOSIUM
HALIFAX, CANADA
JUNE 4TH – JUNE 7TH 2017

**QUANTIFICATION OF NON-STRUCTURAL DAMAGE IN UNREINFORCED
MASONRY WALLS INDUCED BY GEOTHERMAL RESERVOIR EXPLORATION
USING QUASI-STATIC CYCLIC TESTS**

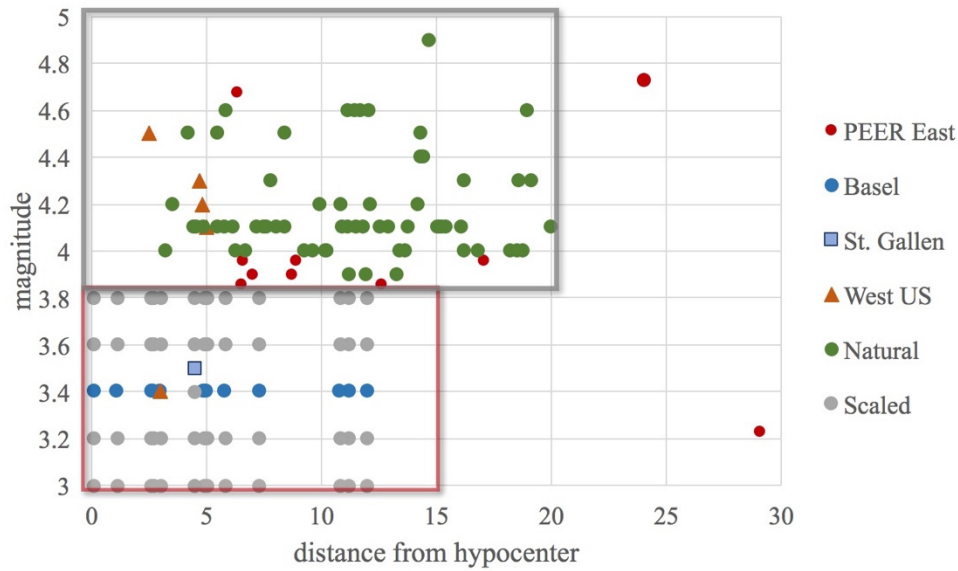
Figure 1: Augmented database used to compute the load sequences (BIN 1: red box; BIN 2: grey box)

BIN2 was augmented with 63 European natural records with the same magnitude, distance and soil conditions. The records belong to soil classes A and B (according to Eurocode 8). The total number of motions of the augmented BIN 2 was 72. Figure 1 shows the augmented dataset.

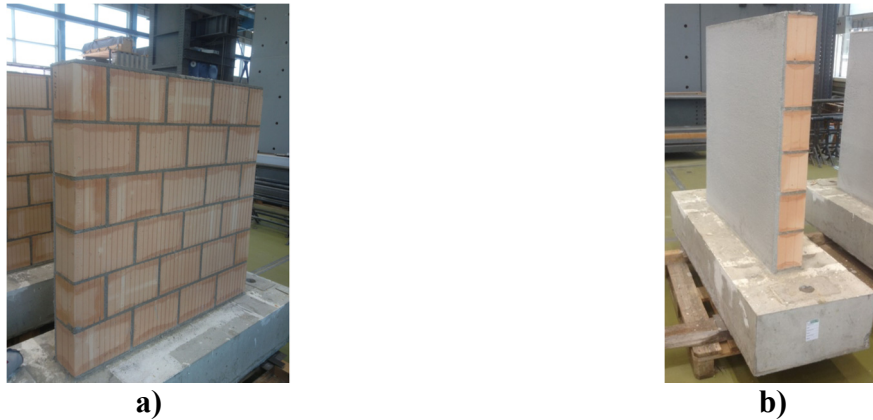
Figure 5: URM wall specimen: a) without plaster; b) with plaster

Five $1.20 \times 1.20 \times 0.15 \text{ m}$ URM wall specimens were built and tested in the Structural Testing Laboratory at ETH Zurich. Convectional hollow Swiss clay bricks (produced by *ZZ Wancor AG*, corresponding to *Swissbrick B15/19*) were used to manufacture each wall. The mortar used for the joints was *Weber mur 920 (Zementmörtel M15)*. The average vertical compression strength of walls, $f_c = 4.50 \text{ MPa}$, was determined 5 months after the construction of the specimens [9]. The front side of each wall was plastered at least 28 days before testing with a 12-14 mm thick plaster

layer (*Zement-Kalk 29* produced by *Granol*). No plaster was applied to the back side. Figure 5 shows the tested URM wall.

As shown in Figure 5, each wall was placed on a concrete foundation, which was then fixed to the reaction floor by post-tensioning bars. A mortar layer connected the wall top to the loading frame of the experimental setup, which is described in the following subsection. The same mortar as used for the joints of the wall was used to produce 10mm thick and fully filled bed and head joints. In order to avoid vertical loads on plaster, the top mortar layer was only applied on the bricks, leaving the plaster free. Note that due to the variable height of the top mortar layer, a small angle has been observed between the top of the wall and the movement of the horizontal actuator. In the following, this angle is considered as negligible.

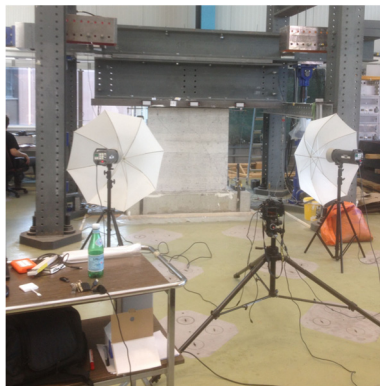
Figure 7: DIC setup: a) camera and flashlight positions; b) detail of the random speckle pattern applied to the plaster surface

Digital Image Correlation (DIC) was used to acquire in-plane displacement and strain fields on the plaster surface during the tests. Figure 7 provides an overview of the DIC setup including the speckling pattern.

A black and white random speckle pattern was painted on the plastered surface of the specimen. The dot size of about $1 \div 1.5 \text{ mm}$ was calibrated to obtain $3 \div 4$ pixel size dots in digital images, which was proved to be an optimal setting for the target measurements [10]. Digital images were taken with a NIKON D810 digital camera with a 50mm lens, while two flashlights guaranteed a uniform illumination and optimal balance of the plaster images. Picture shooting was triggered from the actuator controller at pre-defined displacement values of the test protocol.
