13TH CANADIAN MASONRY SYMPOSIUM
HALIFAX, CANADA
JUNE 4TH – JUNE 7TH 2017

**IMPROVING ON-SITE STORMWATER MANAGEMENT WITH PERMEABLE
INTERLOCKING CONCRETE PAVEMENTS**

Sehgal, Kirti¹ and Drake, Jennifer²

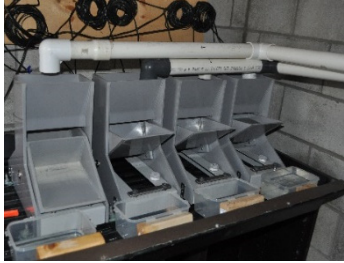
Measured Characteristic	Equipment Used	Installation Illustration	Remarks
Flow Monitoring	Tipping Bucket

<ul style="list-style-type: none"> ▪ 4 tipping buckets of 1 L capacity ▪ Installed at the underdrain outlet ▪ Data recorded at 5 min interval ▪ Connected to HOBO® data loggers
Water Level	Pressure Transducers

The PICP underdrains are accessible at a downstream monitoring hut. Each drain is outfitted with a gate valve allowing stormwater to be temporarily held upstream within the aggregate reservoir. During summer 2016, flow and precipitation monitoring equipment were installed for the four PICP cells. The details of the equipment are summarised in Table 2.
