**13<sup>TH</sup> CANADIAN MASONRY SYMPOSIUM**  
**HALIFAX, CANADA**  
**JUNE 4<sup>TH</sup> – JUNE 7<sup>TH</sup> 2017**

**USE OF ACCELEROMETER TECHNOLOGY FOR QUANTIFYING CONDITION OF  
MASONRY ARCH BRIDGES**

**Nichols, John<sup>1</sup>; Tomor, Adrienn<sup>2</sup> and Benedetti, Andrea<sup>3</sup>**

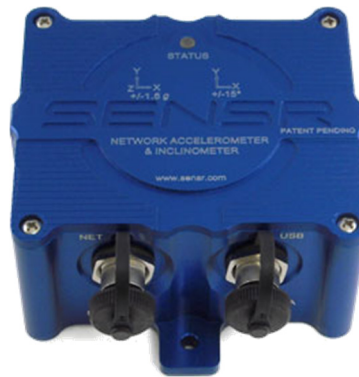
non-Gaussian, usually of short duration and lacks statistical certainty. The current work is carried out using a single SENSR CX1 accelerometer (Figure 1) [10] that uses ambient vibration (often referred to as Brownian motion) [8,11] as a constant environmental load (only influenced by temperature). The resolution of the CX1 accelerometer is around 10 to 20 *micro-g* (where *g* is gravity) and the practical limit for the measurement system is set by Brownian motion with an acceleration around 0.1 to 0.5 *milli-g*, giving an accuracy of ca.  $\pm 1\%$ . The accelerometer records data up to 2000 times per second that allows the frequency up to 1000 Hz to be identified.

**Figure 1: SENRS CX1 accelerometer**

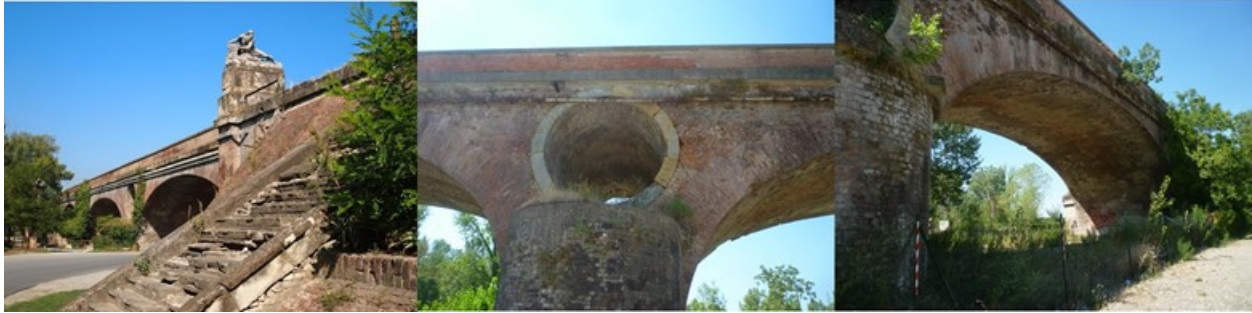
The process of identifying and quantifying damage with the use of the SHAPE system (including accelerometer technology, stochastic and FE analysis) is demonstrated through a case study for a masonry arch bridge. The 20 span 560 m long Taro bridge (see Figure 2) is located in Parma, Italy (built 1815-1821) [15]. Each span is 24 m long, constructed of brick masonry with three-centred arches and 4-metre circular openings in the spandrels. The bridge was damaged in the Second World War and has undergone significant repairs.

**Figure 2: Taro bridge (Ponte Paro), Parma, Italy**

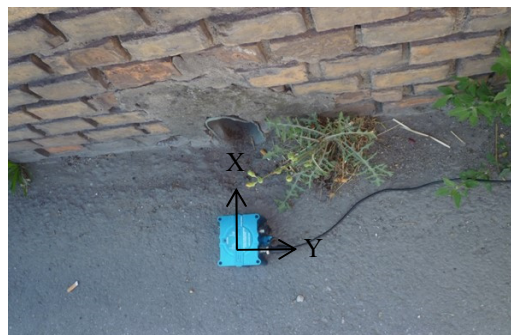
Frequency measurements were taken using a single the SENSR CX1 accelerometer. The CX1 was placed on the road surface next to the parapet (Figure 3) around the  $\frac{1}{4}$  of each span for 1 minute at each location. Data collection for all 20 span took about an hour and was a straightforward process.

**Figure 3: CX1 monitoring**

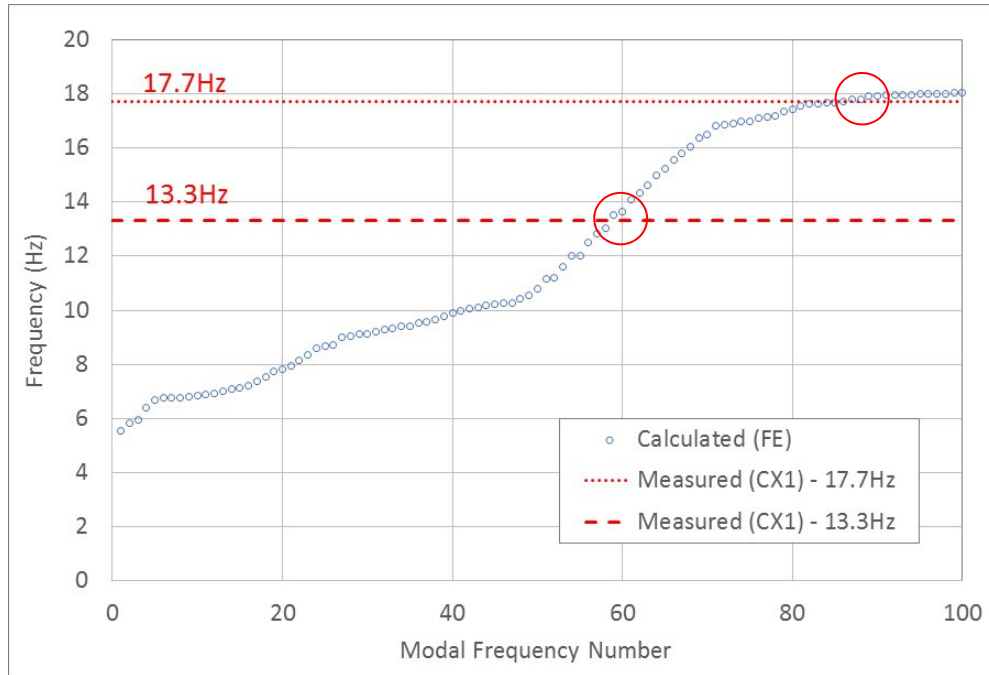
The first 100 theoretical modes from the FE model are shown in Figure 8 together with the two key measured frequencies (13.3 Hz and 17.7 Hz in the Z direction). The measured frequencies however do not match the calculated frequencies exactly. This is not surprising due to difficulties in defining the geometrical and material properties of historical bridges and their inherent variability. The case study highlights one of the fundamental difficulties using FE analysis for masonry structures. A number of reasonable approaches are however possible at this stage.

Sensitivity or probability assessment can be carried or simply the neighbouring modes considered in the vicinity of the measured key frequencies. For the current case study the neighbouring modes are identified (mode 58 (13.02Hz) and mode 59 (13.53Hz) either side of 13.3Hz and mode 85 (17.67Hz) and mode 86 (17.73Hz) for 17.7 Hz) are considered and the description of modes is listed Table 3.

**Figure 8: Comparison of measured and calculated modal frequencies**

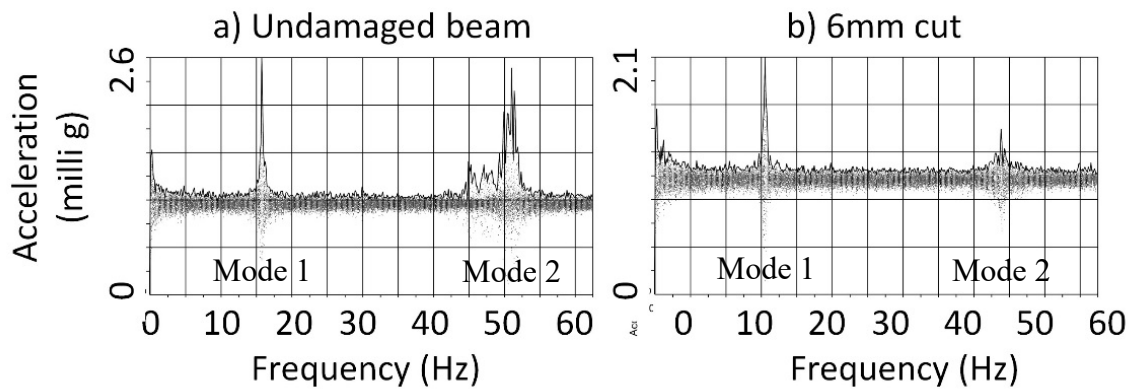
In order to demonstrate the process of quantifying deterioration over time for increasing damage, at least two acceleration recordings with some sort of change in the frequency spectrum are needed. As only one acceleration recording is however available for the Taro bridge, recordings for a simply supported timber beam are used (35 mm (H), 87 mm (W), 2400 mm (L)). The beam was damaged at mid-span by an increasing depth of cut at the bottom and acceleration was measured under ambient vibration. Figure 9 shows the FFT output up to ca. 60 Hz a) for the undamaged beam and b) for a 6mm cut. The first mode is around 15.7 Hz for the undamaged beam and ca. 15.3 Hz for the 6mm cut with a hardly noticeable ca. 2.5% change in frequency. (Standard statistical analysis identifies change to be significant at 5%). Figure 10 shows the measured frequency of the first mode against increasing damage (remaining depth).

**Figure 9: FFT output for a) undamaged beam and b) damaged beam with 6mm cut**

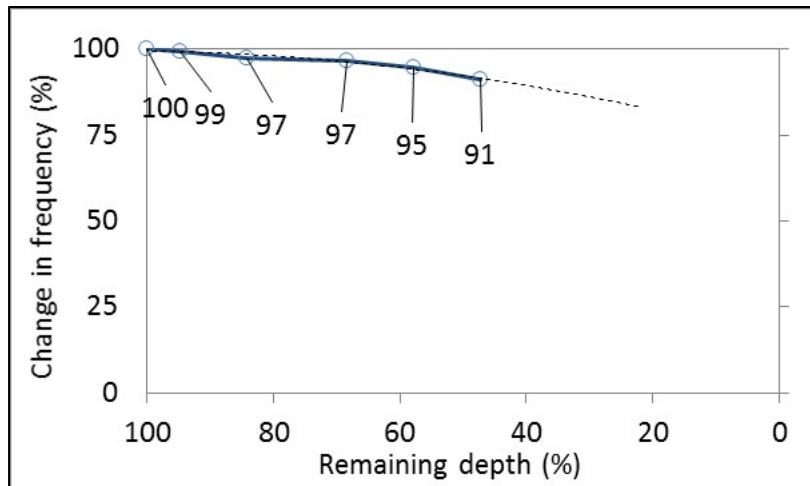
**Figure 10: Rate of deterioration for a beam**
